TECHNICAL REPORT

**SALTER POINT
FORESHORE
RESTORATION PLAN
REVIEW**

SEPTEMBER 2015

FOR
CITY OF SOUTH PERTH

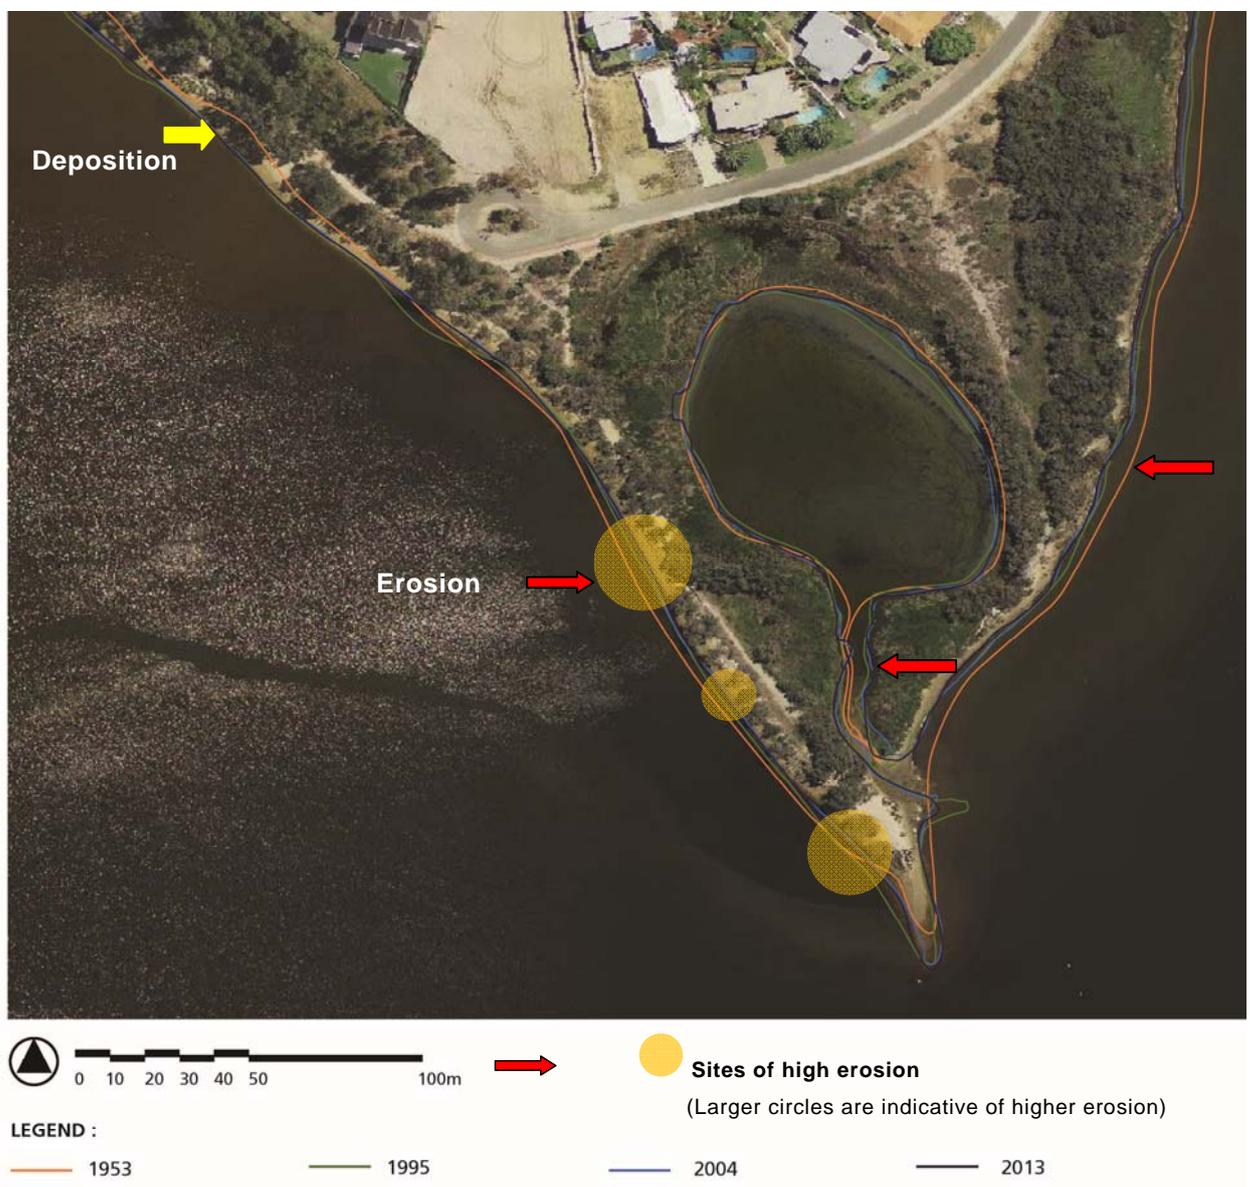
Figure 3 Changes in shoreline extent between 1953 and 2013 (Imagery: Landgate, 2013) showing approximate sites of significant erosion

An observation of historical photographs between 1953 and 2013 has revealed that most of the erosion for the site has occurred along the eastern and western foreshores and the channel connecting the lagoon to the river (indicated by red arrows in Figure 3).

Given the variation in river water levels (some images were taken at different times of the year and both high and low tides), the overall erosion of the western foreshore since 1953 would account for less than 5m of the shoreline loss, with the highest level of erosion being observed in the area currently adjacent to the boardwalk (Zone 2, see red arrow on Figure 3) and at the lagoon outlet. It appears that the shoreline deposition process is occurring to the north west of the site (indicated by yellow arrow).

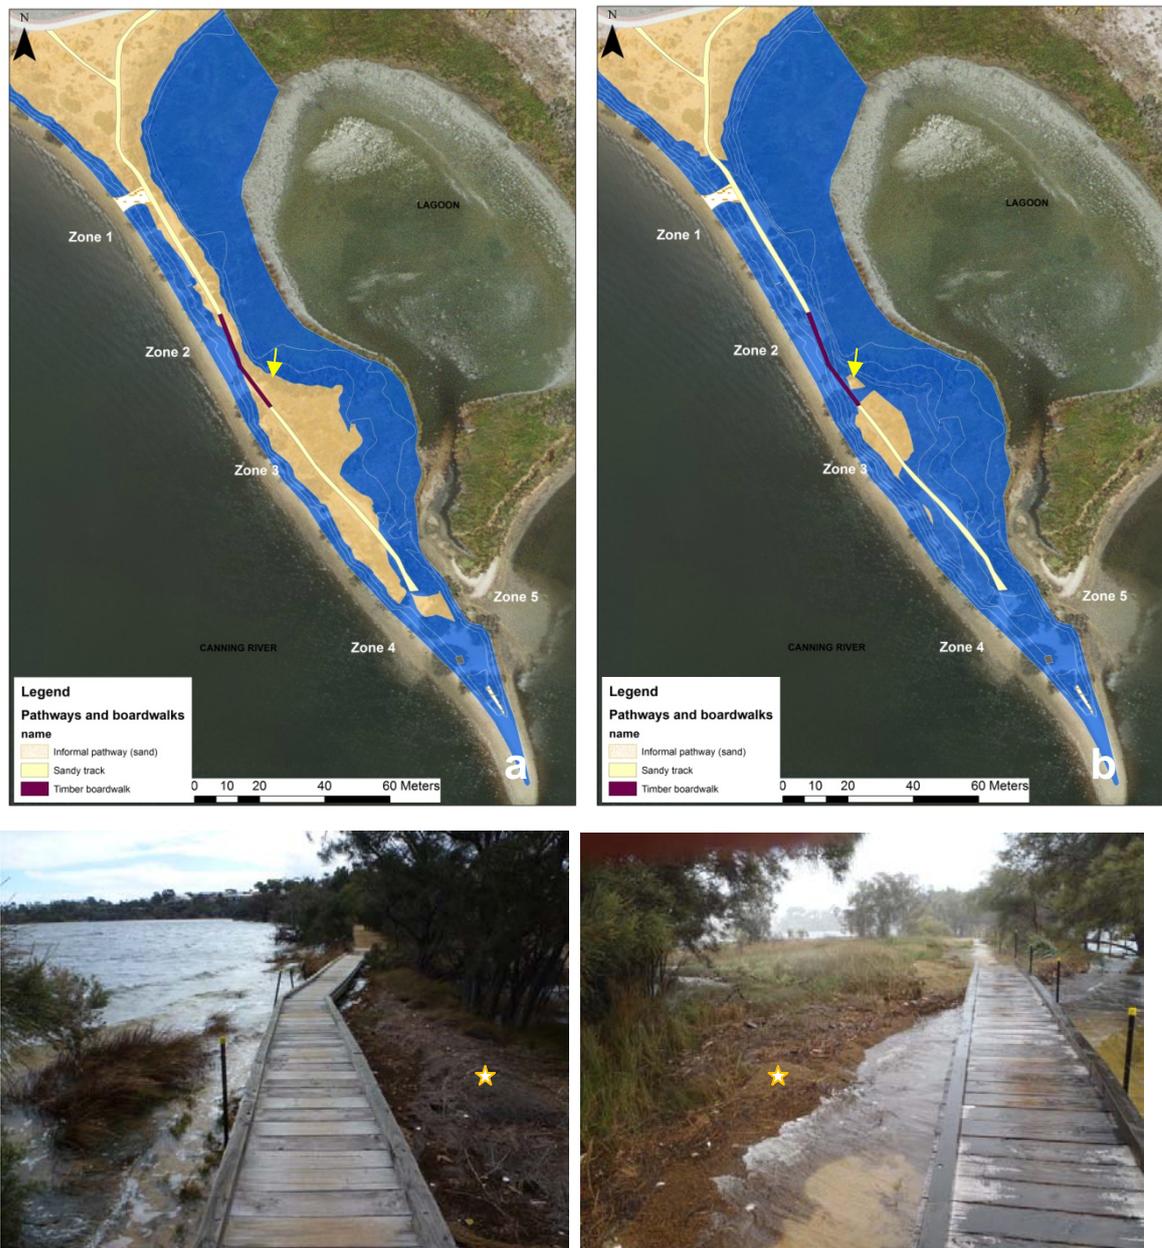
The typical tidal movements for the site and those of the storm surge have been presented in Figure 6 using topographic contours of the area (Figure 6). Photographs of the site during winter high tide (Figure 6 c) and the storm surge on 11th June 2012 (Figure 6 d) are also presented.

Please note that the tide heights presented in Figure 6 (b) and (d) show increased water level to 0.8m AHD on the site which was contributed by strong wind waves.

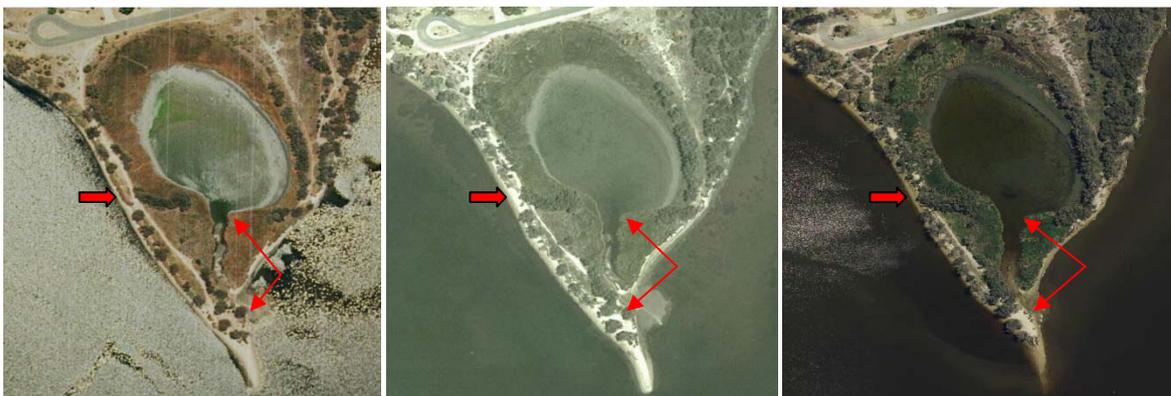
Figure 8 Vegetation losses on site 1995 – 2014 (Source: Landgate, 2014)

Vegetation losses between 1995 and 2013 are shown in Figure 8 below (red arrows).

It is likely that the prolonged inundation and increased salinity due to low rainfall have contributed to the decline of some of the fringing vegetation in the recent years in combination with waves generated by wind and boats. Given that the trees like *Melaleuca cuticularis* and *Casuarina obesa* have very shallow roots (an adaptation to avoid anoxic conditions deeper in the sediment), even small amount of erosion around the roots can destabilise the trees and cause them to be uprooted during strong winter storms. Roots of trees

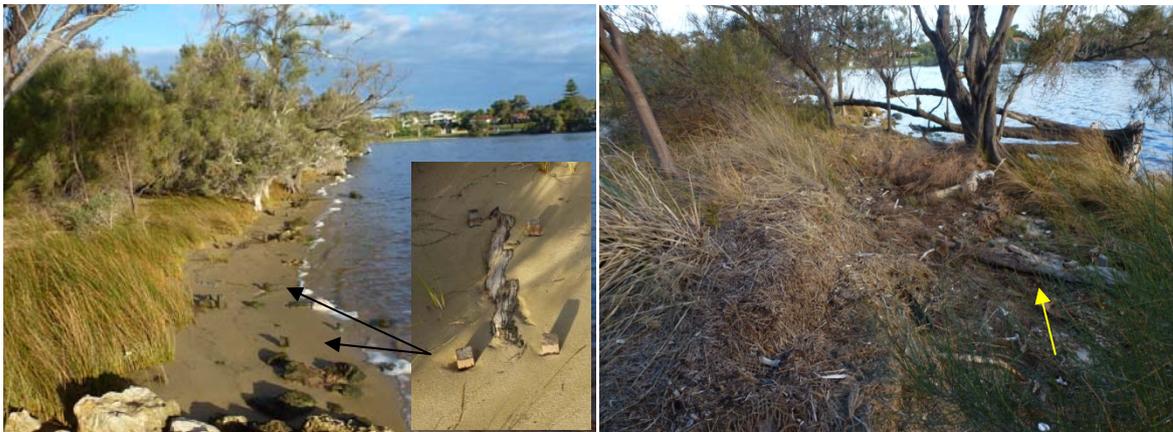
The level of erosion in these zones after restoration works appears to be reduced based on the amount of sand accretion occurring surrounding the woody debris, with most logs being buried two years after installation (Figure 9). Only small areas of Zone 3 contain coir matting predominantly in the upper part of the foreshore where the influence of waves and tides is less frequent.

Figure 9 Coir mesh and scattered wood debris showing site in May 2014 – all logs buried in sand Zone 1 (left) and exposed logs in Zone 3 (right)

Coir mesh and scattered wood debris method of erosion protection was valuable and has prevented further erosion where installed, particularly in Zone 1. However, in the areas of Zone 3 where undercutting at 0.5 and 0.6 mAHD is present, this method does not appear to have been as effective, with little to no sand accretion particularly in areas that have sedges missing (Figure 9). The logs installed in Zone 3 were positioned slightly higher (~0.3 mAHD) than in Zone 1 (0.1 - 0.2 mAHD) which was likely to have been the reason for the difference in addition to increased water scour as a result of the undercut areas.

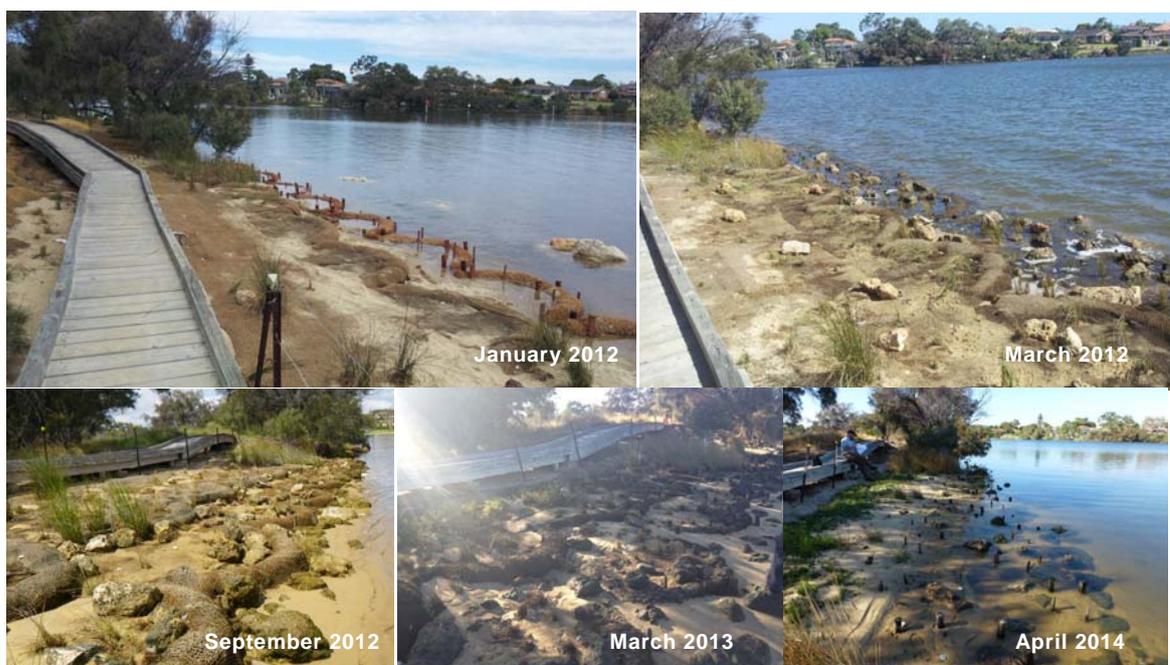
When wet, coir nodes can enhance wave reflection (SRT, 2010) since they have a low porosity which in turn causes undercutting at the base of the log and the loss of coir material. However, despite the loss of the coir logs, the erosion in this area was minimised, and sand accretion promoted.

Figure 10 Coir node restoration in Zone 2 (2012 -2014)

Coir node method was successful in terms of minimising erosion and encouraging sand accretion. However, this method was not the best choice for longer term protection of Zones 2 and 4 and general plant establishment. This is attributed to high wave impact in these zones, particularly in winter. The hard surfaces such as the boardwalk (Zone 2) and the Telstra service access pit (Zone 4), in addition to very little or no vegetation cover and the strong wind waves are the main causes of erosion in these areas. Installing coir nodes at 0.2m AHD did not appear to hold any benefits as they were submerged at all times during autumn and winter periods and this had no effect in breaking the wave impact except at very low tides.

Once the coir logs are eroded, the stake ends are unsightly and offer a tripping hazard. The stakes should be removed either by pulling them out (a difficult and likely disruptive procedure that may cause localised erosion) or cutting the top of the stake and driving it further into the ground using sledge hammer. Driving stakes into the ground or cutting them to be flush with the shore would be preferable as pulling stakes out may break them causing large splinters which would be hazardous to beach walkers.

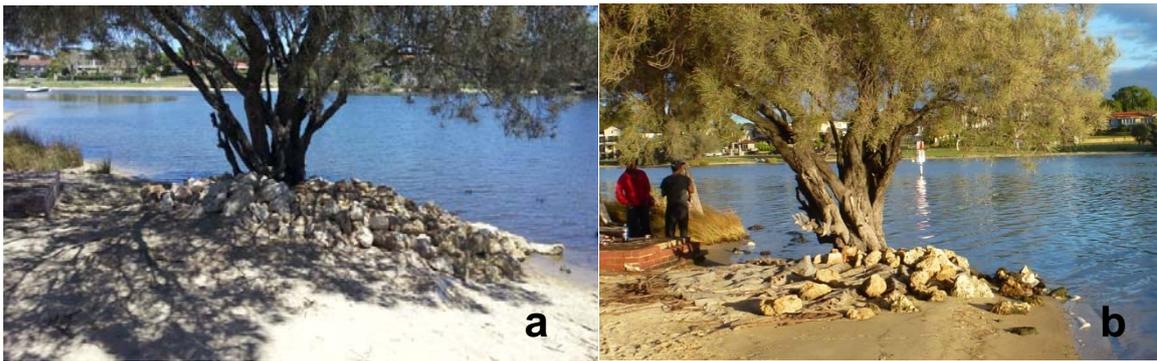
Rock Rip Rap was the simplest method of restoration works implemented on site whereby soil erosion is minimised by dissipating the wave energy across a multitude of medium to small limestone rocks. The rock rip rap was used to protect bases of the large trees (Figure 11) at the spit end (Zone 4) and in areas of high traffic such as access points. This method was deemed appropriate due to high disturbance in the area (high foot traffic) and other methods such as coir logs, brushmattressing and coir matting were not possible due to the proximity of the Telstra cable and size of the tree root ball which would have also hindered planting in the area

Figure 11 Rock Rip Rap surrounding a large tree in Zone 4 in 2012 (a) and 2014 (b)

Beyond keeping the erosion at bay in the low wave impact zone such as Zone 1, Rock Rip Rap did not work well in Zone 4 with no additional sand accretion observed either at the large tree base or at the spit point.

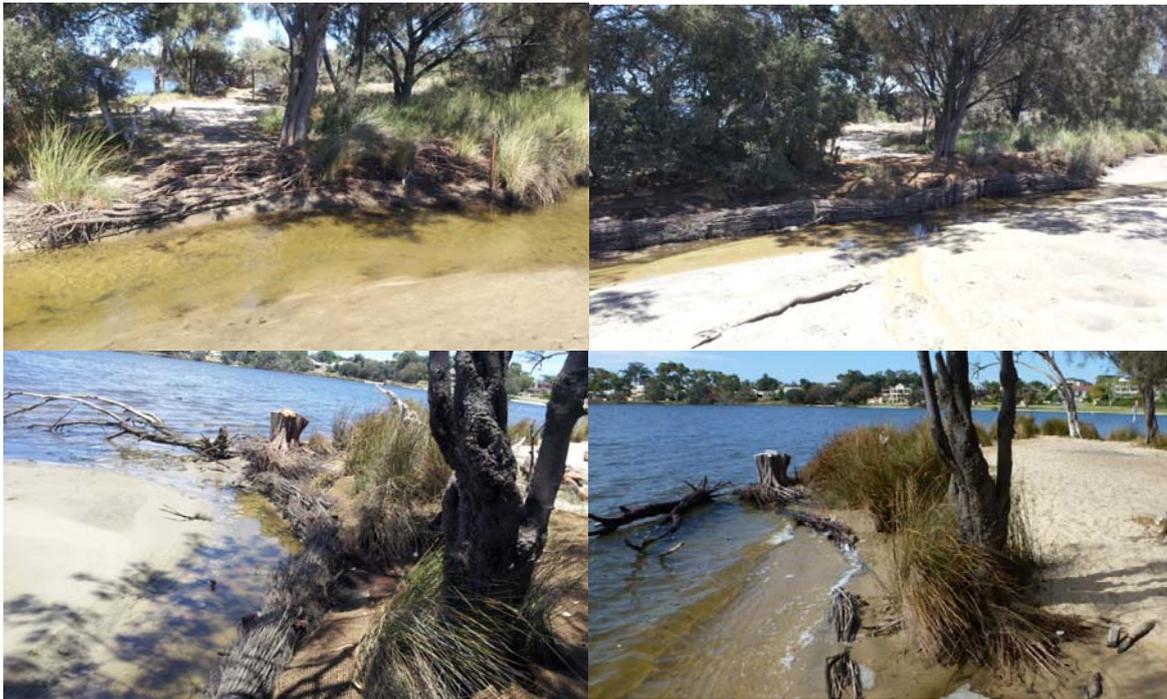
Figure 12 Brush Log technique of erosion control (lagoon outlet)

To maintain the efficacy of this erosion control structure, the brush logs should be monitored and maintained regularly and planting of *J. kraussii* conducted – once established, stems of the sedges can grow through the brush unlike the solid structures such as coir and timber logs.

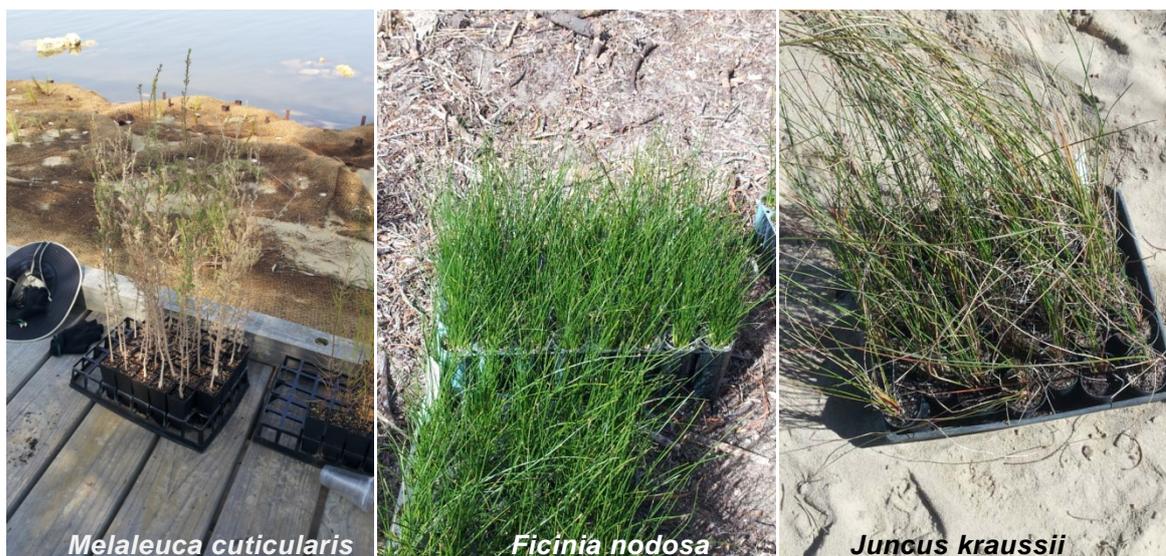
The stock used for planting on site consisted largely of immature plants that were not adequately hardened off to cope with the local conditions. In addition to this, some of the stock was in poor condition showing signs of stress even before being planted on site. These factors and in the case of the foreshore planting the height of the plants were some of the main contributors to poor plant establishment.

Figure 15 Condition of stock planted during restoration works in 2012.

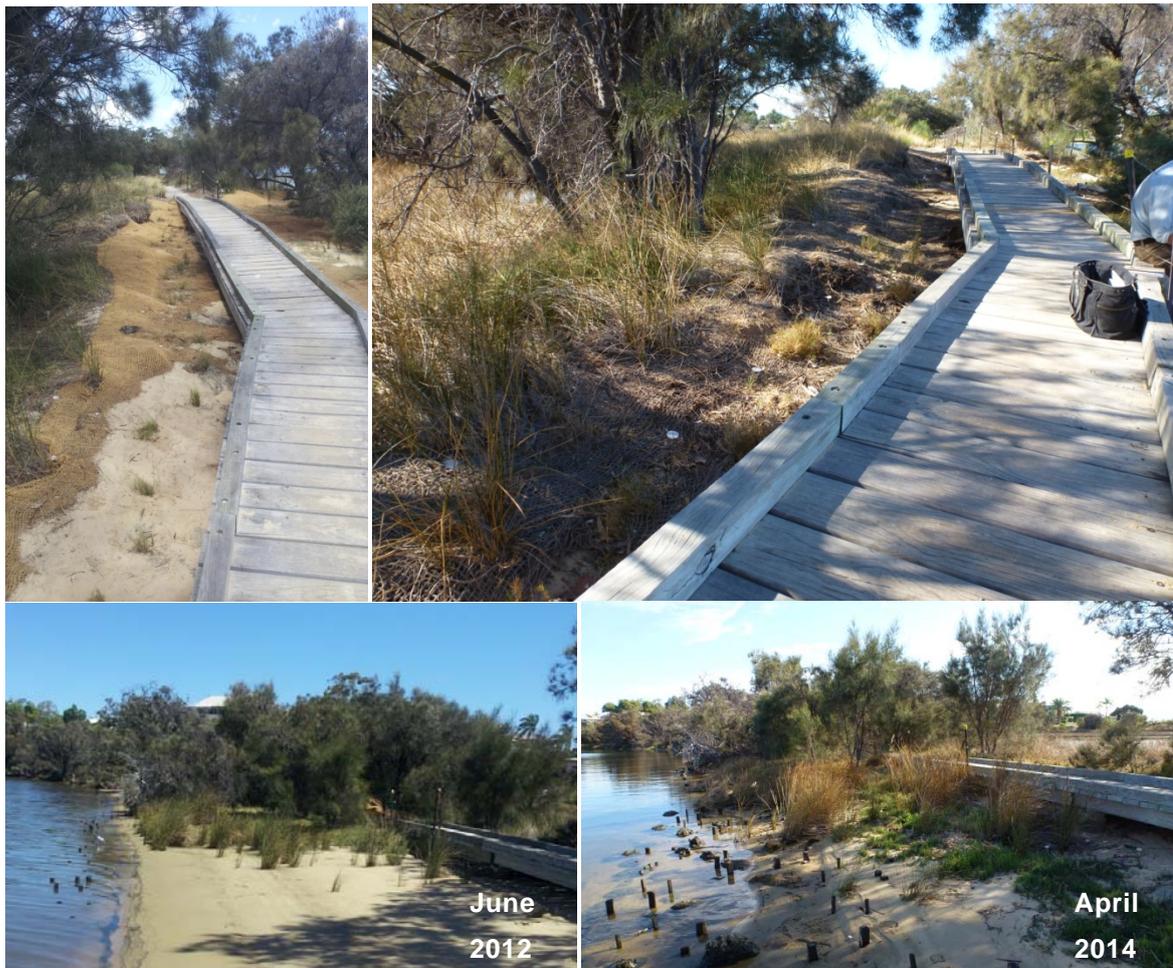
In general the establishment of lower foreshore vegetation was successful for the hardened off plants, plants installed above 0.4m AHD and plants which had sufficient height and size to cope with prolonged inundation. Marine couch (*Sporobolus virginicus*) showed the best rate of establishment with almost all plants surviving (Figure 16, April 2014).

Figure 16 Plant establishment over a two year period (2012 photos are to the left and 2014 photographs to the right)

Hardened off stock and correct planting position for Marine Couch have contributed to its establishment success. *Juncus kraussii* planting showed poor establishment throughout with the exception of the mature stock. Non compliant stock is the main reason for the poor establishment together with incorrect planting of some of the stock below 0.3m AHD which resulted in 'drowning' of new seedlings.

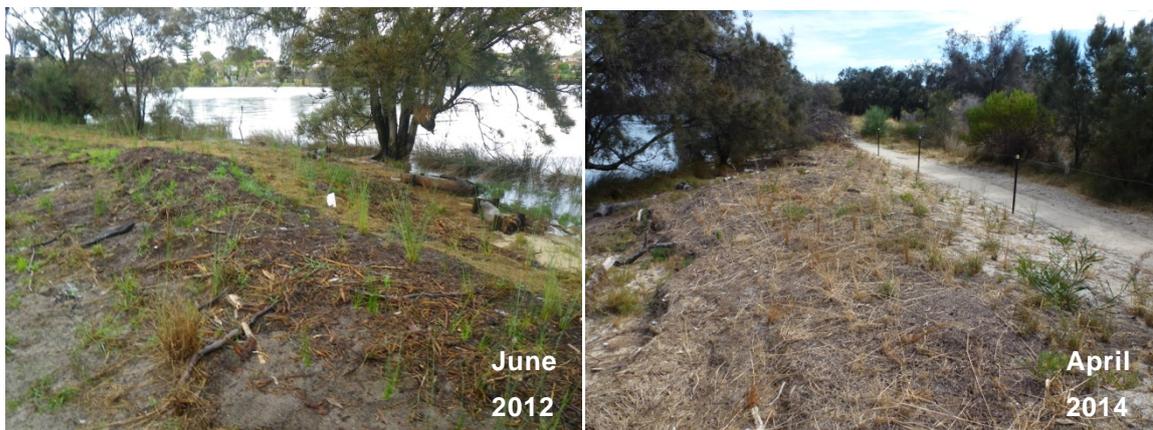
Shading by the surrounding trees, leaf litter and weeds also affect the growth of newly planted tubestock, although the weed cover is relatively low.

Figure 17 Upper Foreshore planting in the southern section of the spit (Zone 3) in 2012 (looking west) and the same area (looking north) in 2014

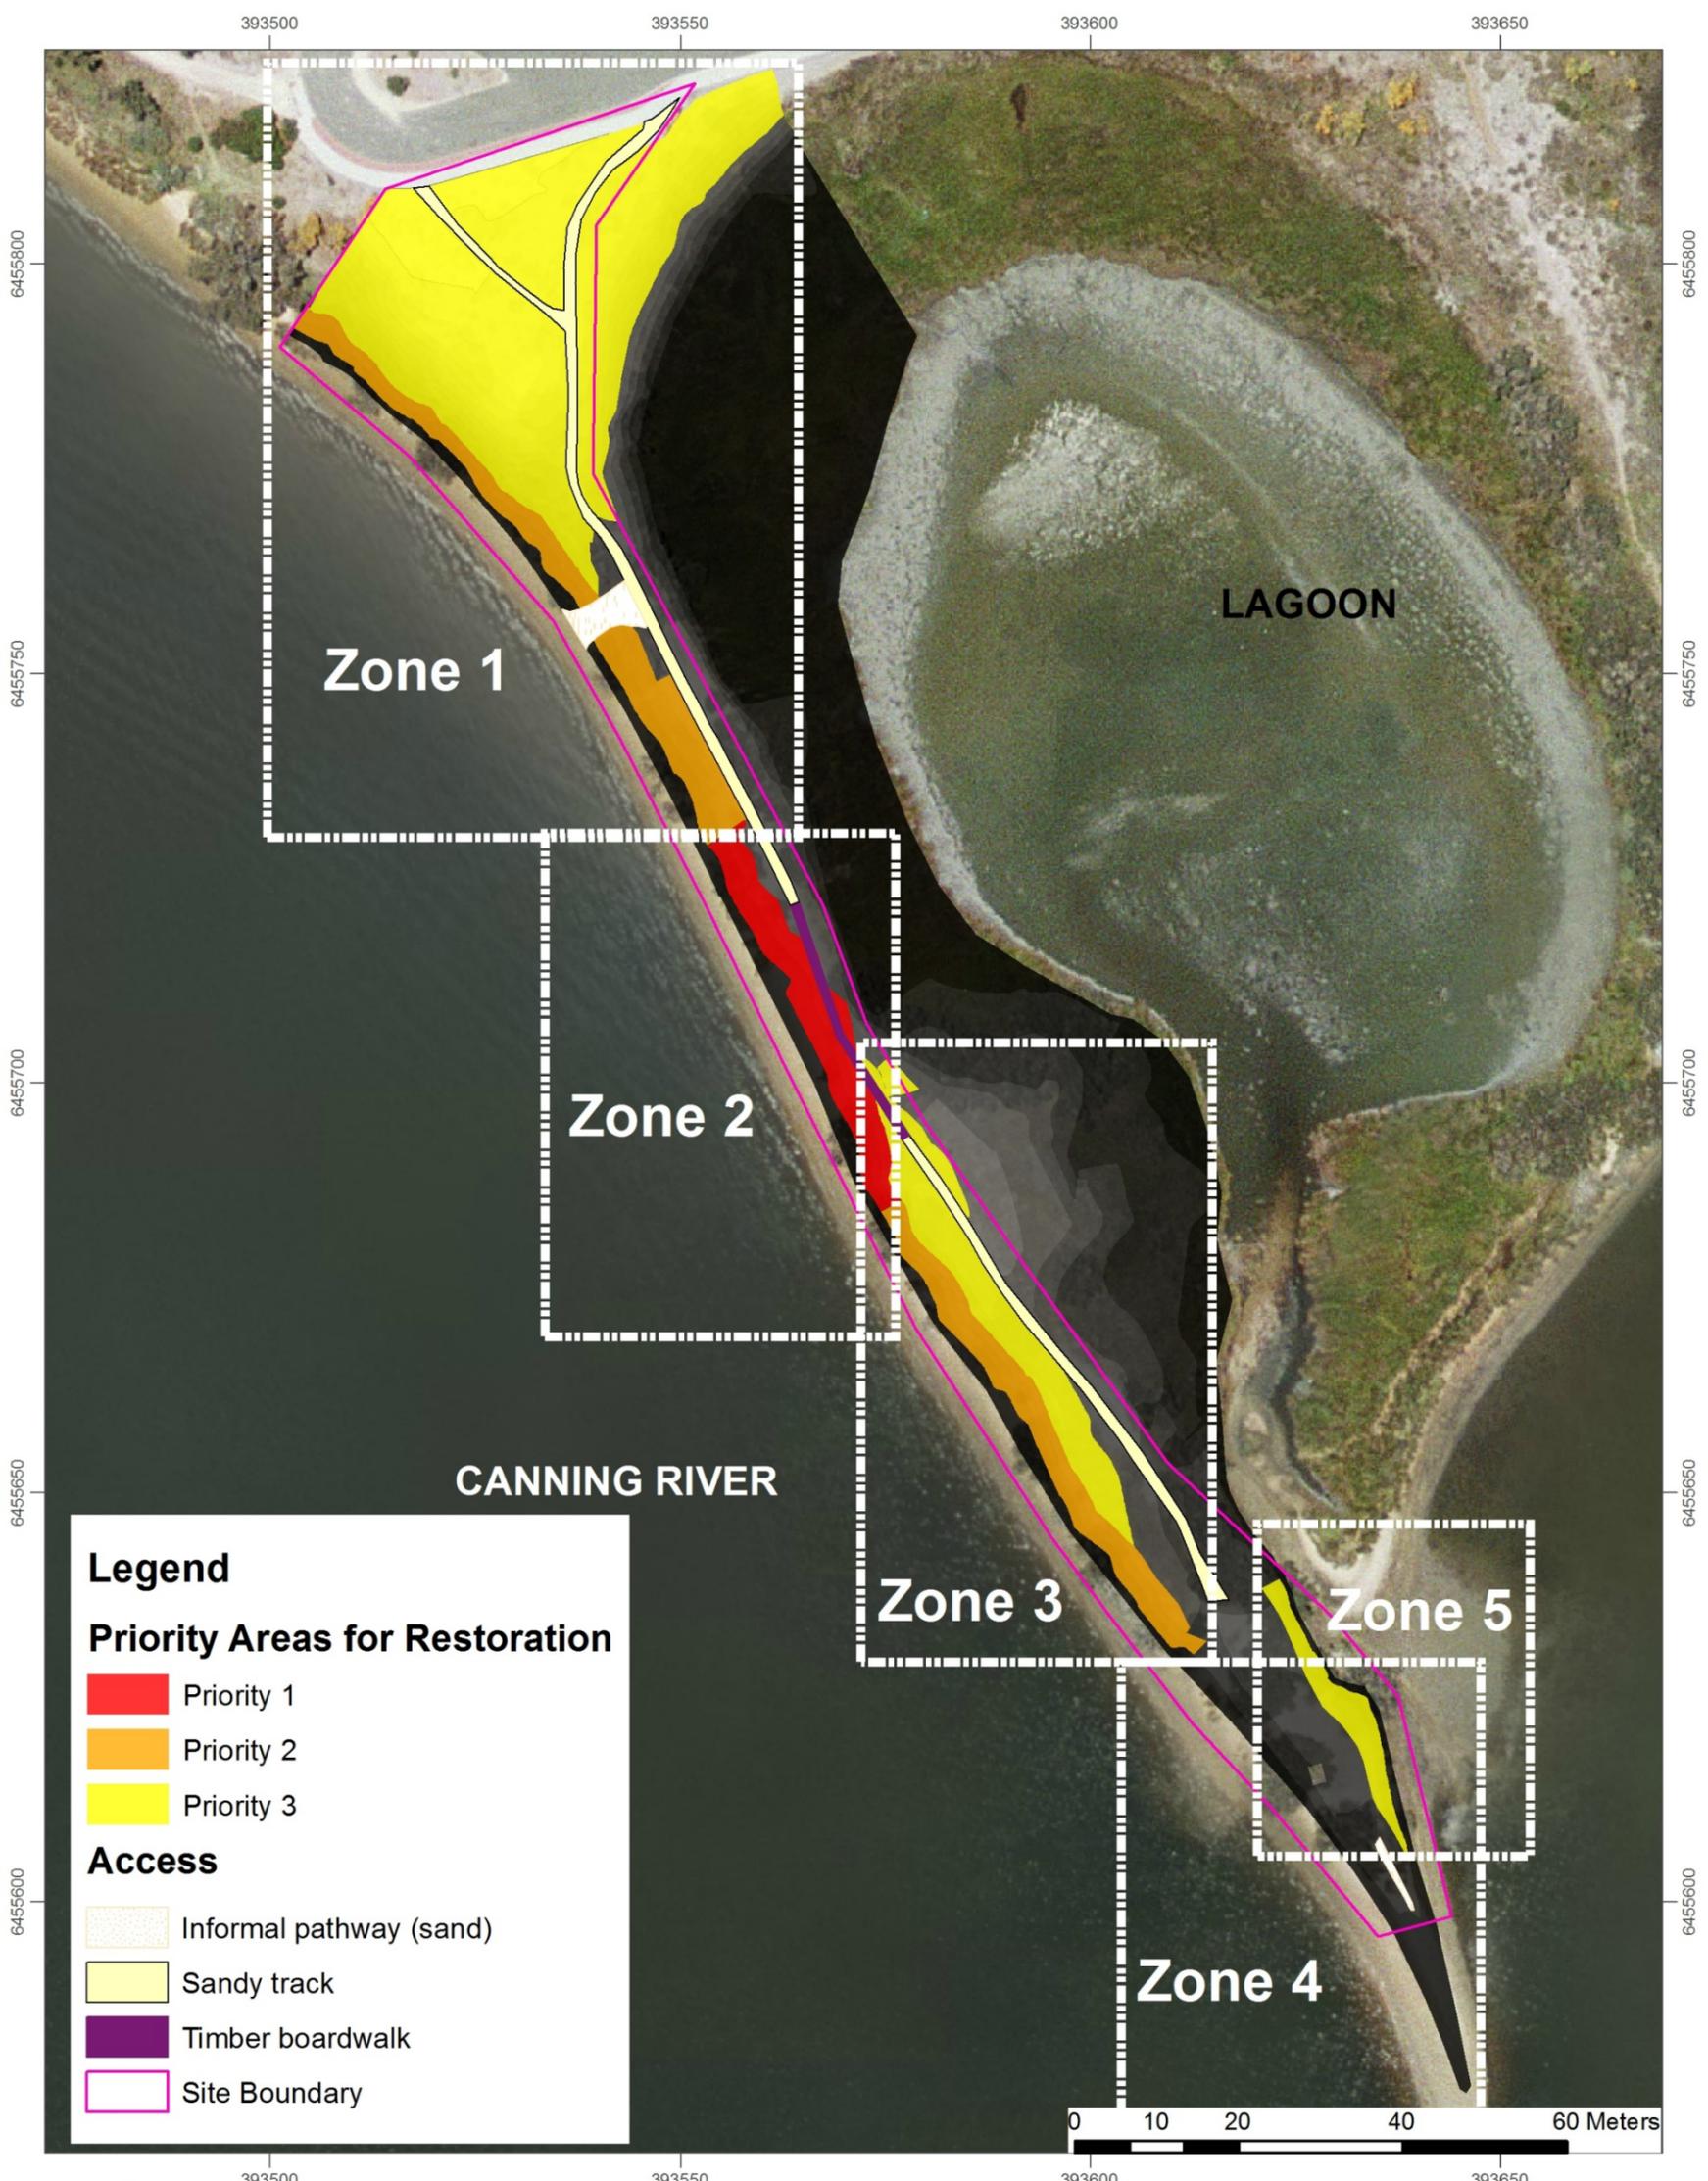
Salter Point Spit - Priority Areas for Restoration

The priority areas as at June 2015 based on the current level of erosion and plant cover are outlined in Figure 20 together with the proposed planting plan in Figure 21.

Figure 20 Prioritisation of areas for restoration at Salter Point spit
