St Martin in the Field, Structural Report

Project number: P21104
 Site location: Cnr Dyson & Vista Streets,
 Kensington, WA 6151

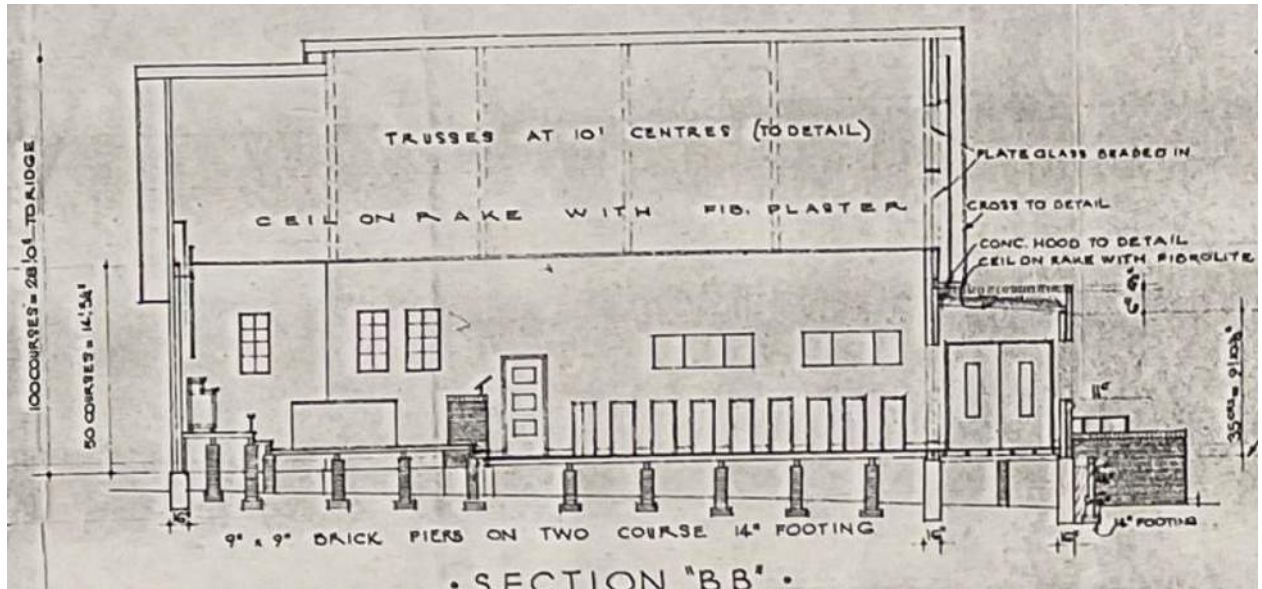
5.1.2 The maximum height of the building (from the existing drawings) from the top of the footing blocks (which is above the existing ground level) is 100 brick courses or 28'0" (refer Fig 1 below). This equates to just over 8.5m which, when added to the additional height from the top of the footing blocks to the ground, triggers the requirement in AS1170.4: Earthquake Actions to design the building to Earthquake design category II. This would require significant upgrades to the all the joints between various elements of the building (eg floor to wall, rafters/trusses to wall etc) and an assessment of the strength of the masonry walls under lateral earthquake loads, as well as Wind loads.

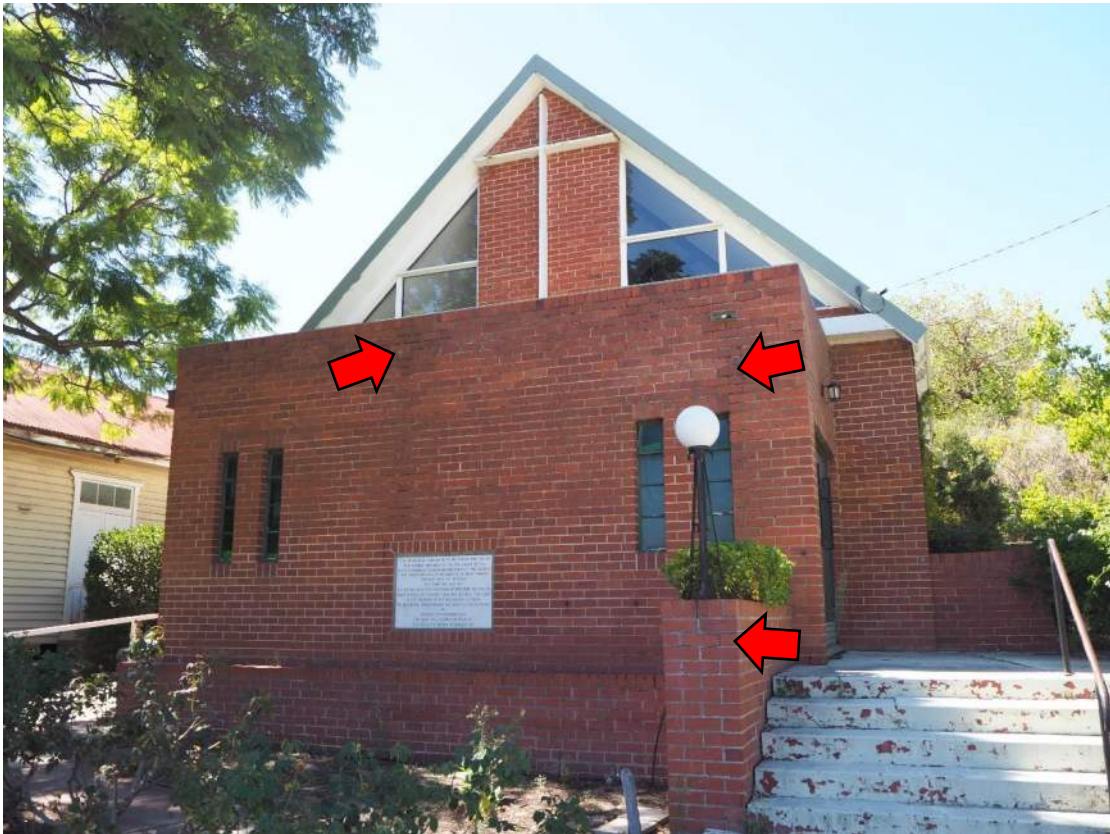
Photo 02 – Fretting mortar and damp staining, southwest elevation

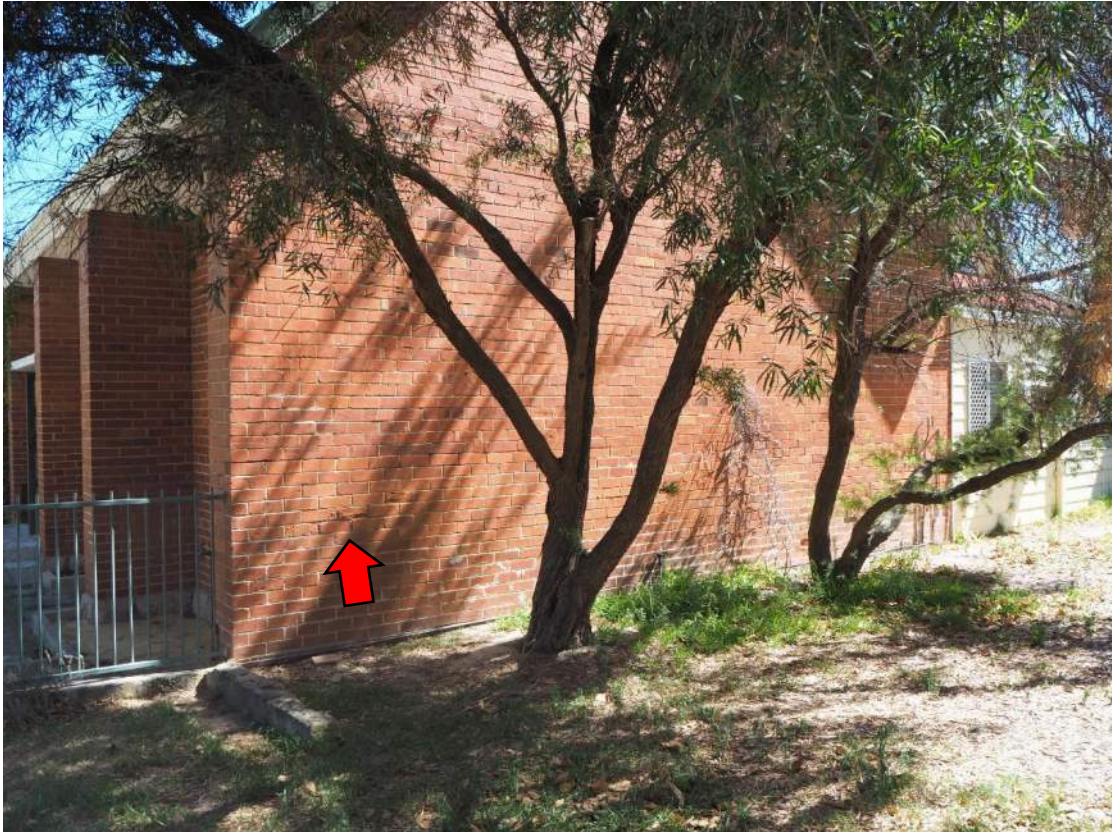
Photo 03 – Fretting mortar, northeast elevation

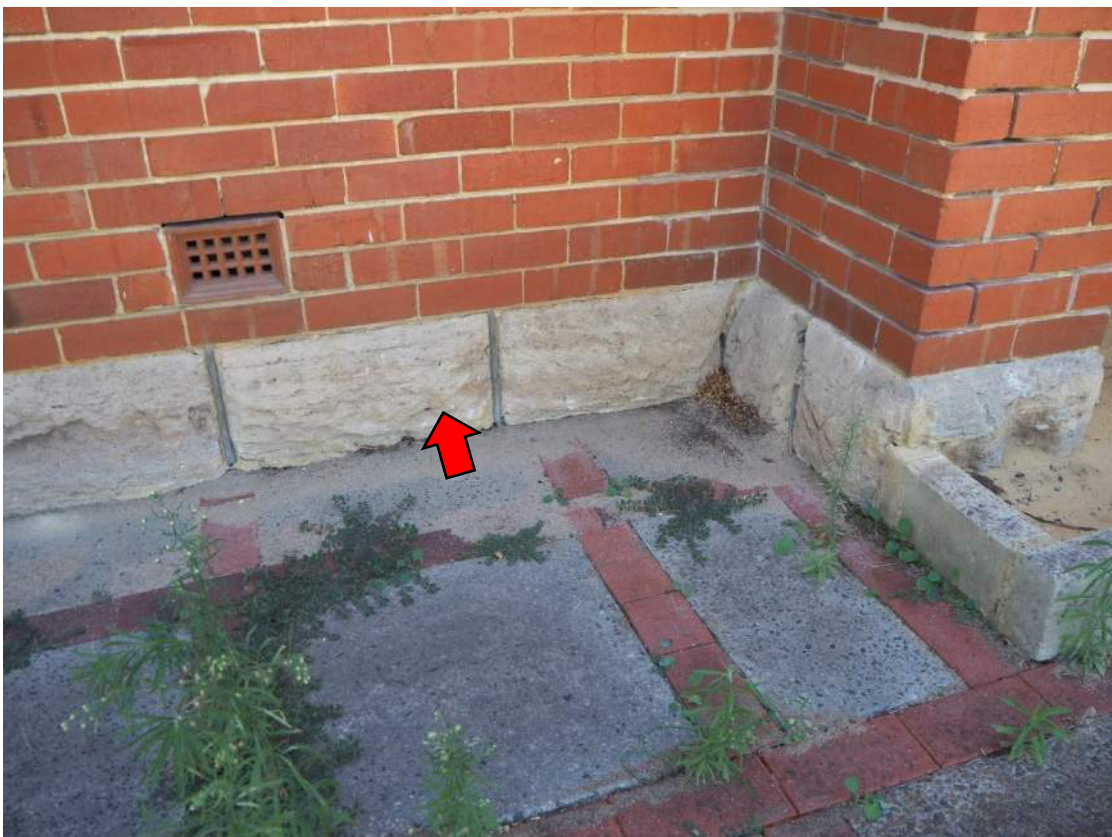
Photo 04 – Example of limestone footing blocks in good condition

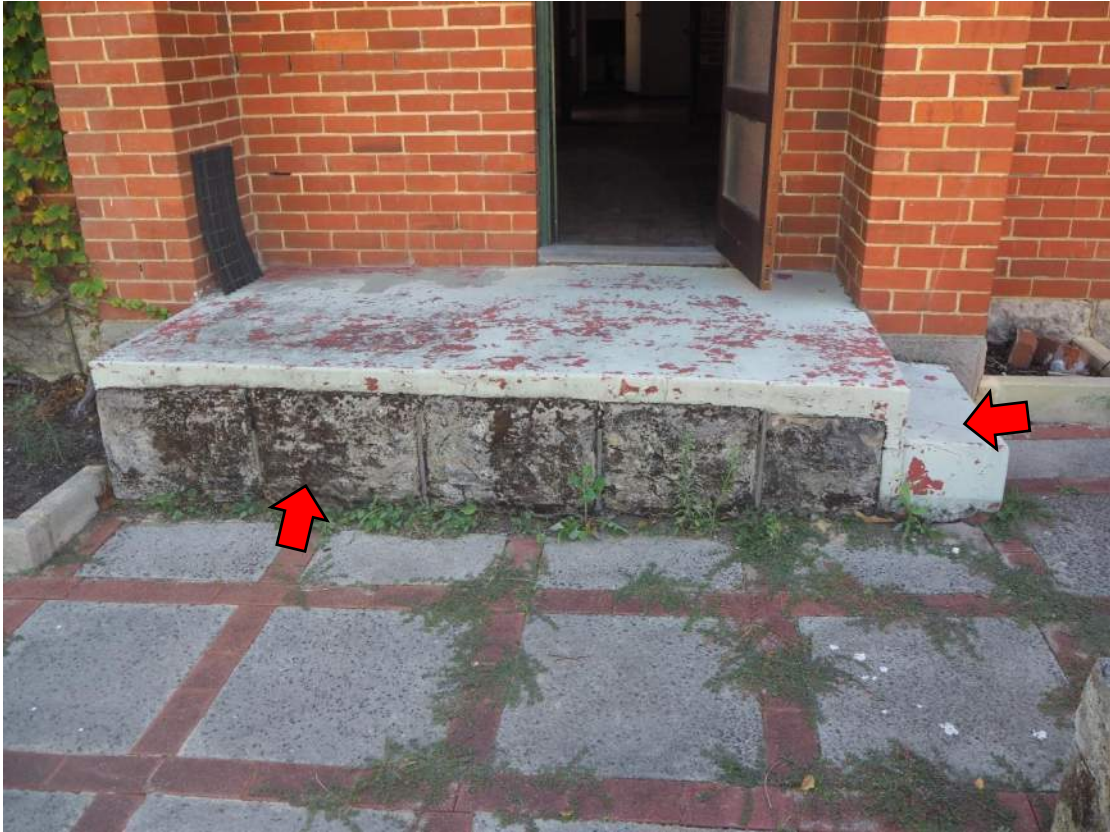
Photo 05 – Entrance steps weathered, and concrete cracked

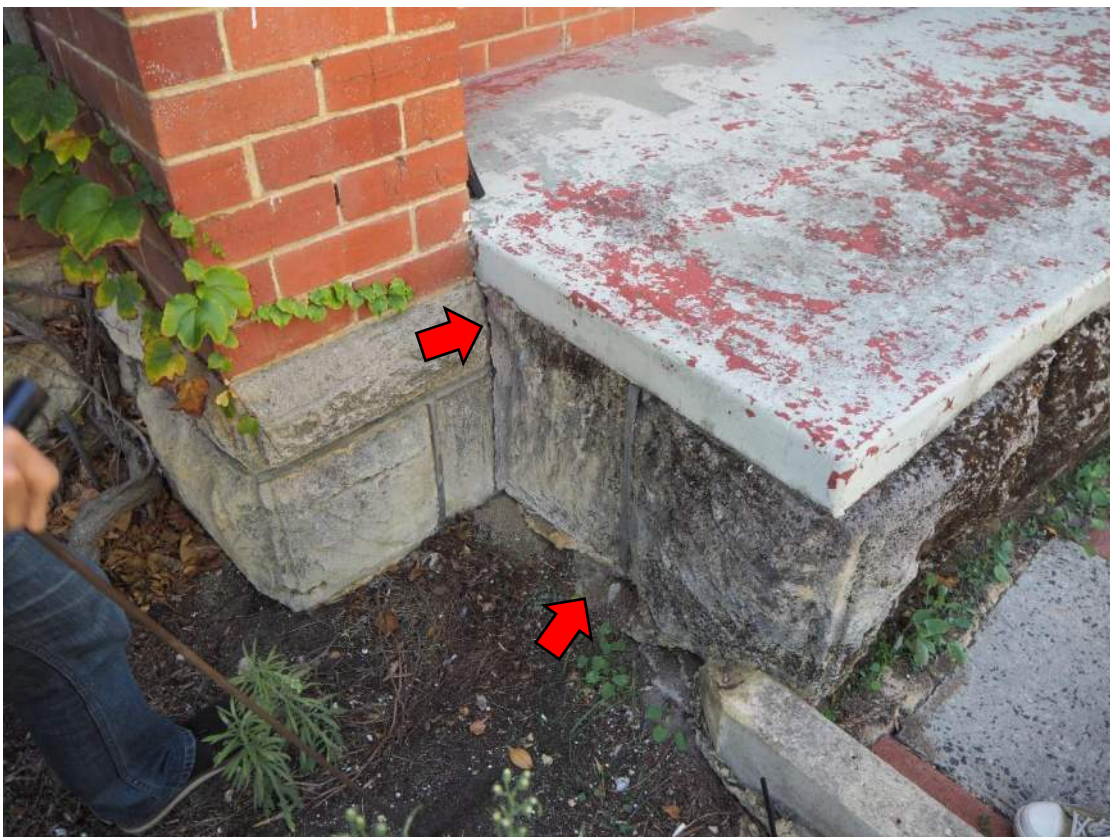
Photo 06 – Step footing blocks undermined and crack opening up between them and the original footing blocks.

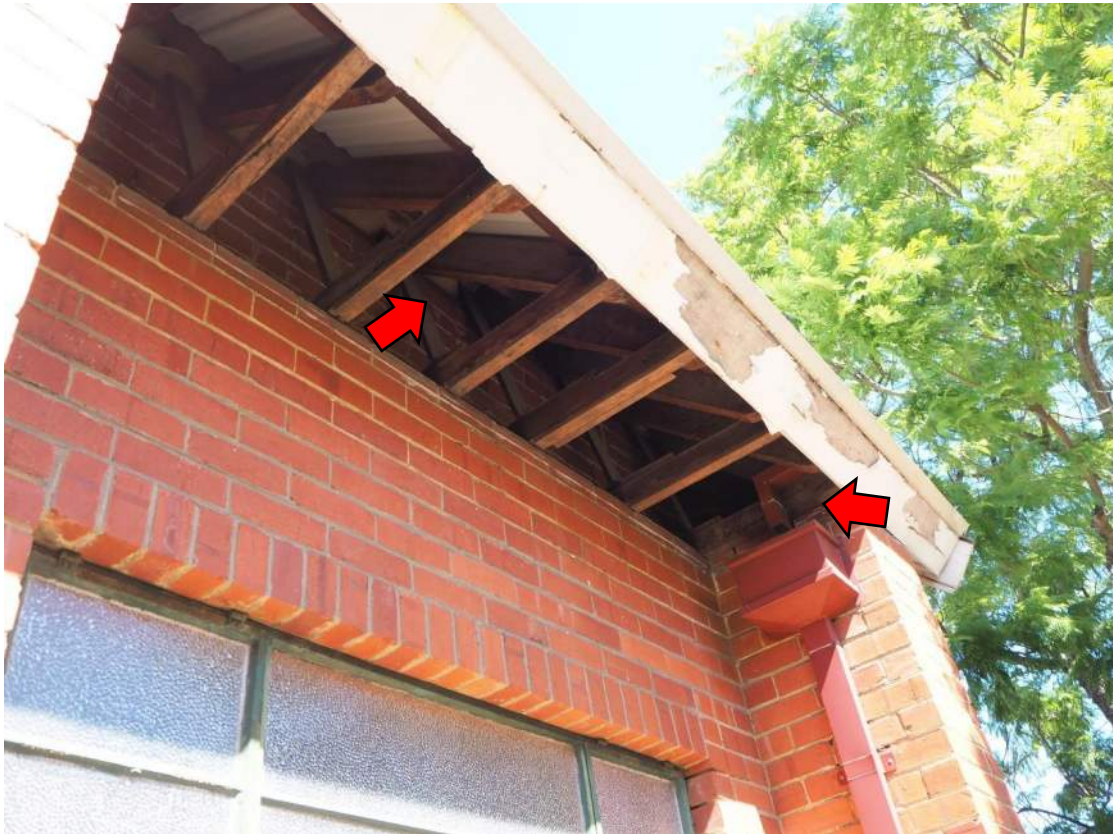
Photo 07 - Missing eaves boards. Note connection between hidden eaves gutter and downpipe rain head.

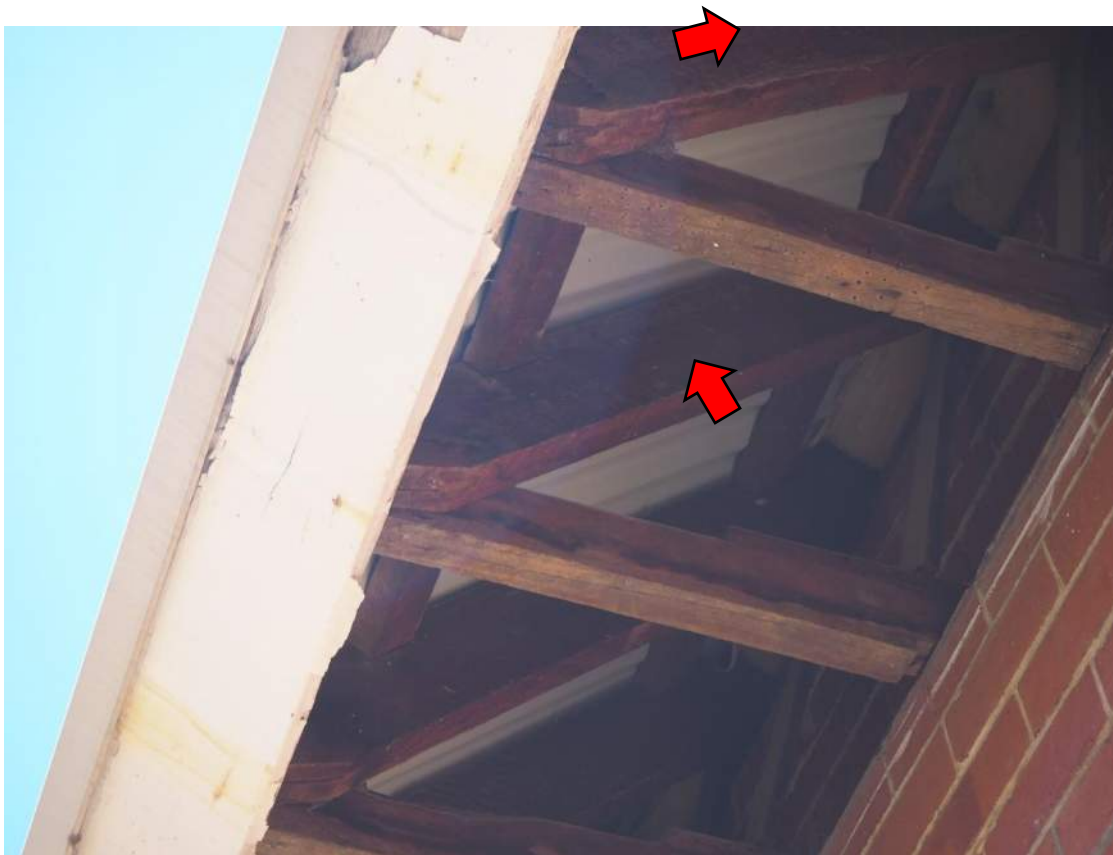
Photo 08 - Roof timber appeared in good condition.

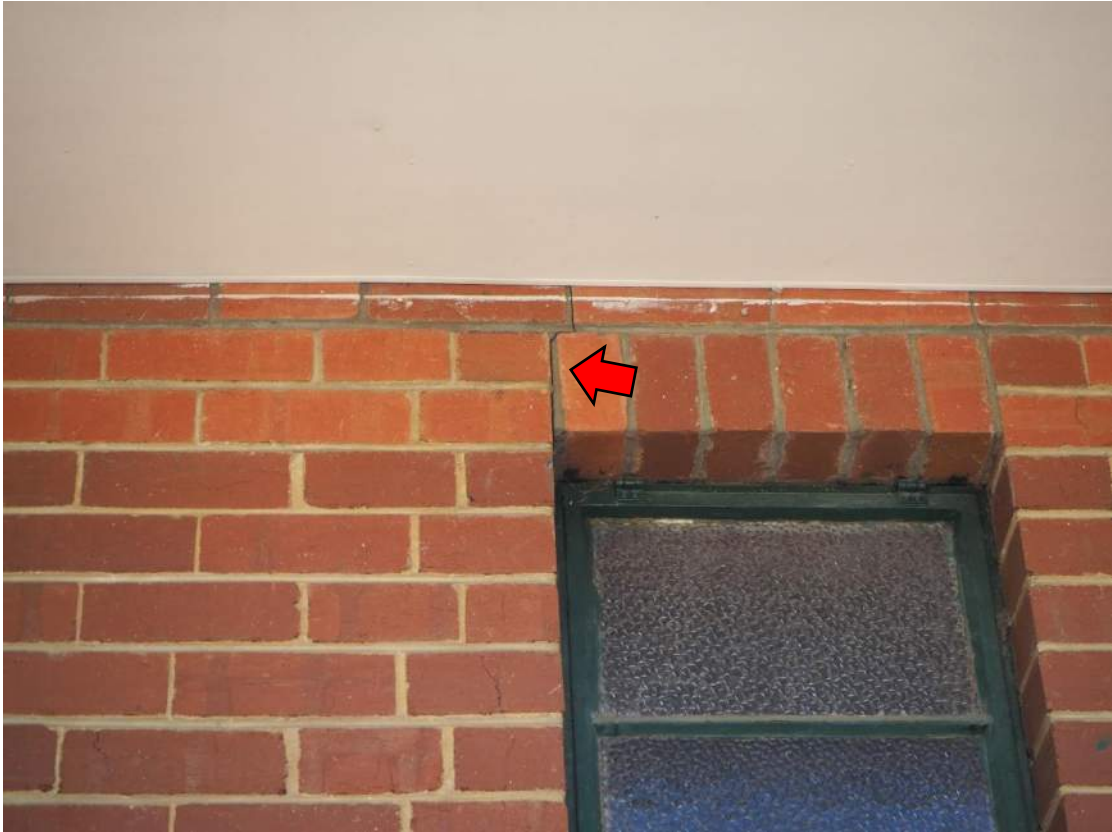
Photo 09 - Small crack in lintel above window

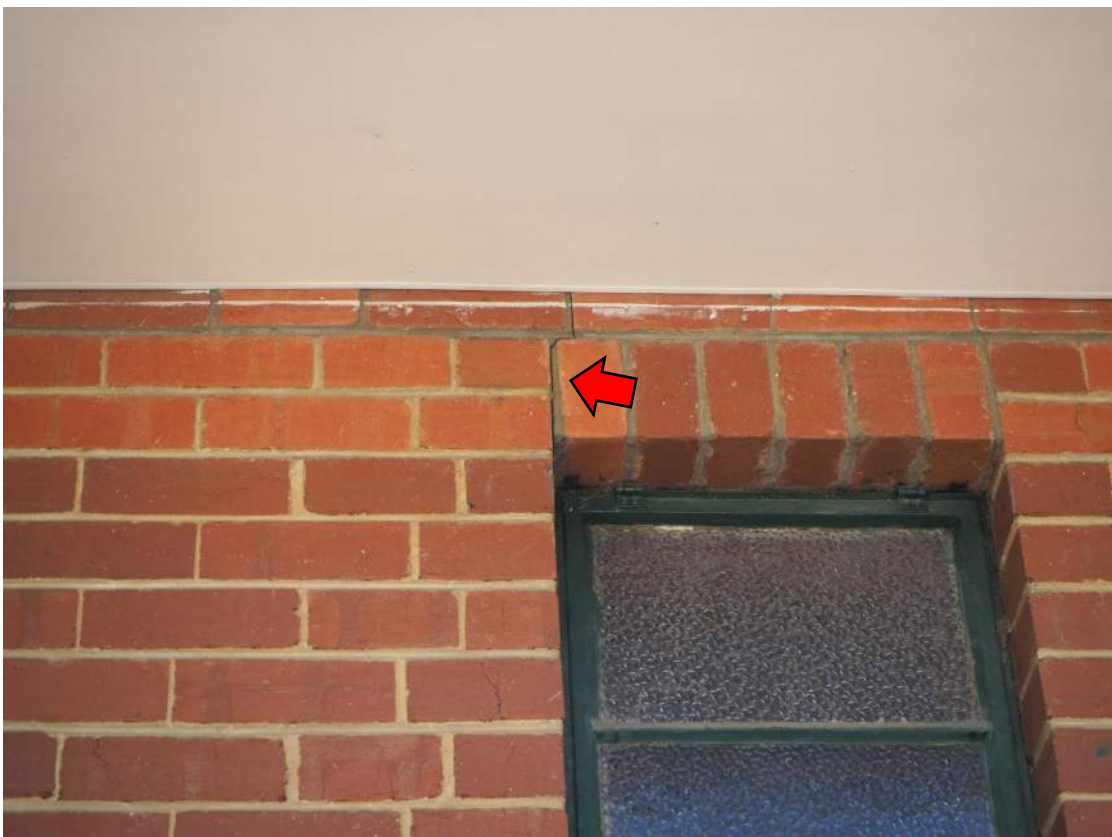
Photo 10 - Small crack in lintel above window

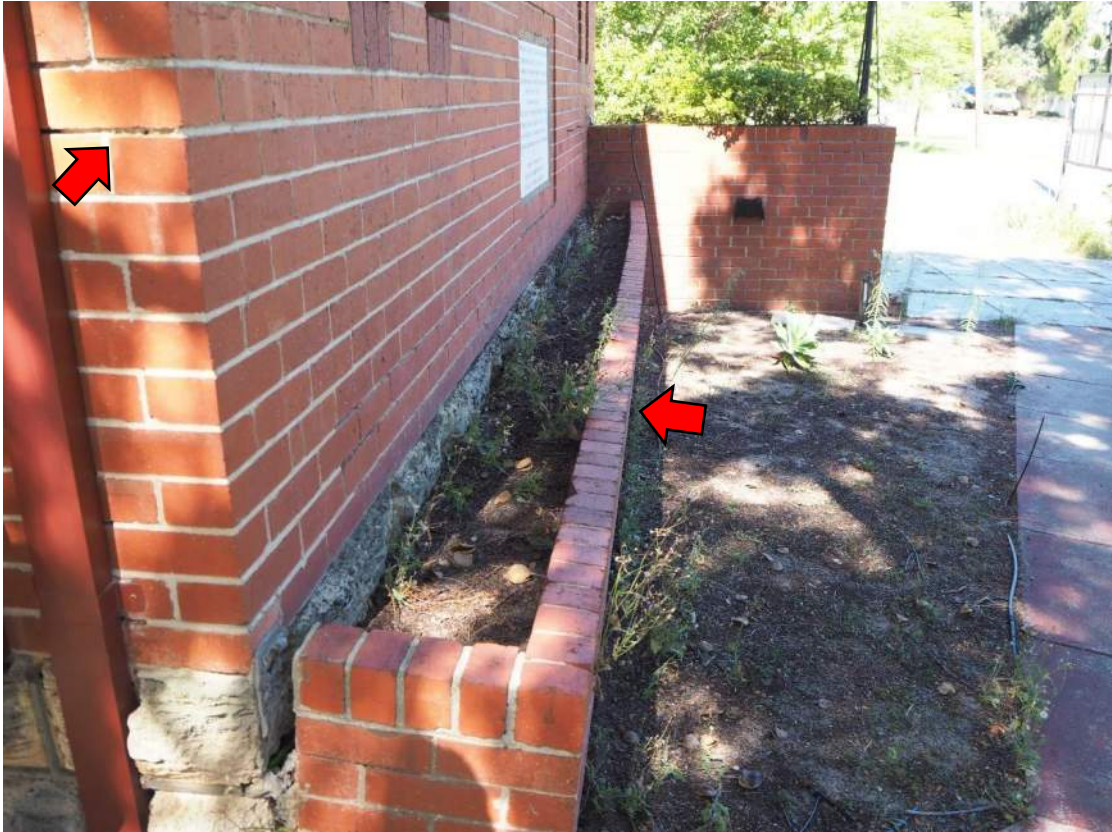
Photo 11 – Planter bed retaining wall has failed. Also note the fretting brickwork

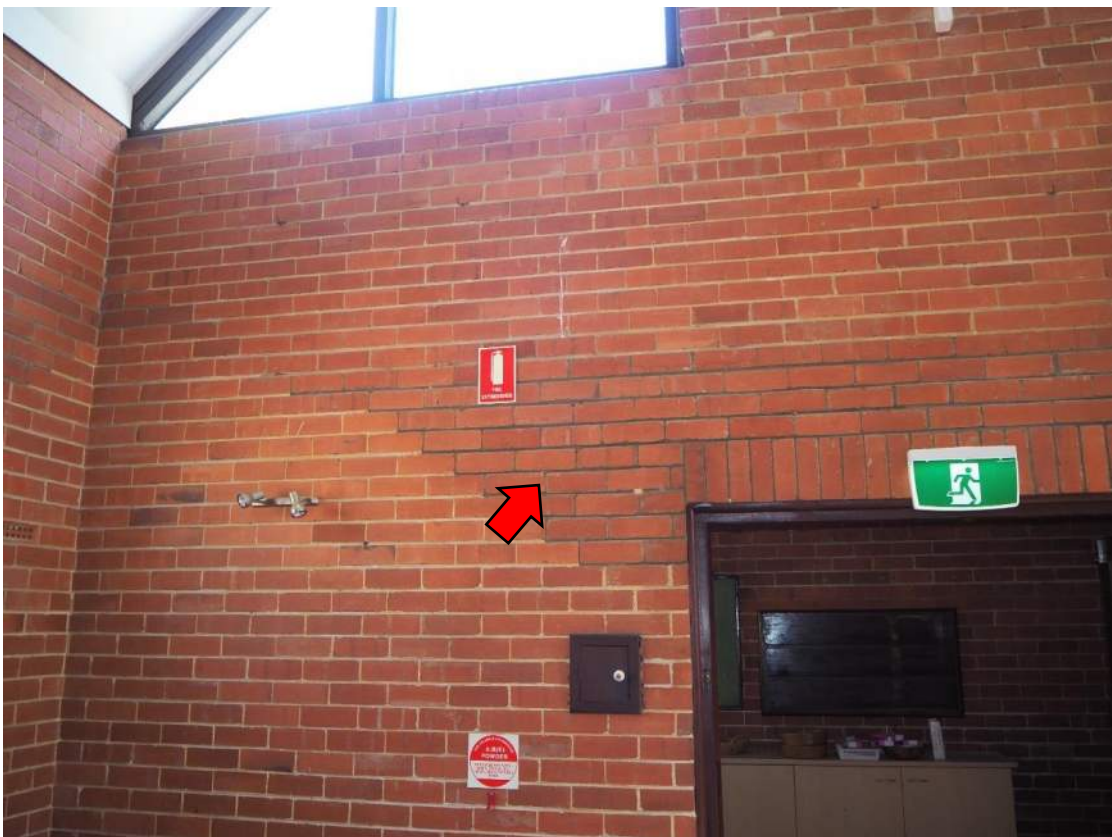
Photo 12 – Different coloured pointing above doorway.

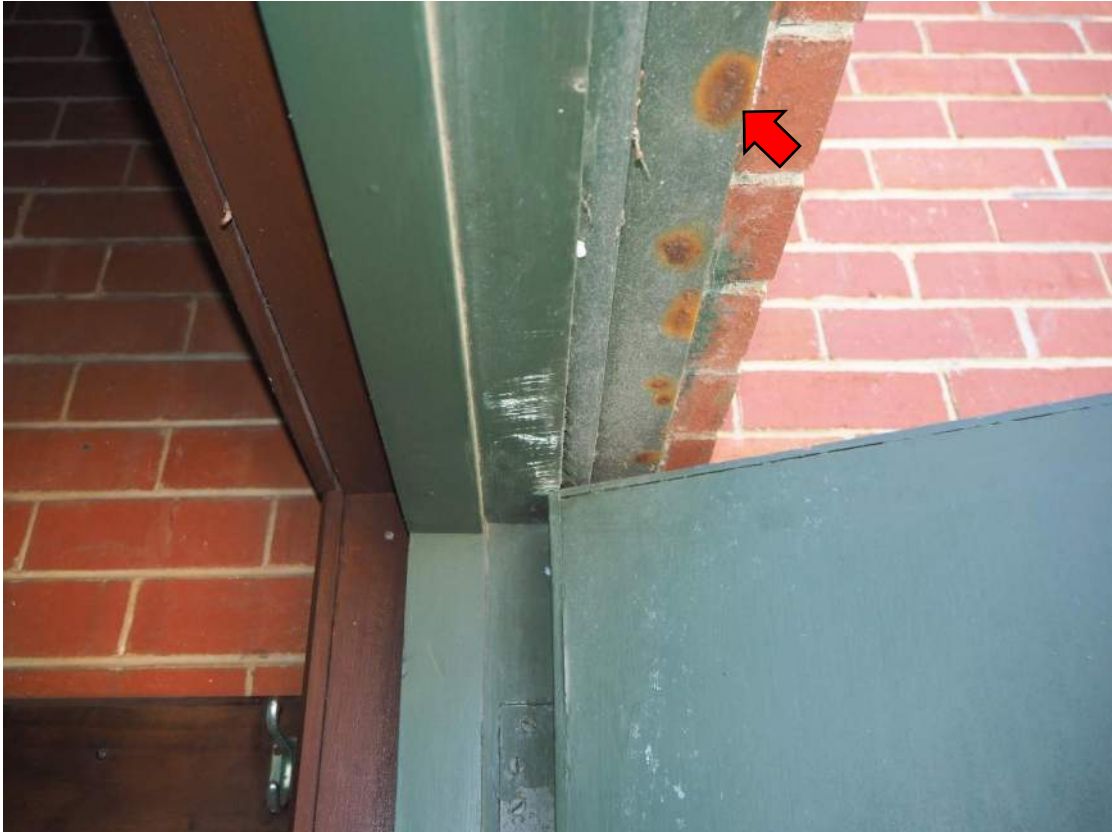
Photo 15 – Corroding lintel over doorway

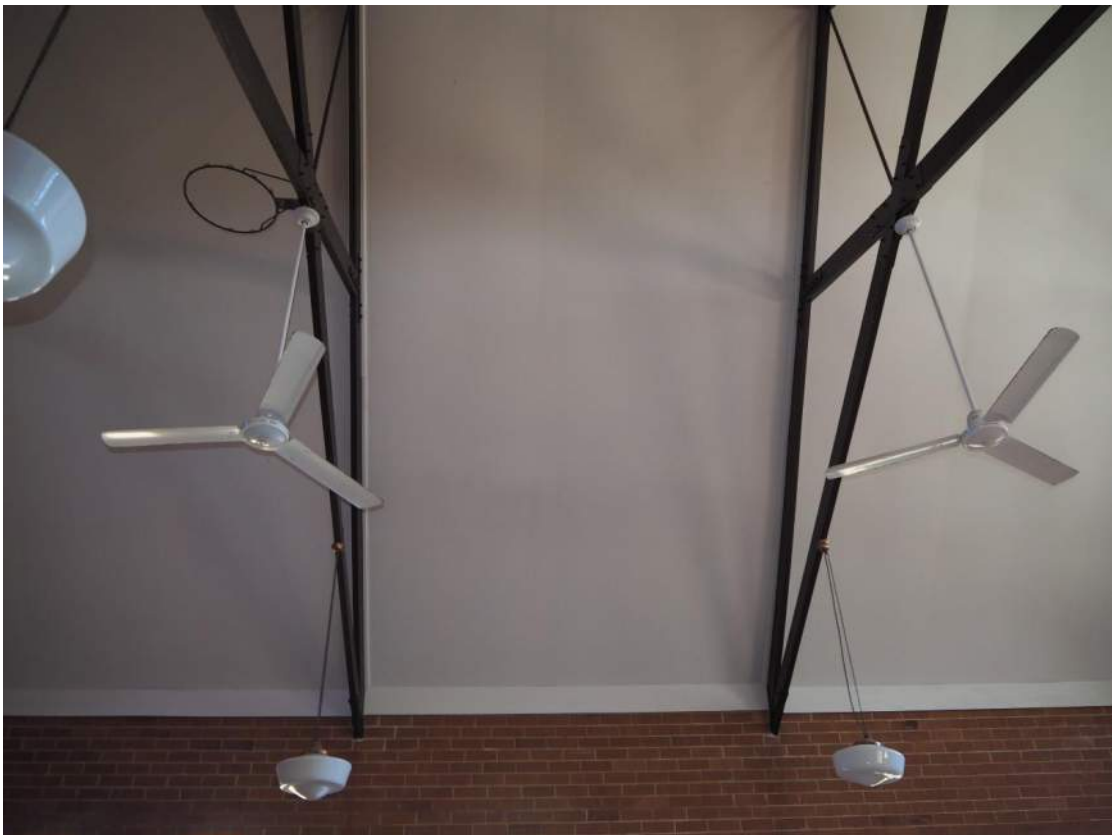
Photo 16 – Church hall ceilings in good condition

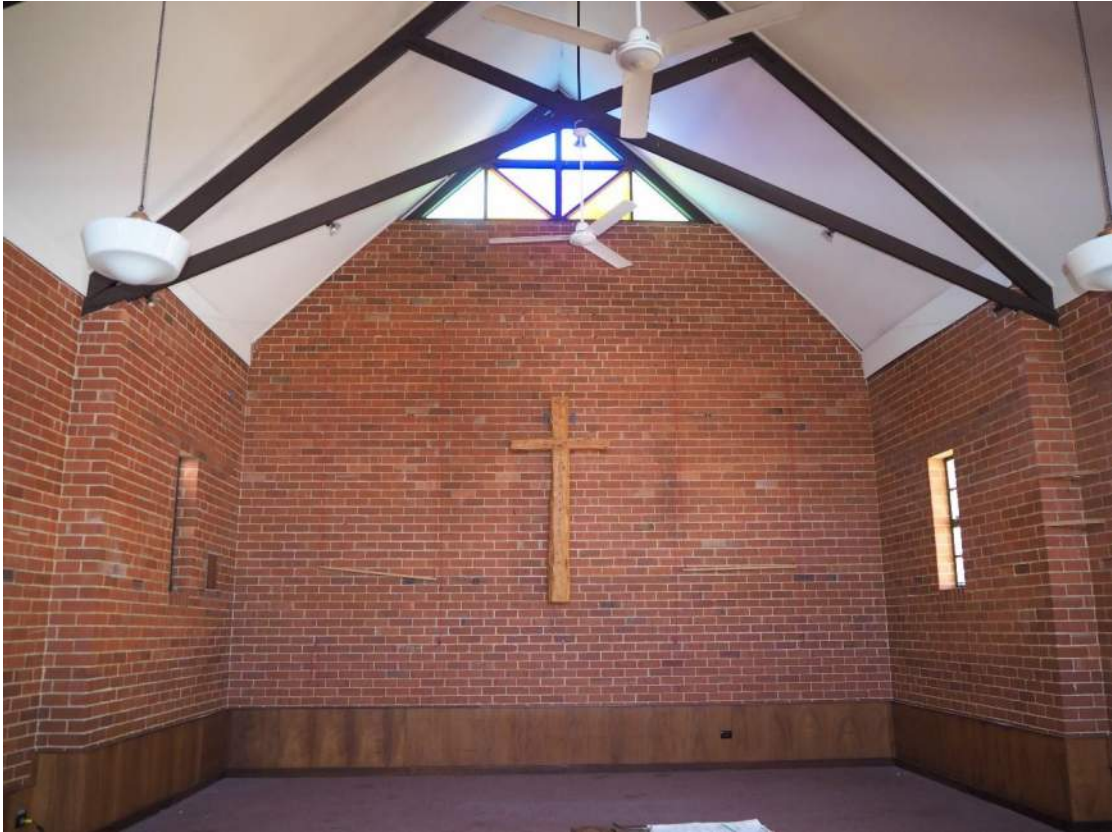
Photo 17 – Church hall walls and ceilings in good condition.

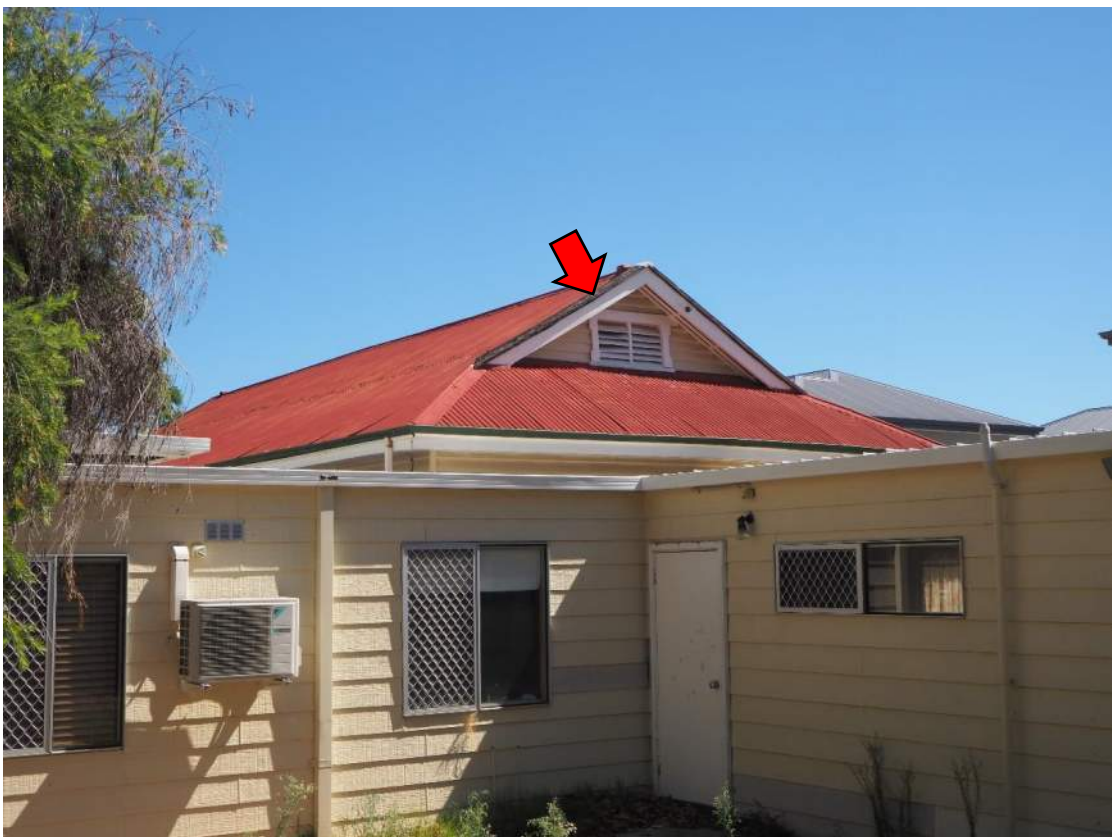
Photo 18 – The roof sheets were in fair condition with some fading. Note the severe weathering of the barge boards on the fascia.

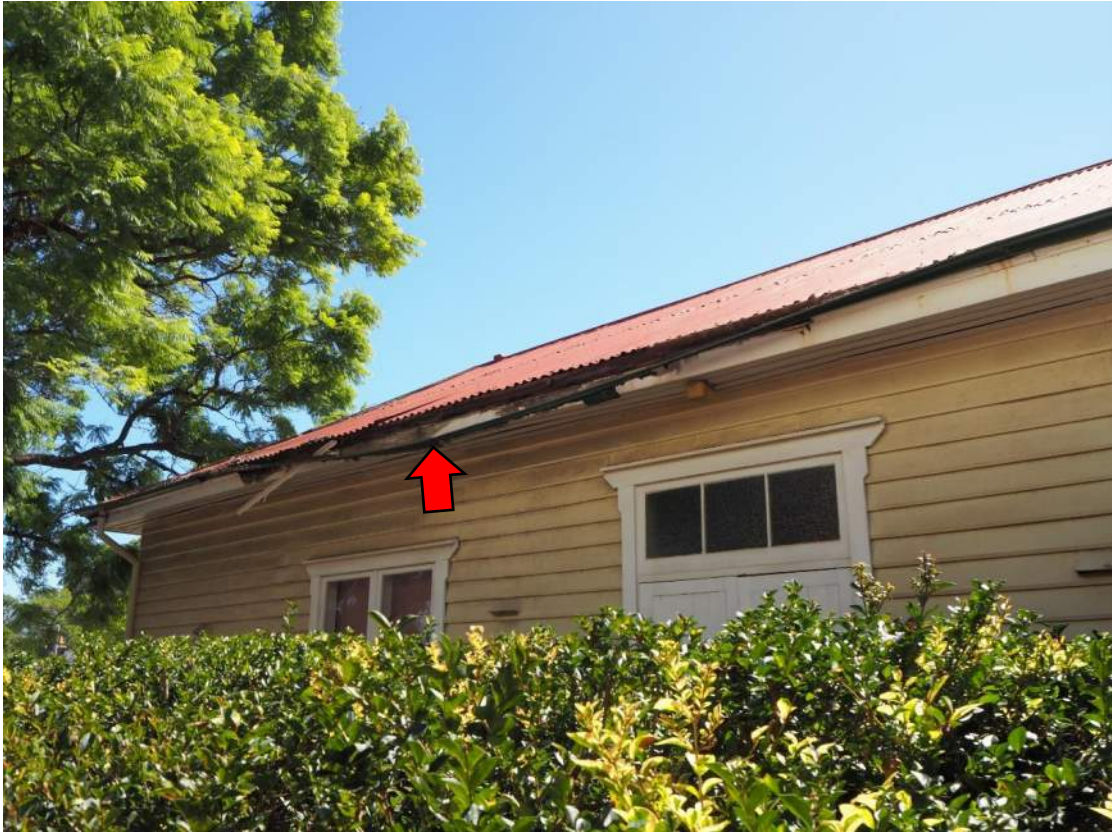
Photo 19 – Corroded and collapsed gutter, southeast elevation.

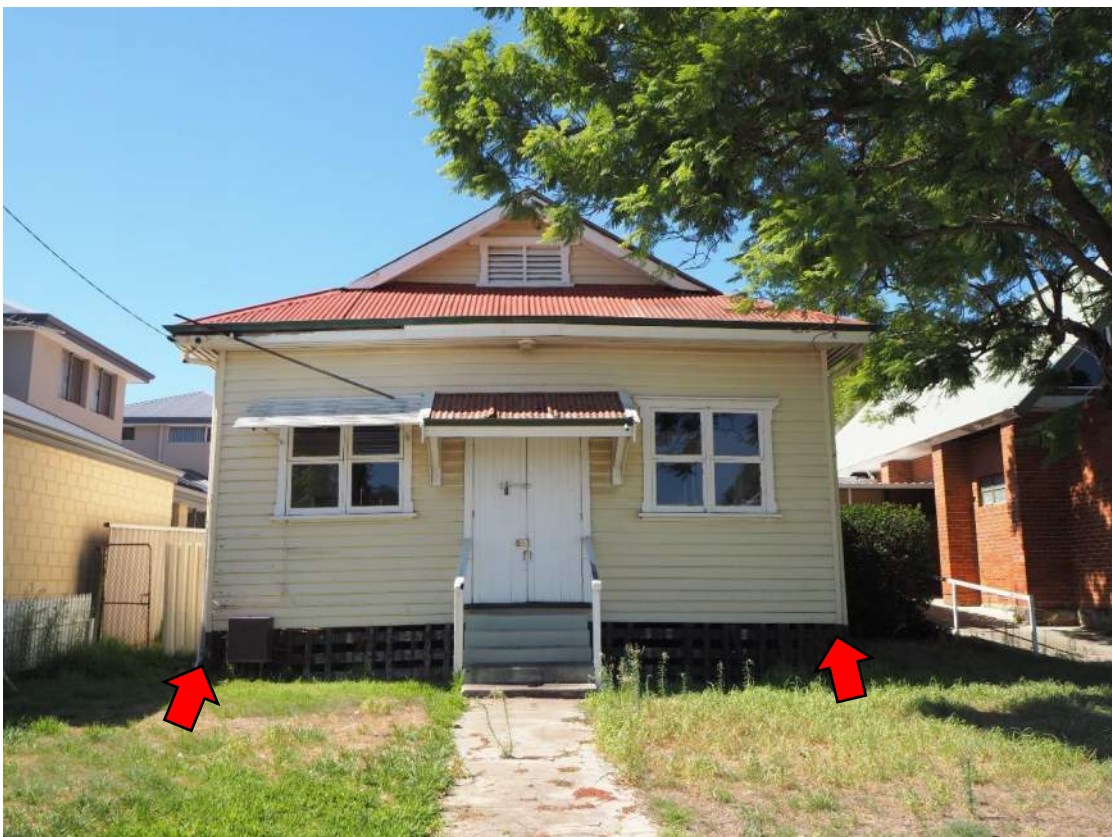
Photo 20 – The sides of the front entrance structure were sagging

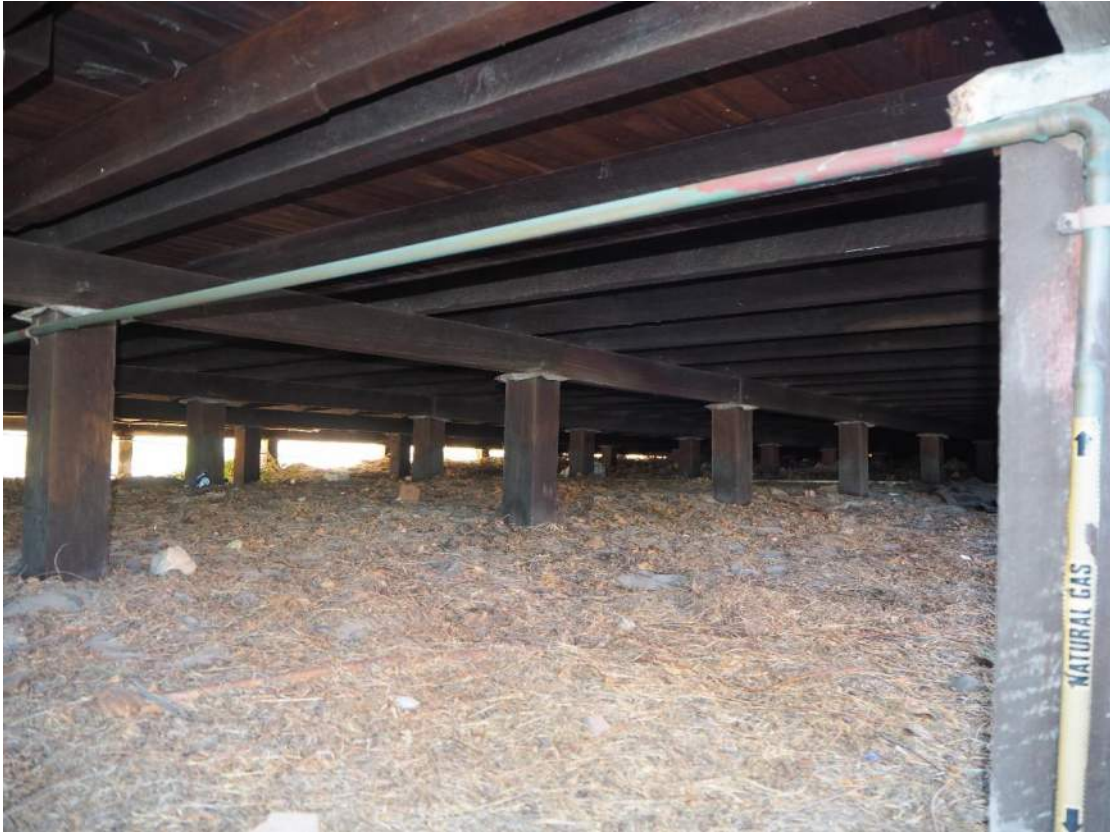
Photo 21 – The floor timbers appeared in good condition.

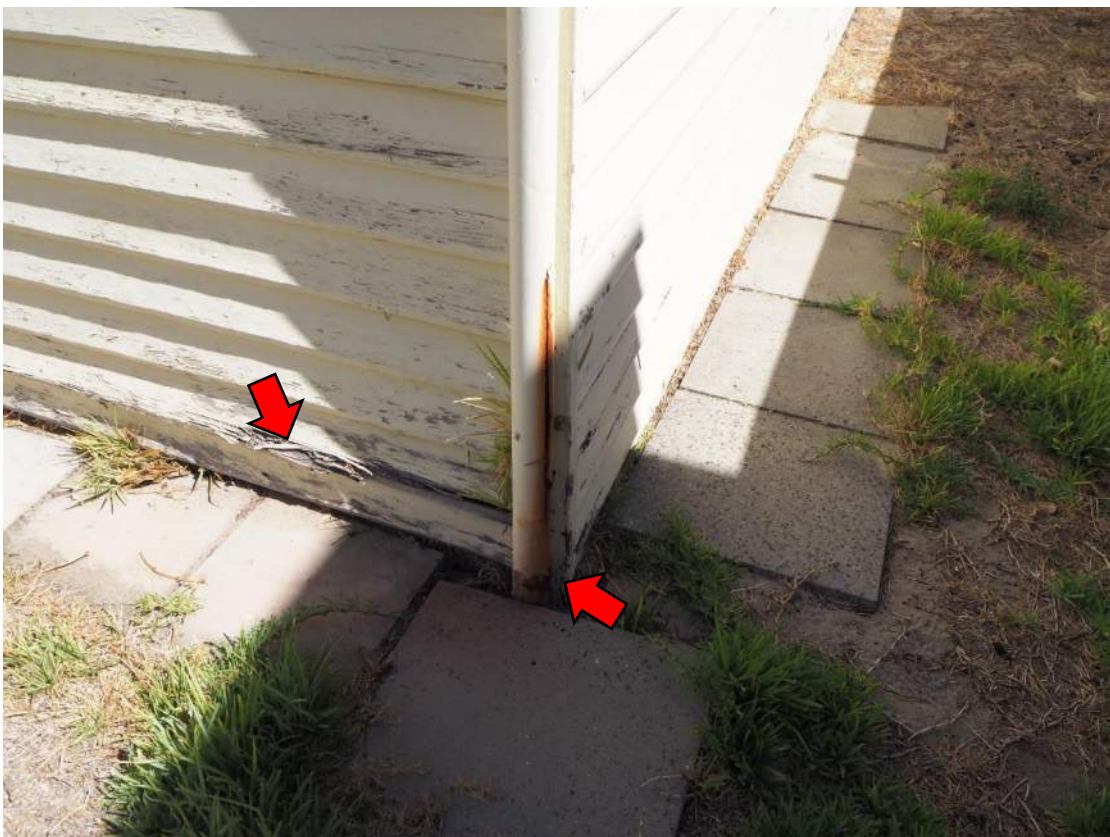
Photo 22 – The timber weatherboard was badly weathered in places and the downpipe was corroding and discharging directly onto the ground.

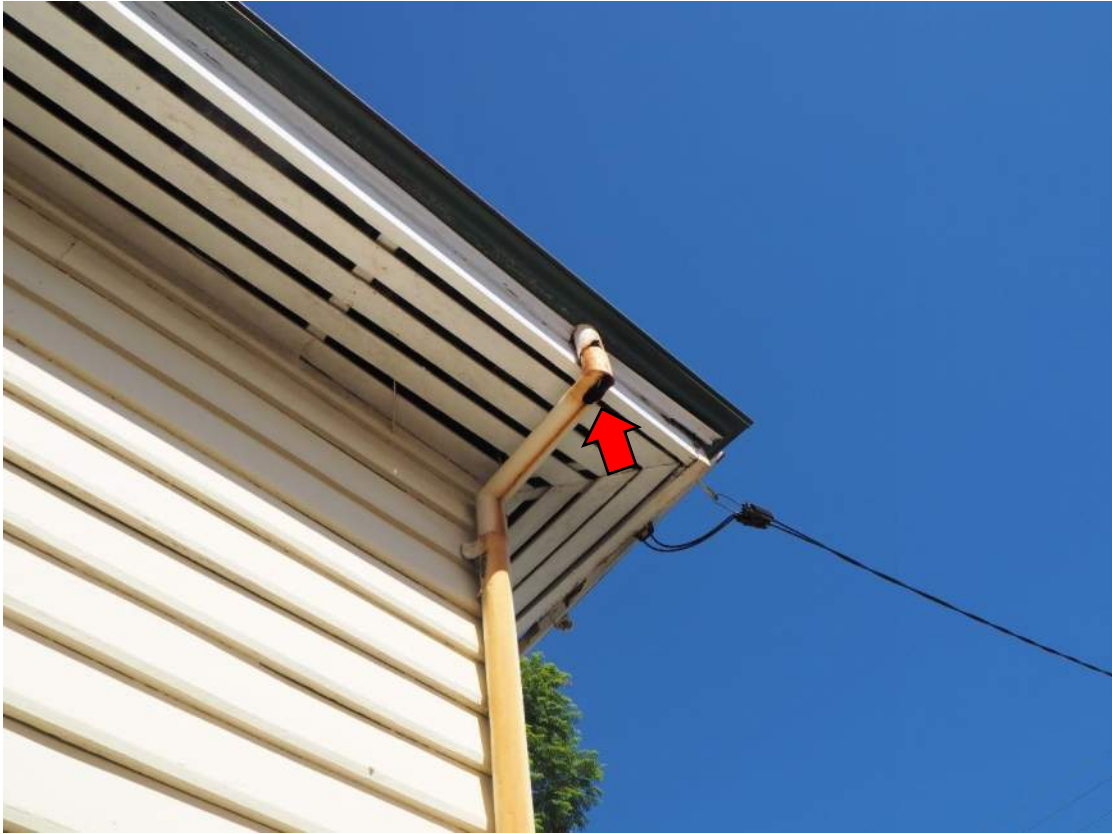
Photo 23 – Severely corroded downpipe.

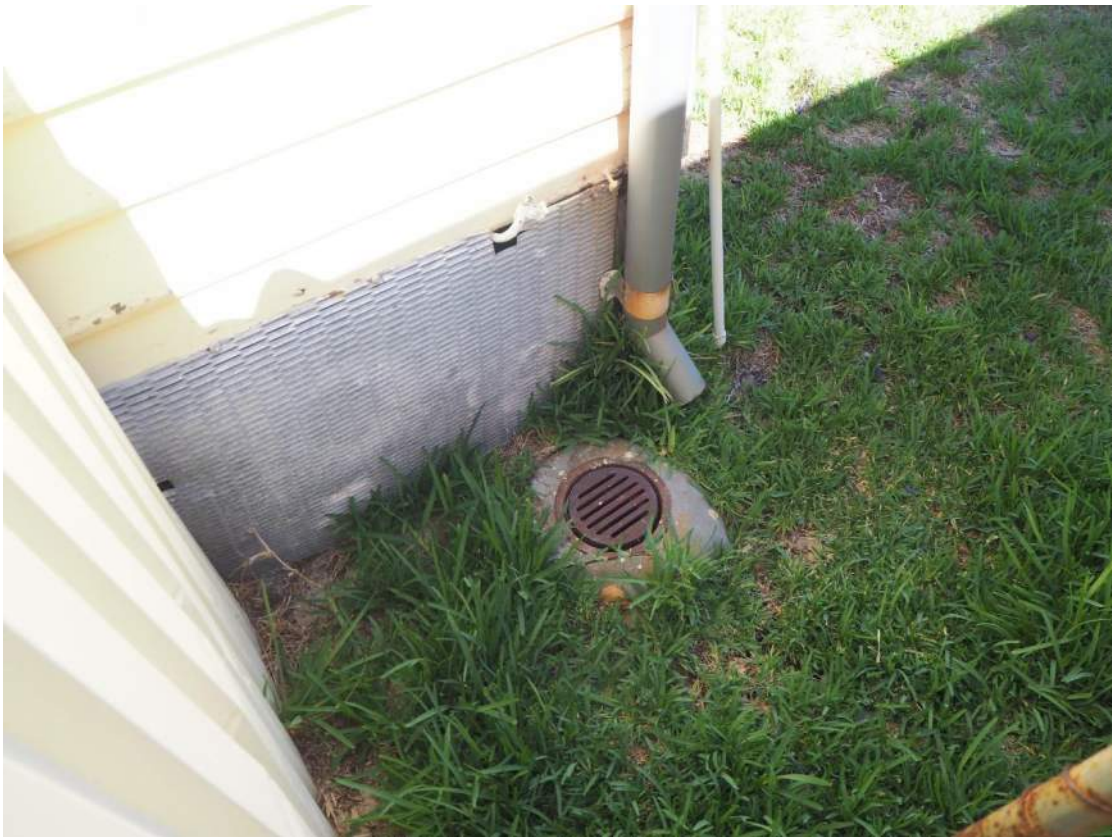
Photo 24 – Downpipe discharging onto the ground

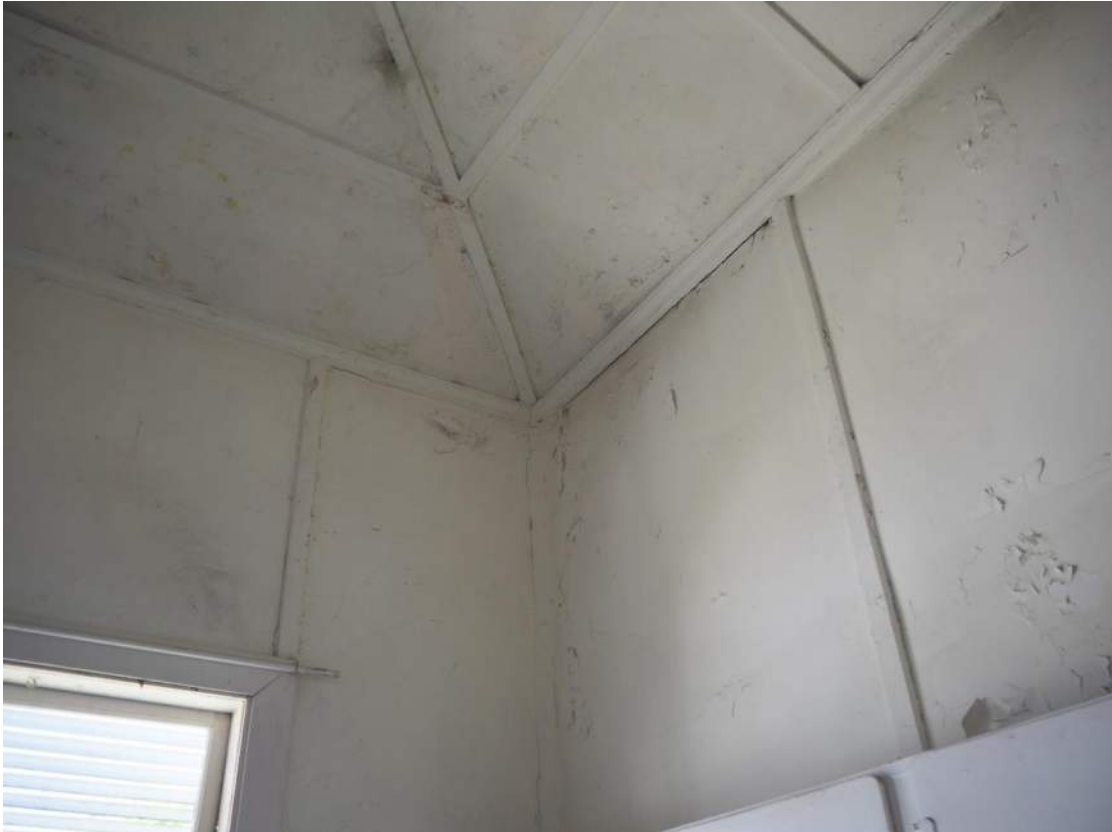
Photo 25 - Internal paintwork on ACM(?) sheets in poor condition.

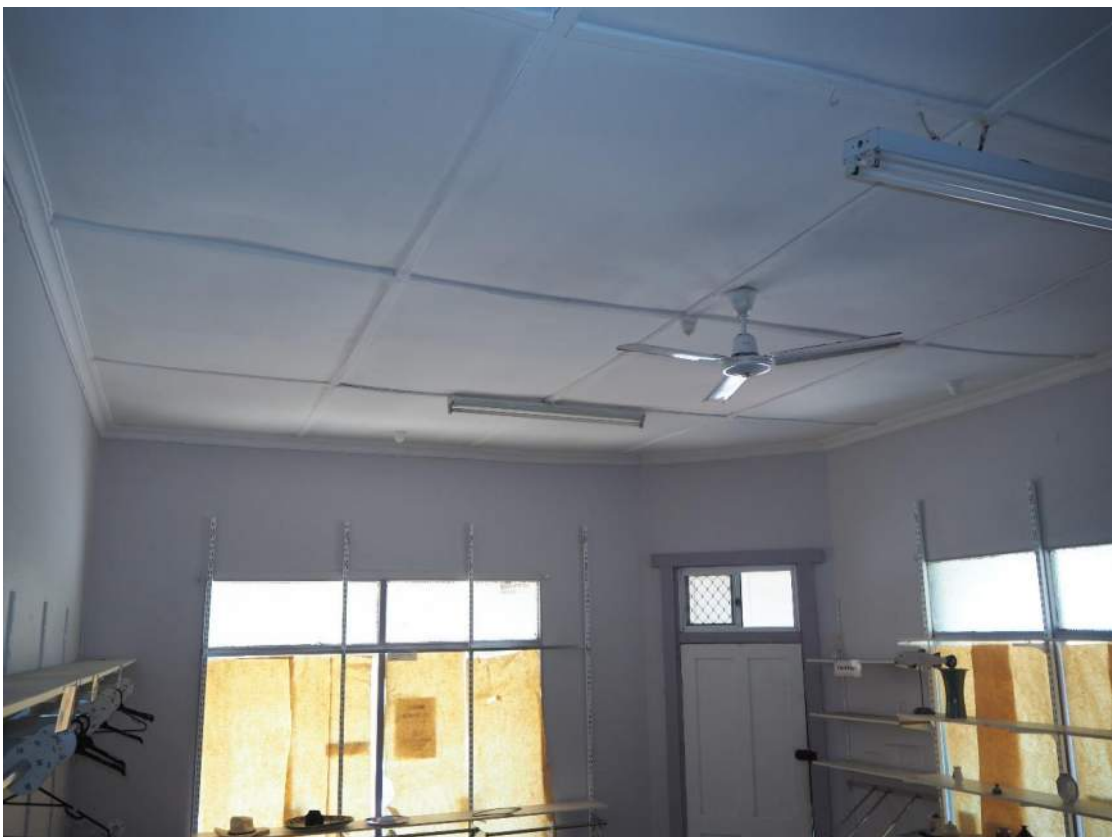
Photo 26 - Ceiling sagging in corner shop
