St Martin in the Field, Structural Report

Project number: P21104
 Site location: Cnr Dyson & Vista Streets,
 Kensington, WA 6151

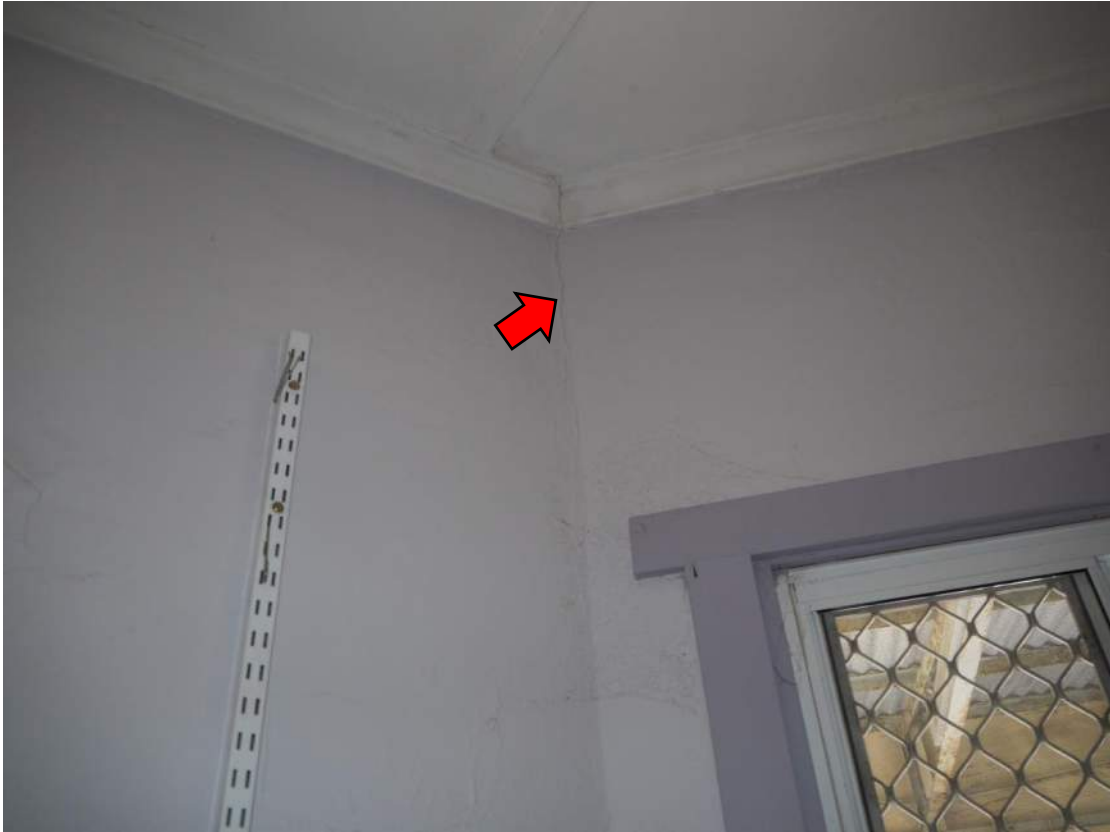
Photo 27 – Minor crack above door to corner shop.

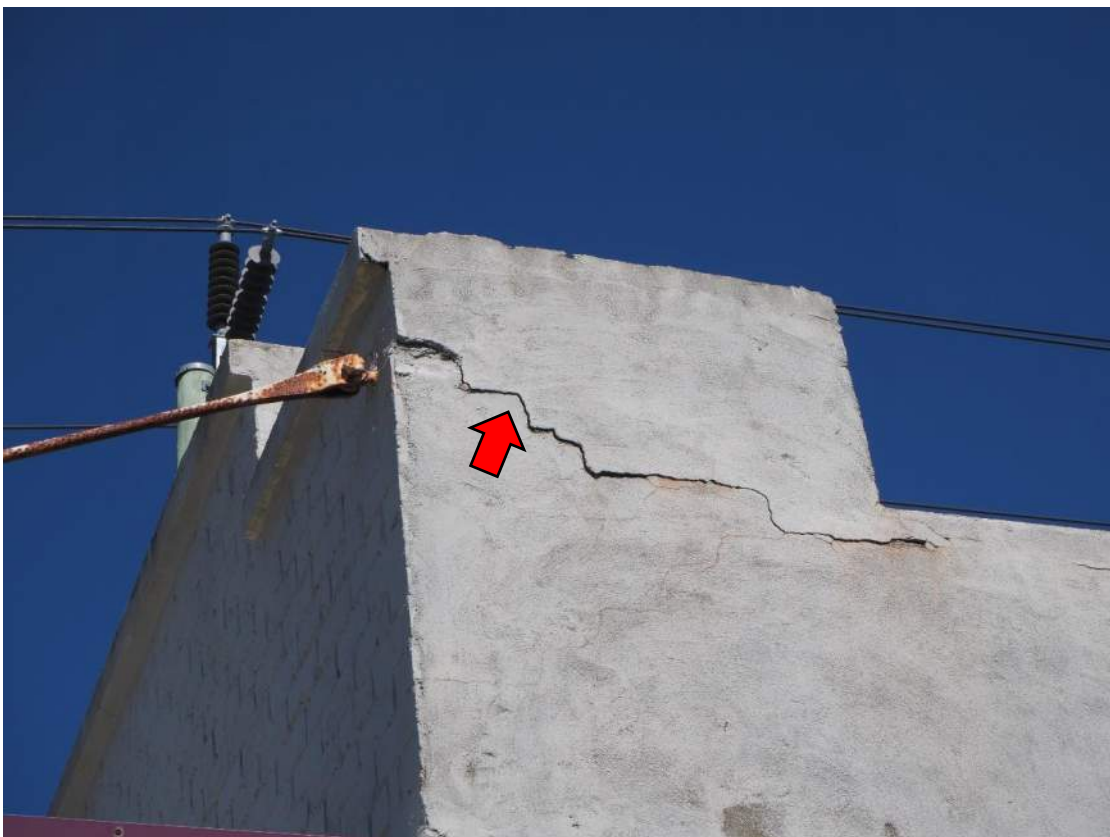
Photo 28 – Crack in parapet caused by awning tie. Awning tie corroding.

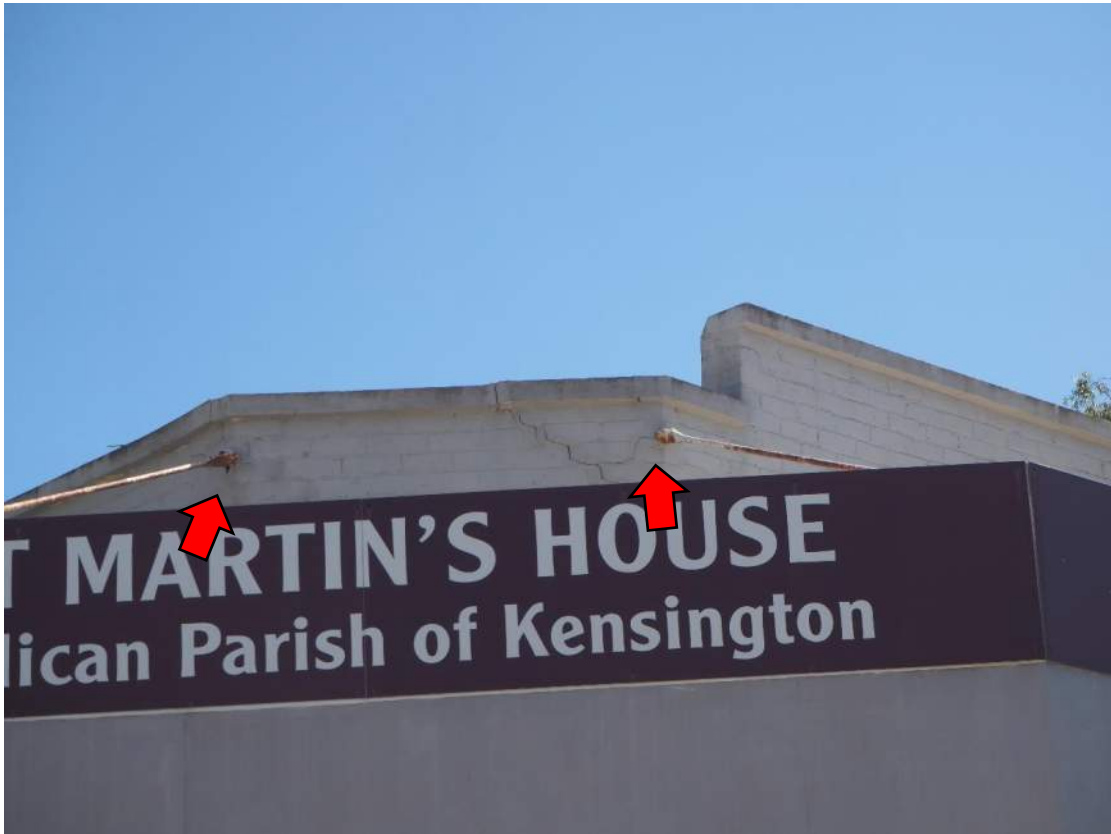
Photo 29 – Cracks in parapet caused by awning ties. Awning ties corroding.

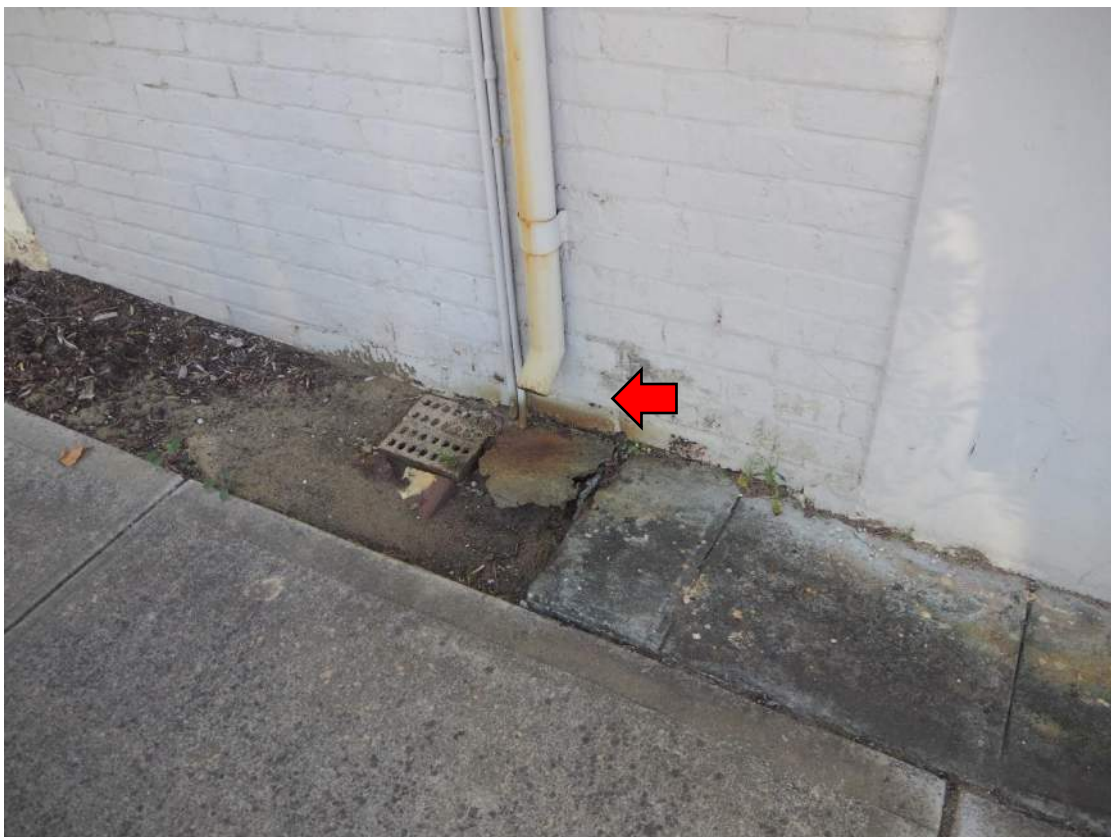
Photo 30 – Downpipe discharging directly onto the ground.

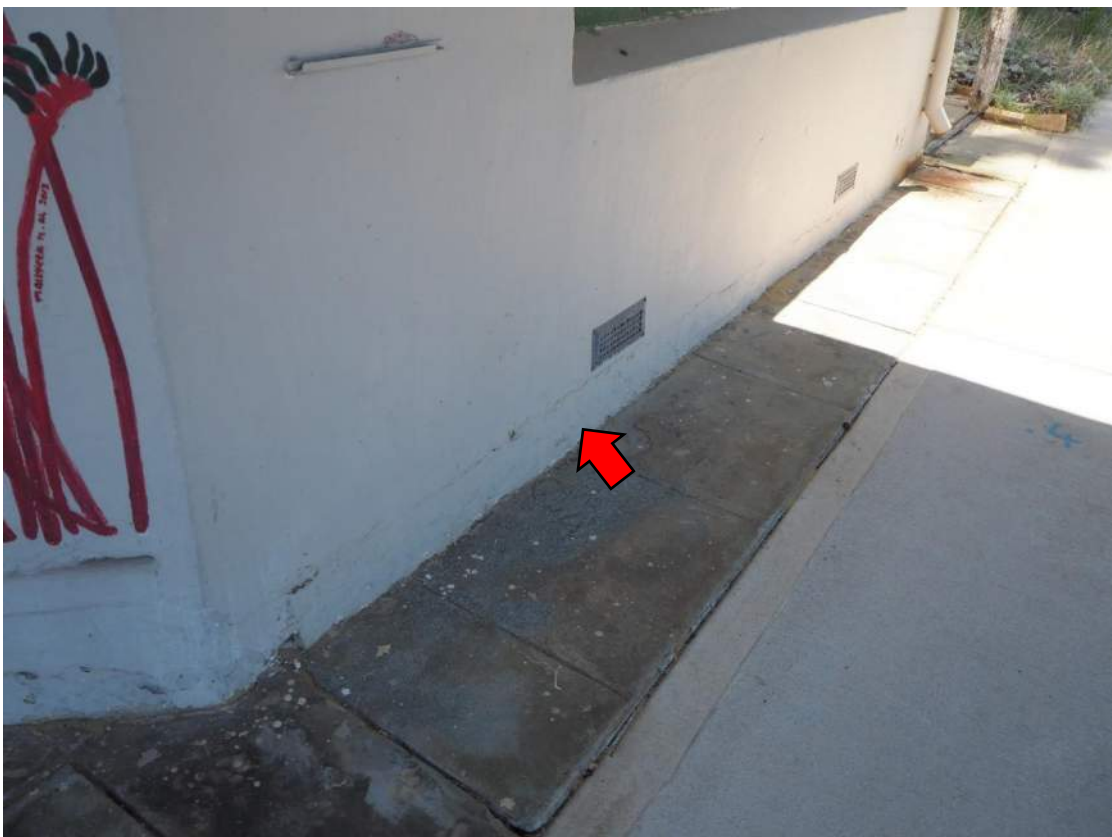
Photo 32 – Cracks and damp damage to base of wall.
