TECHNICAL REPORT

CLONTARF FORESHORE RESTORATION PLAN

FOR
CITY OF SOUTH PERTH

REPORT NO. RPT-1421-001 V3

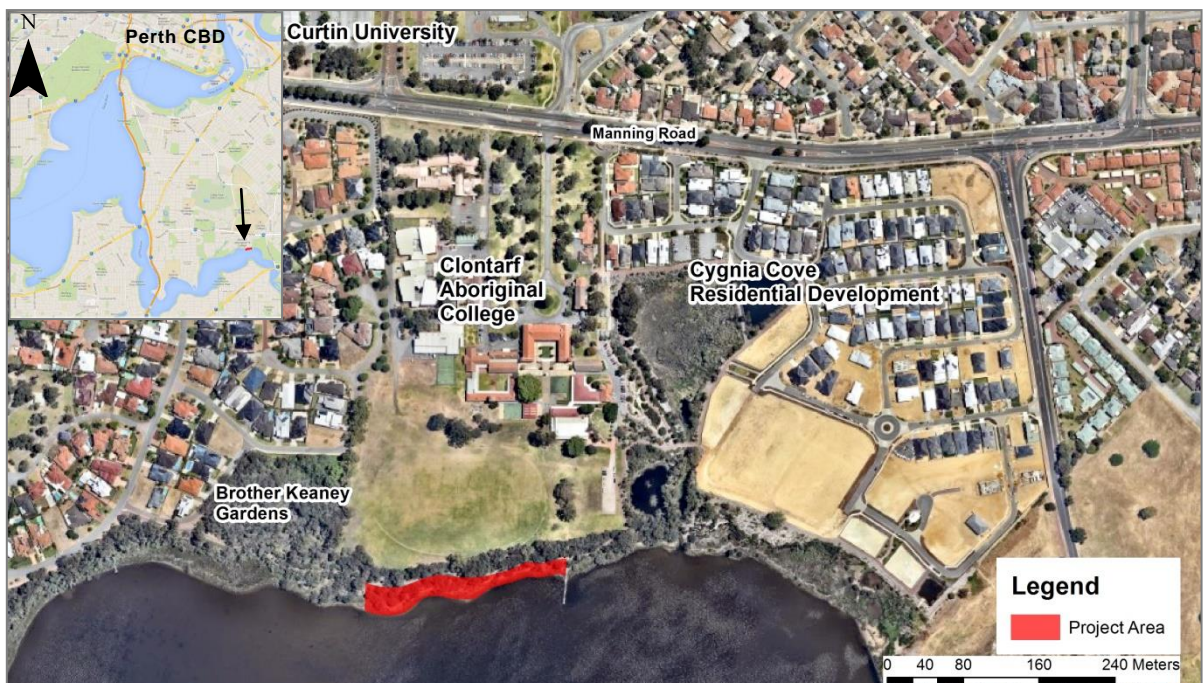
Figure 1 Project area location (Imagery: NearMaps November, 2016)

Clontarf Foreshore (the project area) is a 0.4 hectare (ha) section of the Canning River Foreshore in Waterford, City of South Perth, located approximately 8 kilometres (km) south-east of the Perth Central Business District (CBD). The site is located directly behind Clontarf Aboriginal College sporting grounds and forms a part of Bush Forever Site 333. Previously this section of the foreshore was named 'Clontarf Central Zone' as part of the Clontarf Foreshore Management Plan (City of South Perth, 1993). The location of the project area is presented in Figure 1.

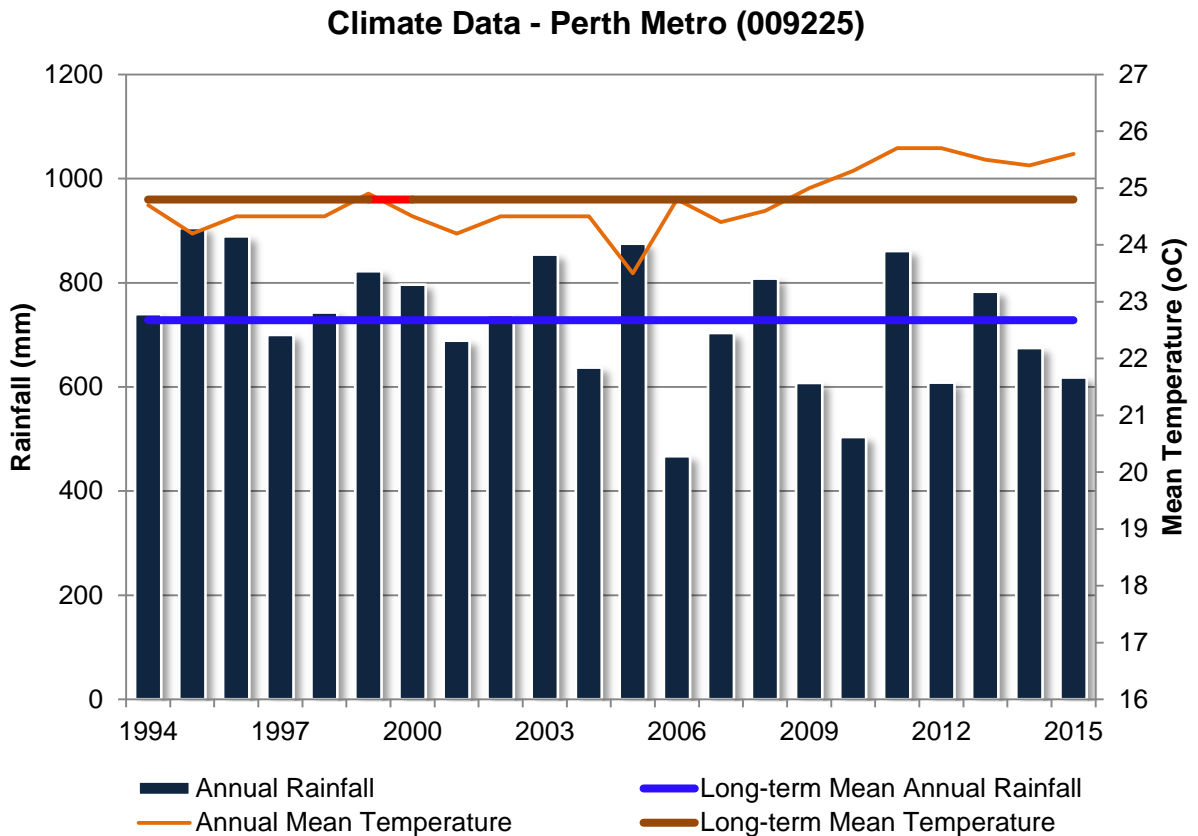
Figure 6 Mean rainfall and mean temperature maxima for Perth Metro (009225) weather station for years 1994 to 2016 (BoM 2016)

The mean minimum and maximum winter (July) temperatures are 7.7°C and 18.4°C whilst the mean minimum and maximum summer (February) temperatures are 18.4°C and 31.7°C. The average annual rainfall is 728.1mm, with 54% (393.8mm) falling in the winter months (June to August). The historical climate data for Perth Metro weather station, showing annual rainfall and mean temperature maxima for years 1994 to 2015 is summarised in Figure 6.

When observing recent temperature and rainfall trends particularly since 2008 the mean annual temperature maxima have consistently exceeded the long-term average by 0.2 to 0.9°C. This trend is likely to continue in the future, and as such any revegetation works need to take these changing conditions into consideration.

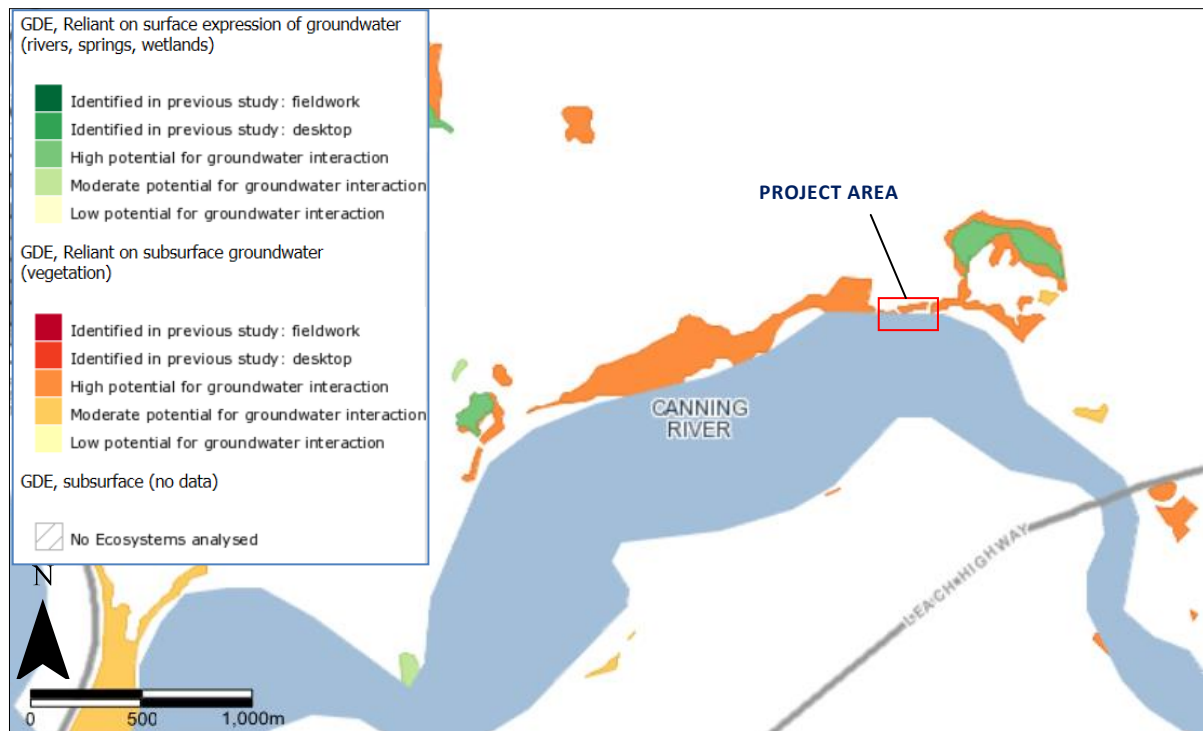
Figure 7 Groundwater Dependent Ecosystem Map of the site and the surrounding areas (Source: BoM, 2012)

The vegetation on the site has been mapped as a groundwater dependant ecosystem (GDE), reliant on subsurface groundwater in the broad scale mapping (see Figure 7, BoM, 2012). Evidence of groundwater seeps or springs exists on site near the jetty where large clump of *Baumea articulata* and *Bolboschoenus caldwellii* are found. These species require an input of fresh water throughout the year as is the case with *Melaleuca raphiophylla*. Having these species so close to the river and in the tidal zone indicates that the supply of freshwater to the plants is permanent.

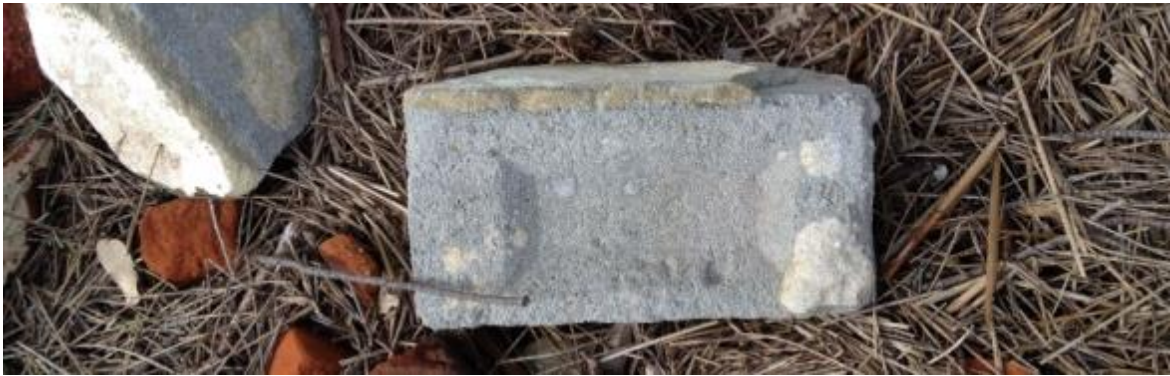
Figure 10 Cement brick made by the Clontarf Boys during late 1940s early 1950s (Old Clontarf Boys *pers. comm.*)

The site visit with the Old Clontarf Boys committee in May 2014 has confirmed that the Clontarf Foreshore site (i.e. the project area) does not contain any visible objects or materials of heritage value. However, the cement bricks which were once made by the Clontarf boys were mentioned as something that would be worth saving (if intact bricks are found) so that they could possibly be used for the future projects such as the support pillars for interpretive signage or artwork. The example of the cement brick is presented in Figure 10.

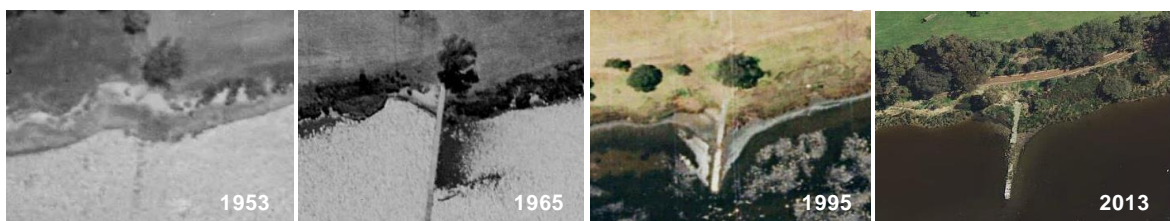
Figure 12 Changes in sand accumulation due to jetty construction (Imagery: Landgate, 2014)

The jetty protrudes perpendicular to the shoreline and the dominant wind direction (south westerly winds). As such the sediment movement has been altered and the sand has accumulated surrounding the jetty particularly on its eastern side. The jetty in its construction (cement slabs on top of loosely held brick and building material rubble) acts as a groyne. As the rubble foundation deteriorated over time, the shift in the amount of sand on both sides of the jetty has occurred, with less sand being deposited on the western side of the jetty.

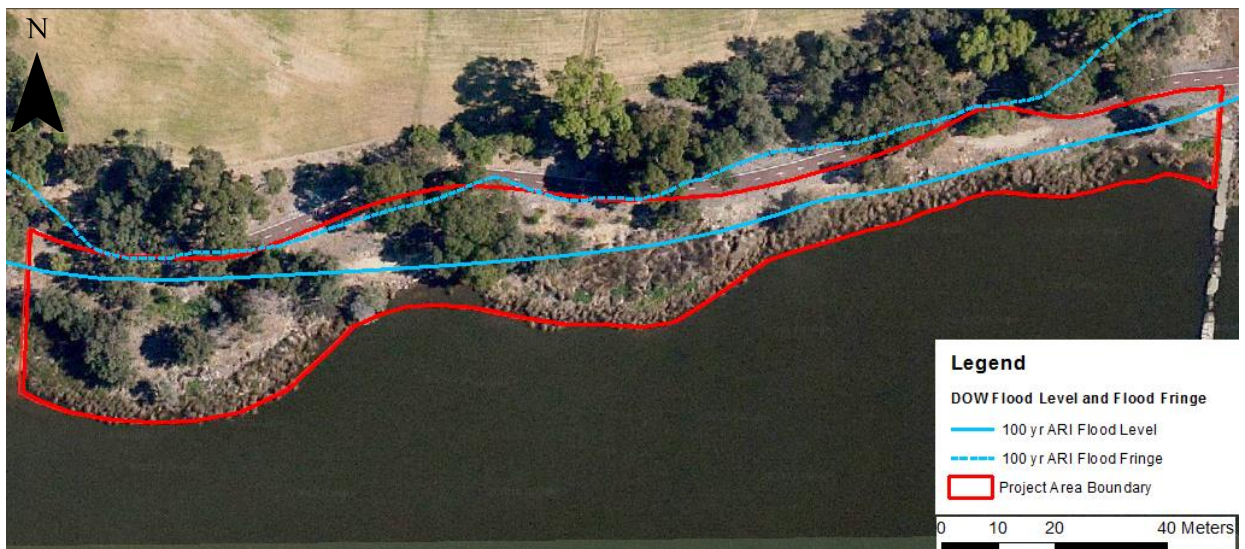
Figure 14 Extent of current and predicted flooding due to mean sea levels (Source: DoW, 2013)

The mapped 100 year floodway and the flood fringe boundaries for the project area are presented in Figure 14 (DoW, 2013).

100 year ARI "Present Day"	1.47 mAHD
100 year ARI Future (2110)	2.27 mAHD

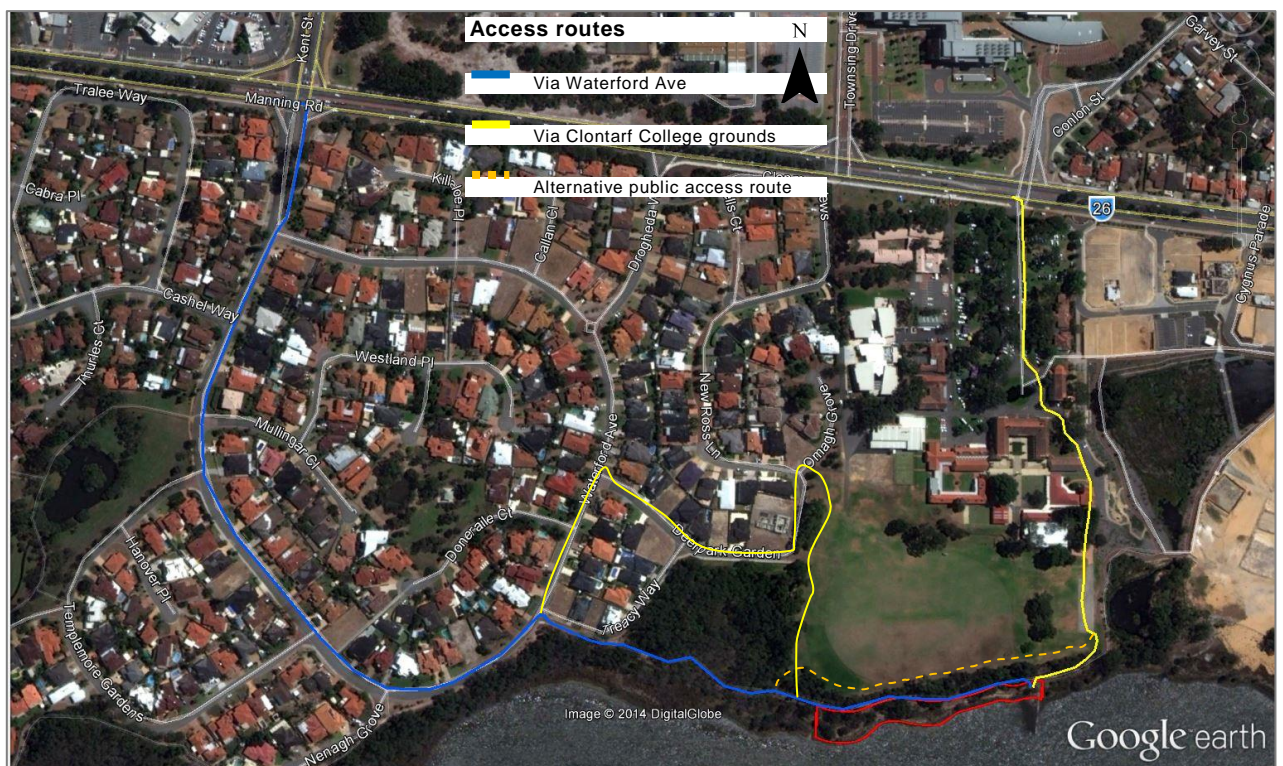
Figure 16 Site access pathways

Adequate site access and storage is essential for the efficient implementation of works. Due to the limitations on vehicle access to the site, any implementation works will require sufficient traffic management along the adjacent DUP. Authorisation will also need to be sought from the Main Roads Western Australia and the City of South Perth for any significant vehicle movement along the DUP. In addition, access via Clontarf College Grounds might be required and arrangements need to be in place with the College prior to using this as a pathway. Given that southern section of the sports oval becomes waterlogged during winter, this area will not be used for site access during the planting period.

The two possible access ways are via DUP from Waterford Avenue from the west and via Clontarf Aboriginal College carpark and the DUP from the east (Figure 16).

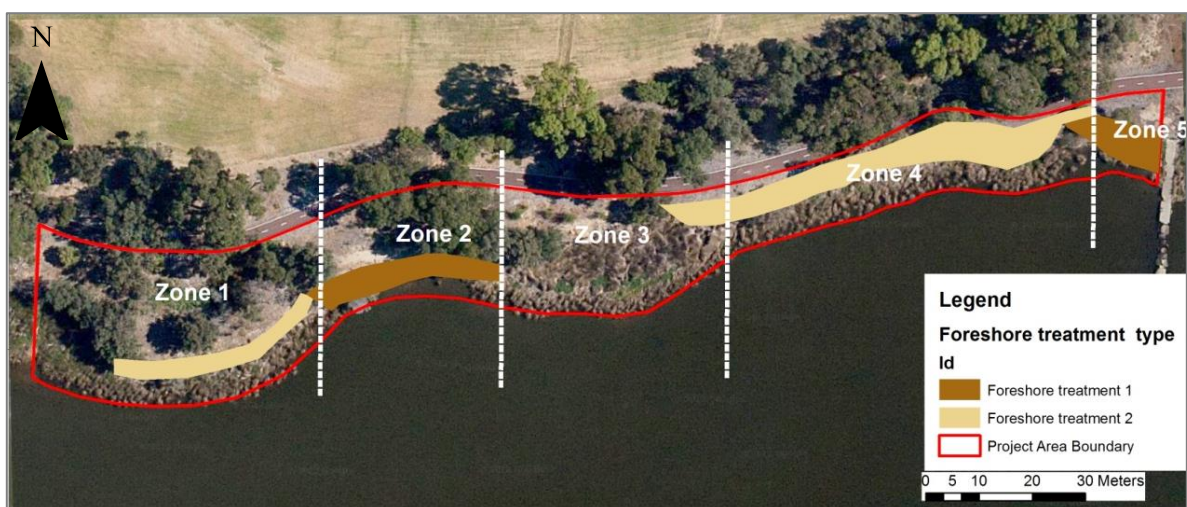
Figure 17 Approximate extent of the foreshore treatment areas

Figure 17 shows the proposed extent of the areas where foreshore treatments will be applied (e.g. Zone 2 and 5 are to undergo Foreshore Treatment 1, and Zone 1 and 4 are to undergo Foreshore Treatment 2. Zone 3 has adequate protection from the existing vegetation and will not require specific erosion control method).
