Mt Henry Peninsula Foreshore Management Plan 2004

REPORT FOR THE CITY OF SOUTH PERTH
MOUNT HENRY PENINSULA MANAGEMENT PLAN
COPYRIGHT STATEMENT 2002
ECOSCAPE (AUSTRALIA) PTY LTD
ABN 70 070 128 675

Mt Henry Peninsula Management Plan

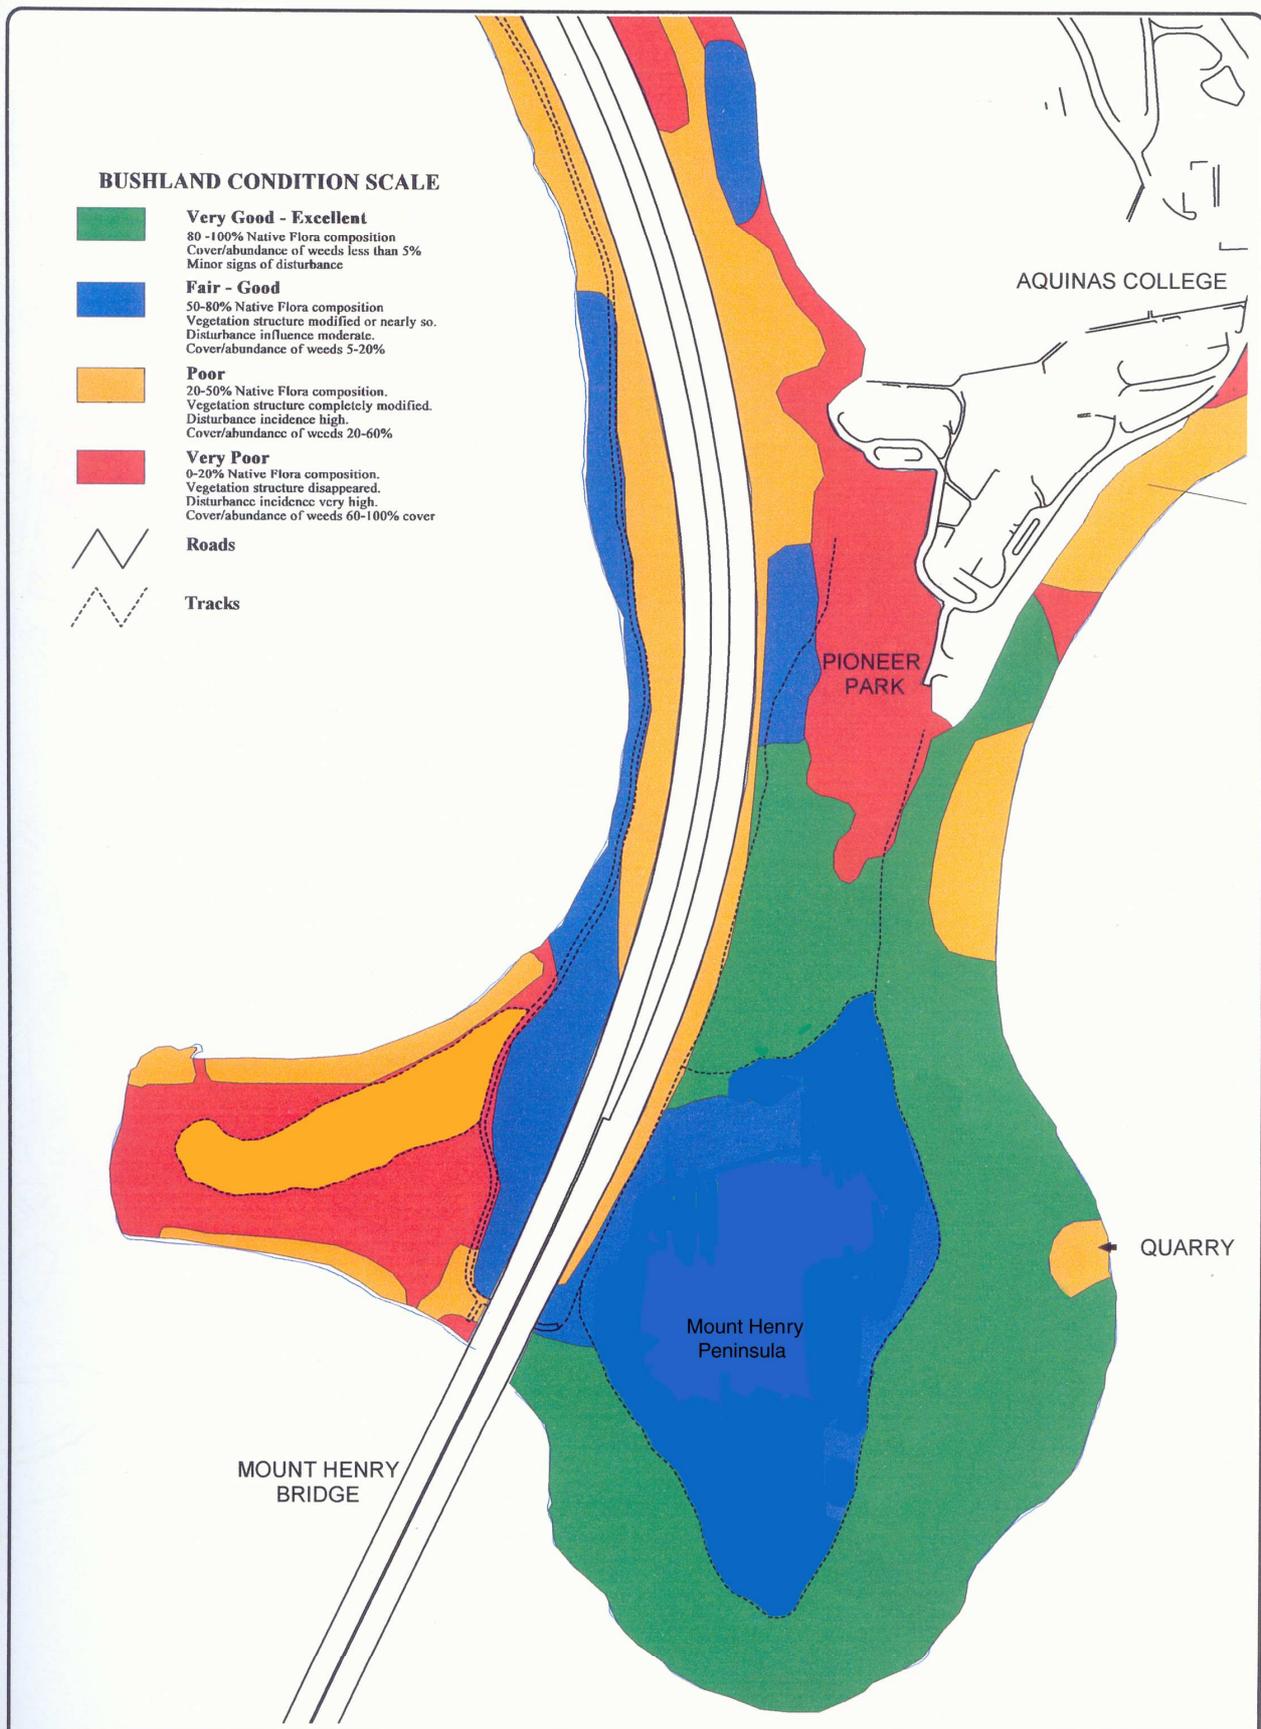
FIGURE 2 : Bushland Condition Within Study Area

Figure 2 Bushland Condition Within the Study Area

The use of this scale allows the production of clear maps that show the various condition ratings attributed to areas. The resulting maps can be used to determine management priorities for restoration, and can also be used to determine the success of restoration efforts if bushland condition mapping is undertaken at regular intervals. A map of the Bushland Condition in the study area is shown in Figure 2.

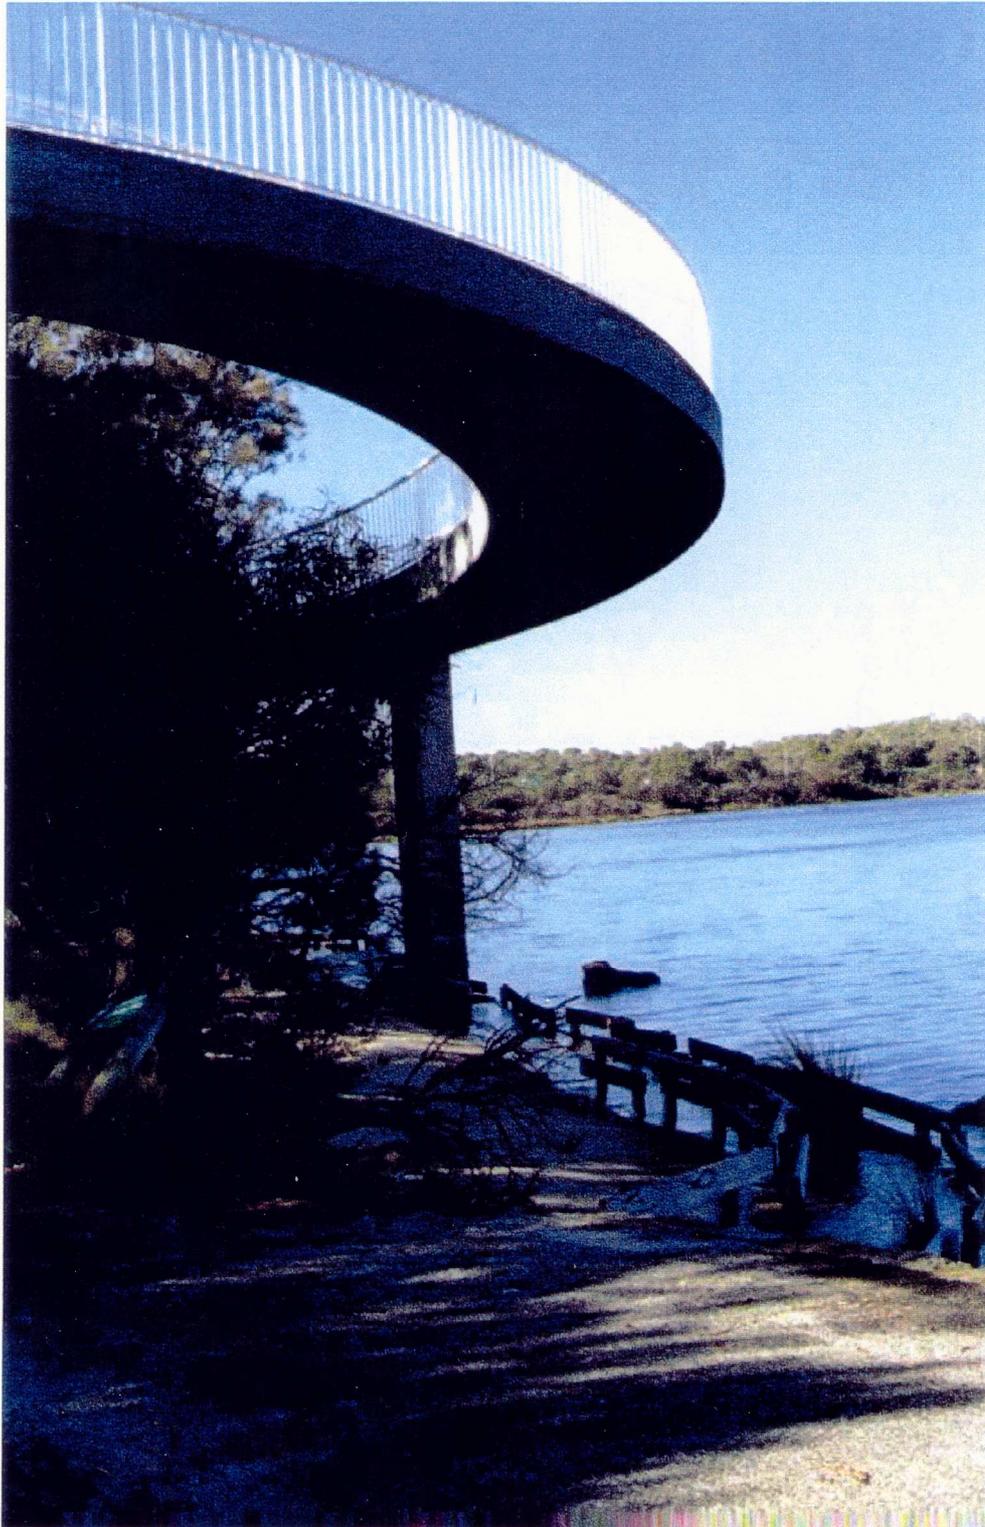
Figure 2.1 – Edgewater Road Overpass

Note bank inundation and erosion

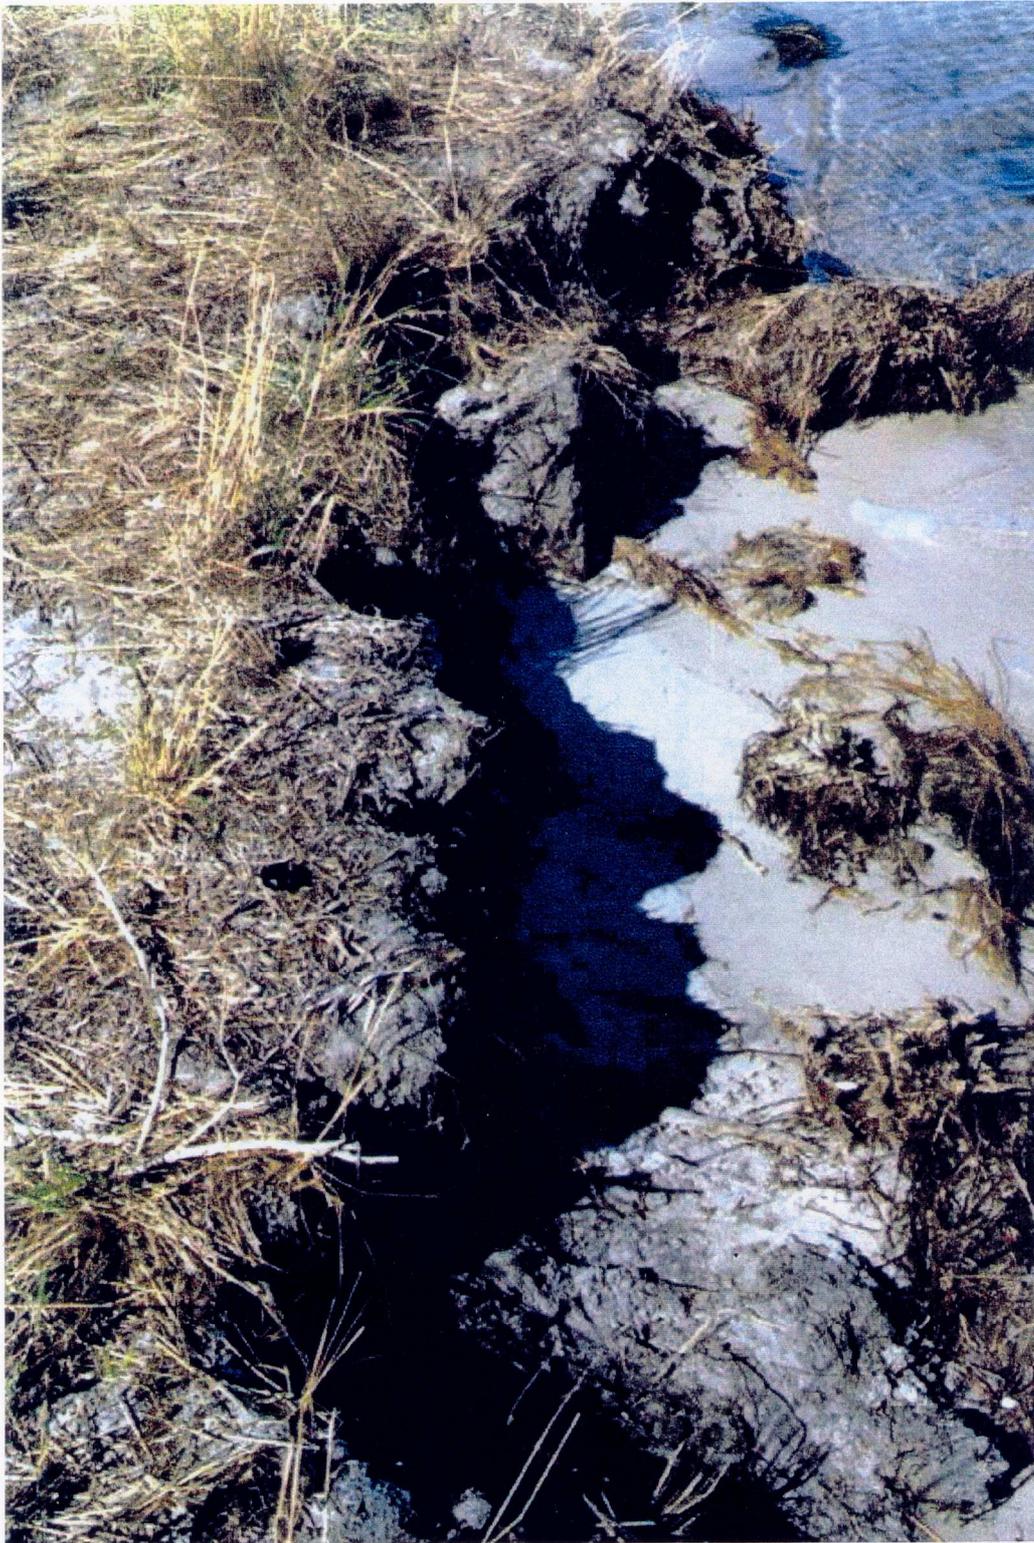
Figure 3.1 – Spit West of Mount Henry

Note bank slumping / erosion

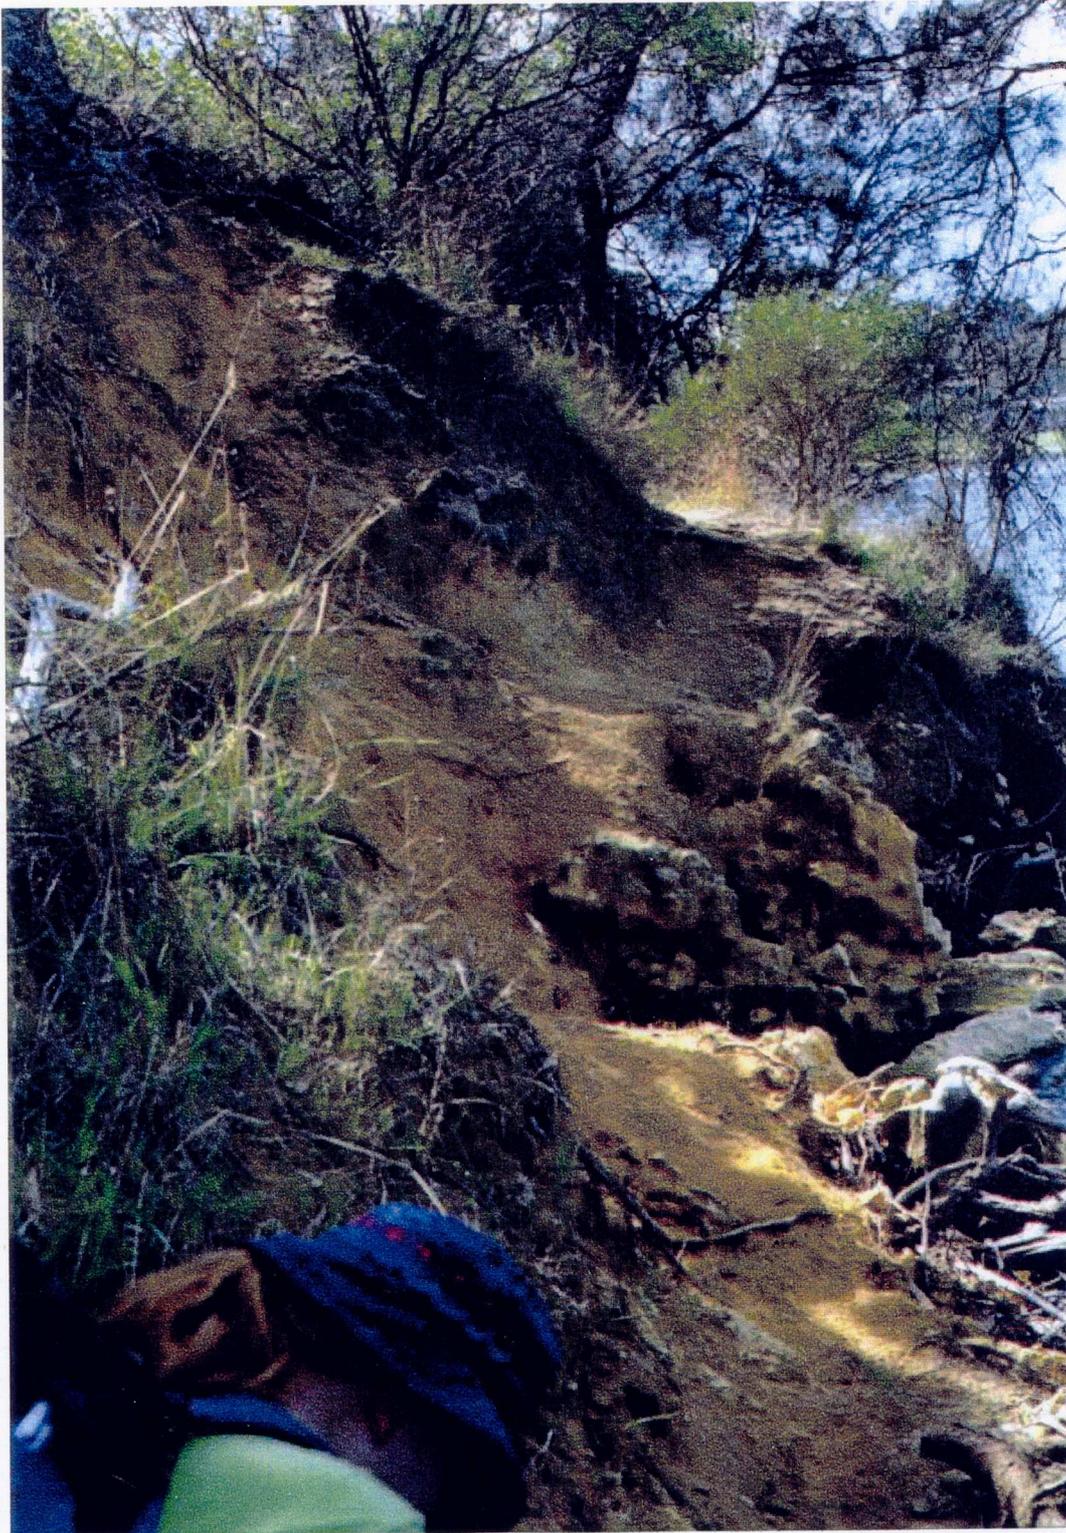
Figure 4.1 – Southwest Face of Mount Henry

Note erosion of walking track
M P ROGERS & ASSOCIATES

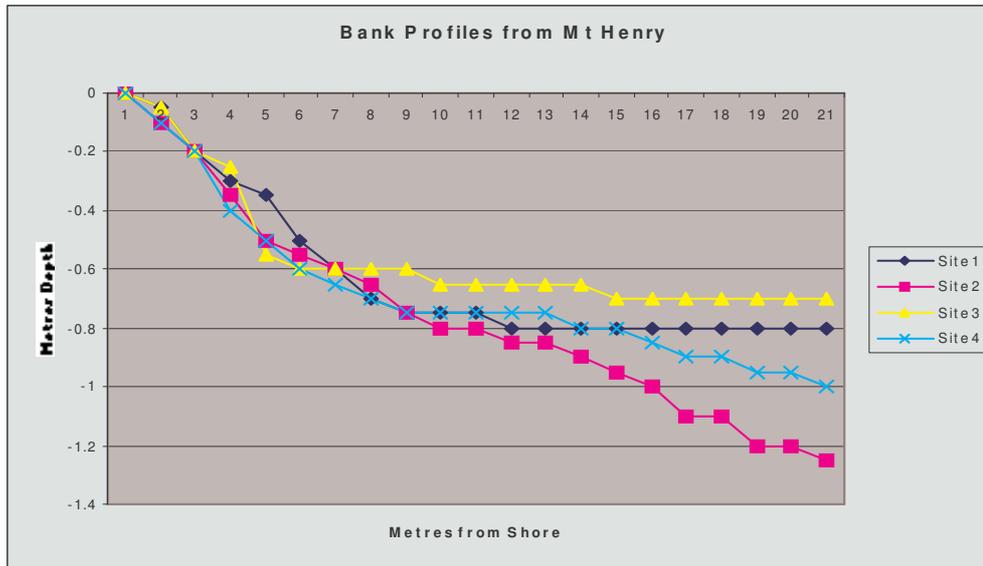
The following bank profiles were measured by Ecoscape on the 16th June, 2002.

Site 1	Site 2	Site 3	Site 4
Direction (degrees)	250	250	250	290
MGA Easting	391923	392111	392216	391980
MGA Northing	6456442	6456148	6455912	6455455
		Depth From Surface		
Metres from Shoreline	Site 1	Site 2	Site 3	Site 4
0	0	0	0	0
1	0.05	0.1	0.05	0.1
2	0.2	0.2	0.2	0.2
3	0.3	0.35	0.25	0.4
4	0.35	0.5	0.55	0.5
5	0.5	0.55	0.6	0.6
6	0.6	0.6	0.6	0.65
7	0.7	0.65	0.6	0.7
8	0.75	0.75	0.6	0.75
9	0.75	0.8	0.65	0.75
10	0.75	0.8	0.65	0.75
11	0.8	0.85	0.65	0.75
12	0.8	0.85	0.65	0.75
13	0.8	0.9	0.65	0.8
14	0.8	0.95	0.7	0.8
15	0.8	1	0.7	0.85
16	0.8	1.1	0.7	0.9
17	0.8	1.1	0.7	0.9
18	0.8	1.2	0.7	0.95
19	0.8	1.2	0.7	0.95
20	0.8	1.25	0.7	1
