MEMORIAL CHURCH OF ST  
MARTIN IN THE FIELDS AND  
DURBRIDGE HALL  
50 Dyson Street, Kensington

Heritage Assessment

Prepared for:  
Elberton 7 Pty Ltd

May 2021

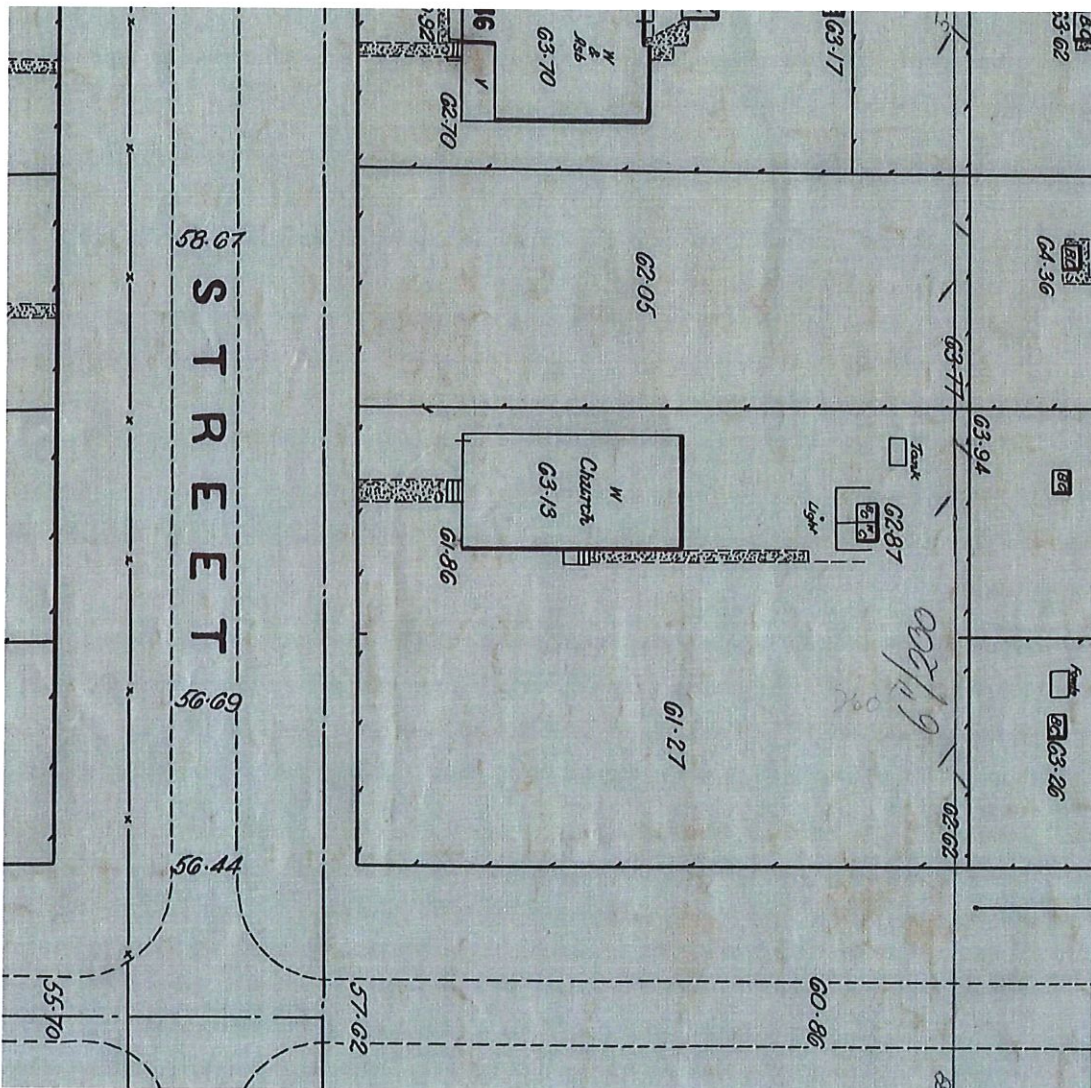
Figure 1 MWSS and DD Sewer Plan completed in 1936. The plans shows that about 60% of residential lots were developed. St Martin's is indicated as a weatherboard church, with a pair of toilets to the rear and a water tank. 1936 SROWA\_series634\_cons4156\_item0548

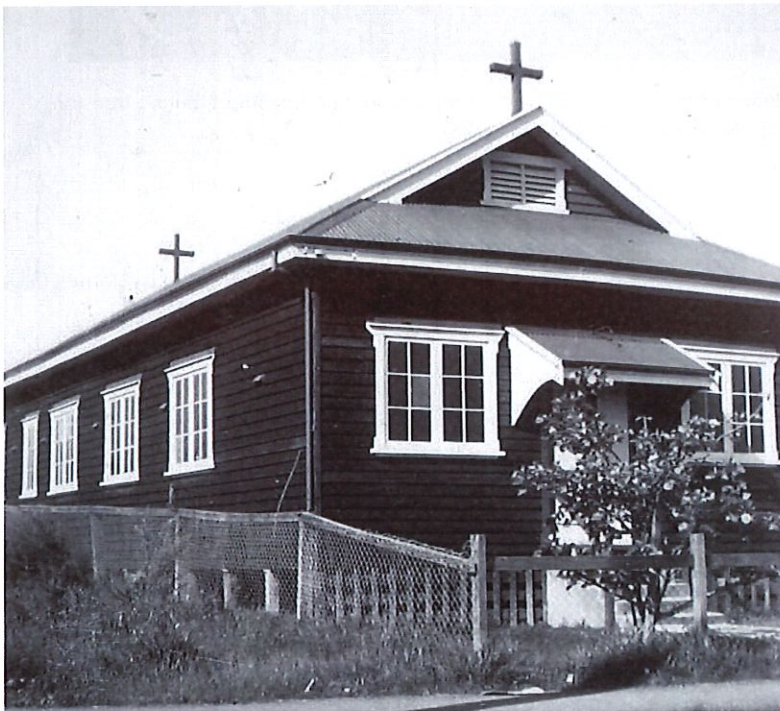
Figure 2 An image of the church taken in 1948, when the weatherboards were oiled and the windows small pane casements. Courtesy Anglican Diocesan Trustees.

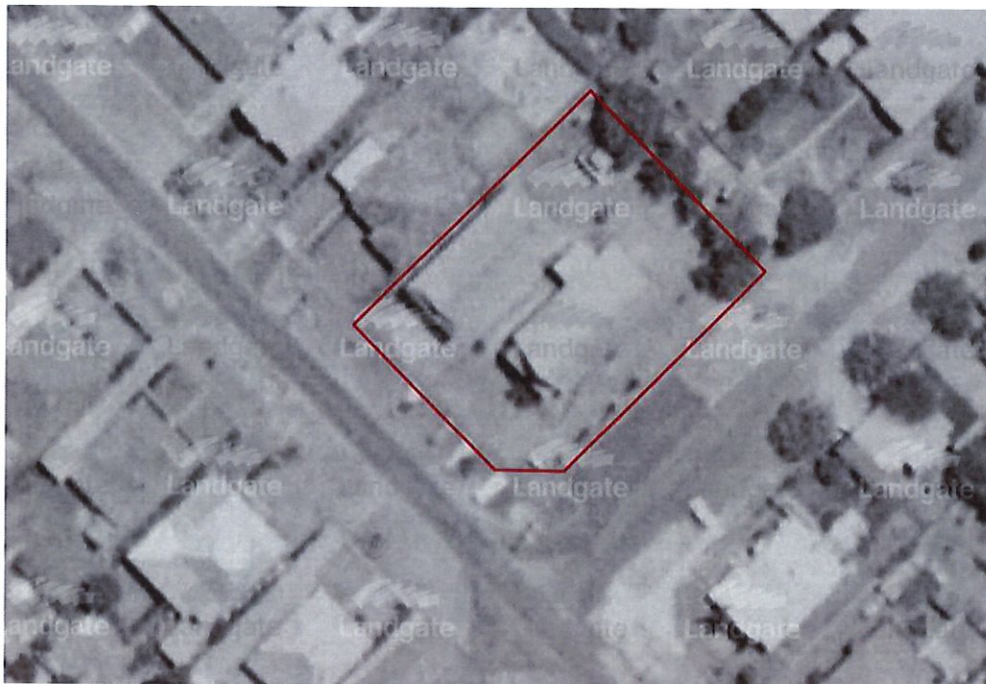
Figure 3 1953 after completion of the new church, with new trees on Brandon Street, but no trees on Dyson Street. Landgate aerial photograph taken in 1953.

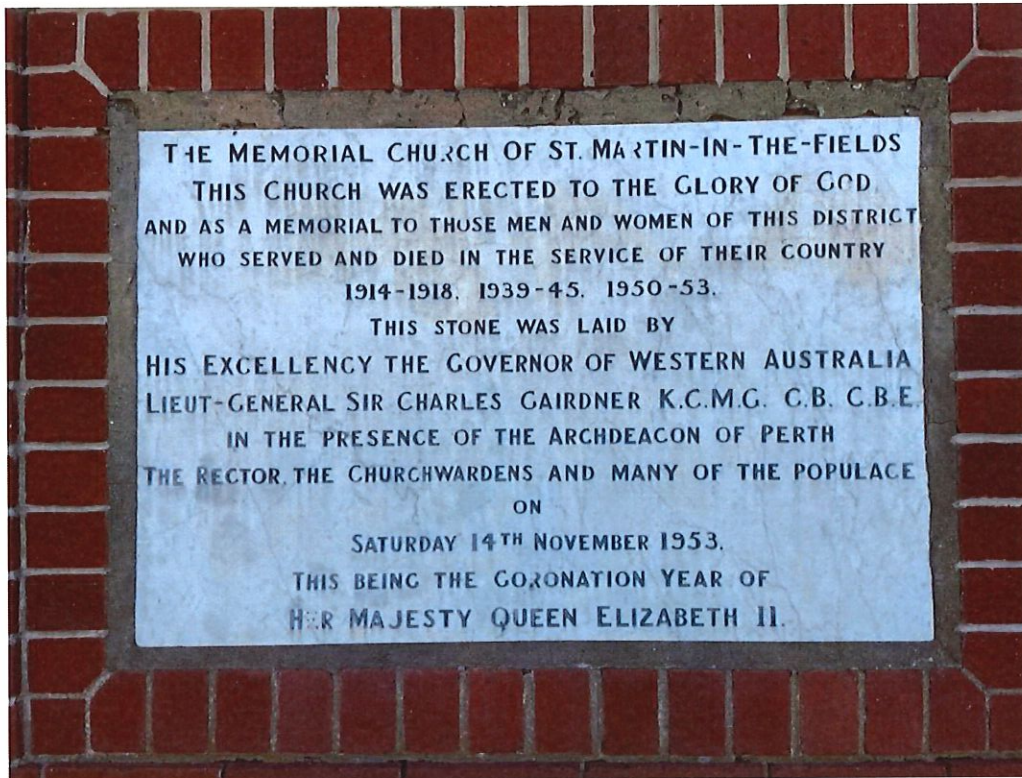
Figure 4 Dedication plaque on the front of the church. *Griffiths Architects December 2020.*

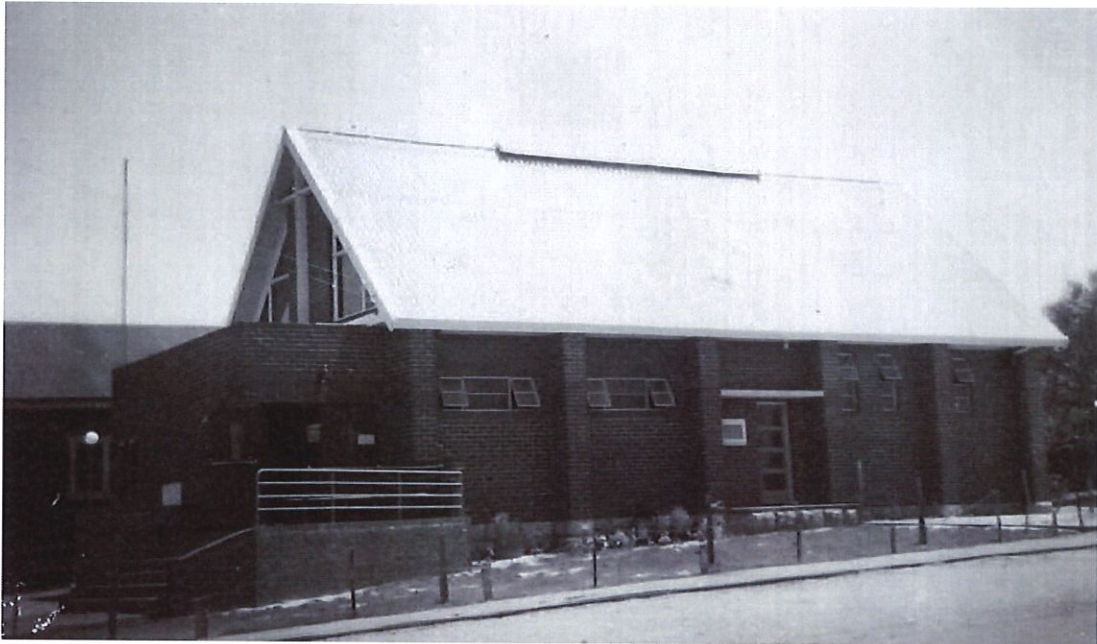
Figure 5 5 St Martin's in the Field photographed by *E.W. Doncaster 27 January 1955* Courtesy Anglican Diocese.  
In the 1970s, additions were constructed to adjoin the two buildings and in c1990 this was extended toward the rear of the lot to provide covered access to the toilets.

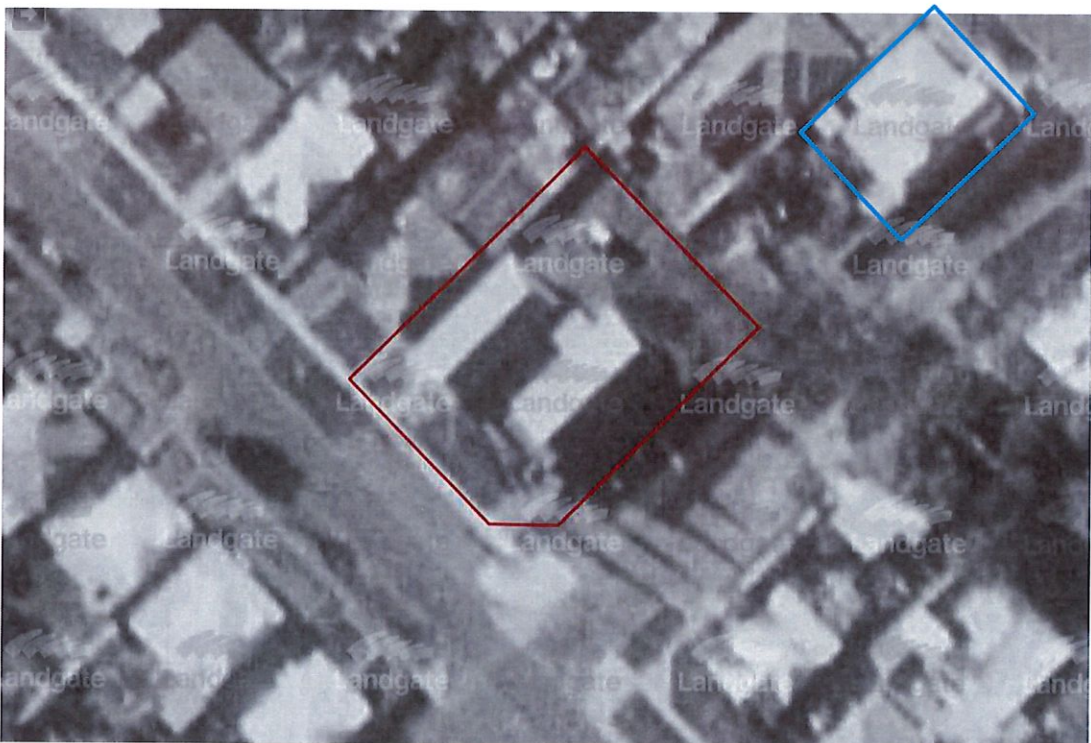
Figure 6 1974 Church and Hall with linking additions outlined in red. The building that housed the Op Shop is outlined in blue. *Landgate aerial photograph taken in 1953*

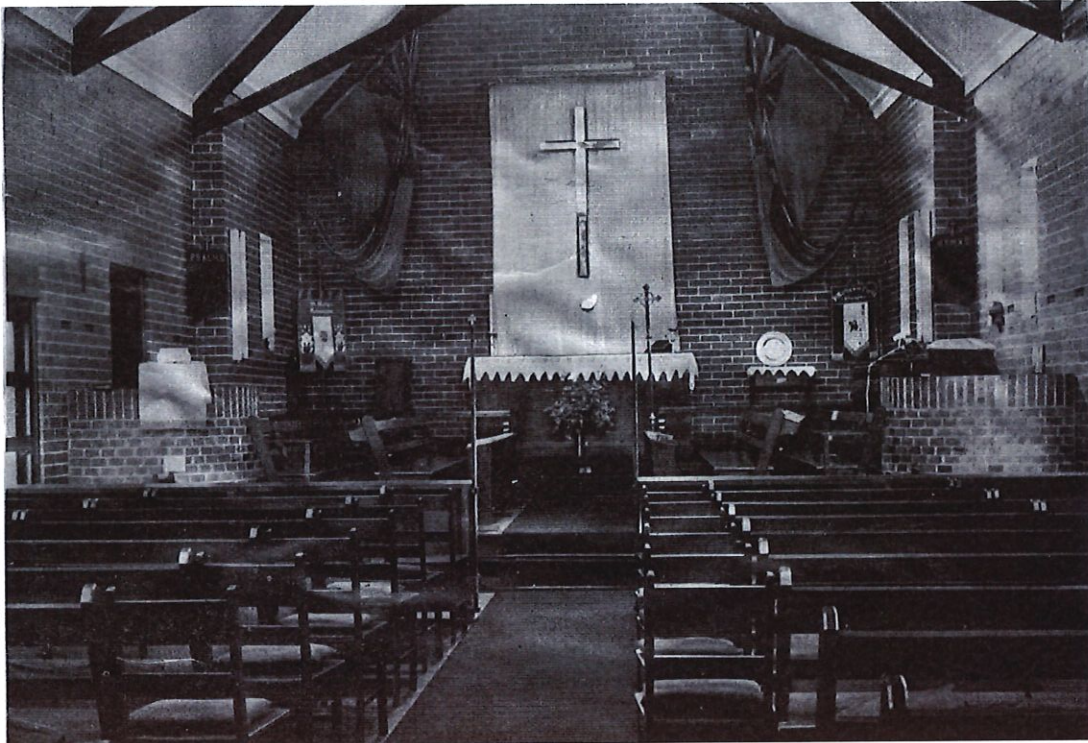
Figure 7 St Martin in the Field interior 1956 from the parish Magazine. The interior has been stripped of pulpit, altar rail, altar, crucifix and pews. *Griffiths Architects May 2021.*

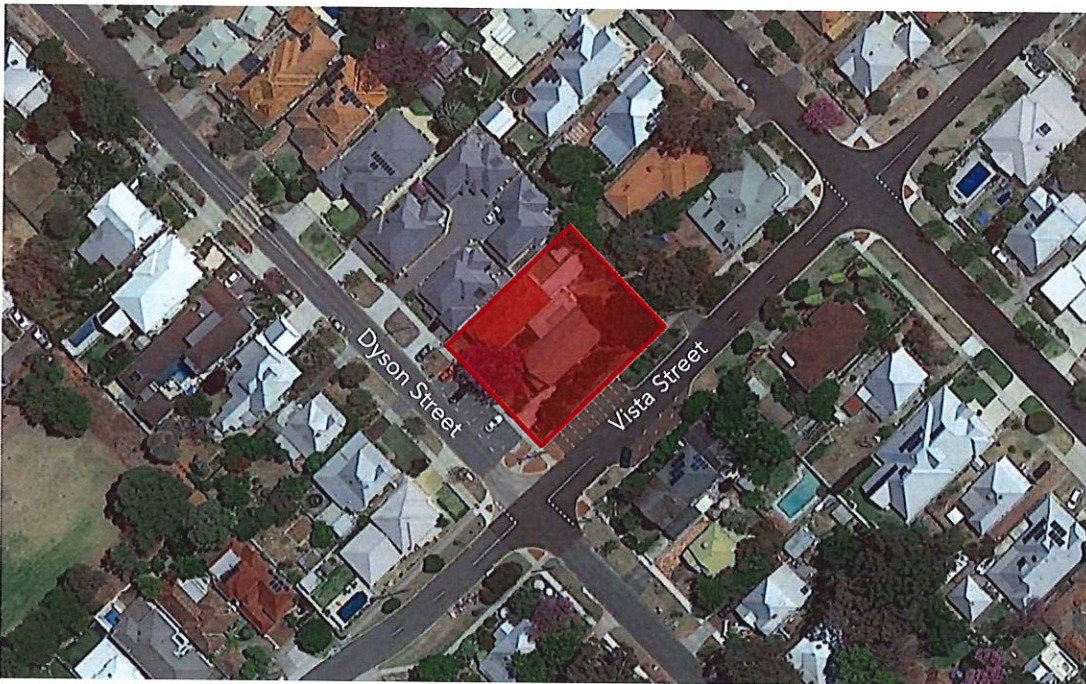
Figure 8 Site plan not to scale, site indicated in red. Nearthmaps 2021.

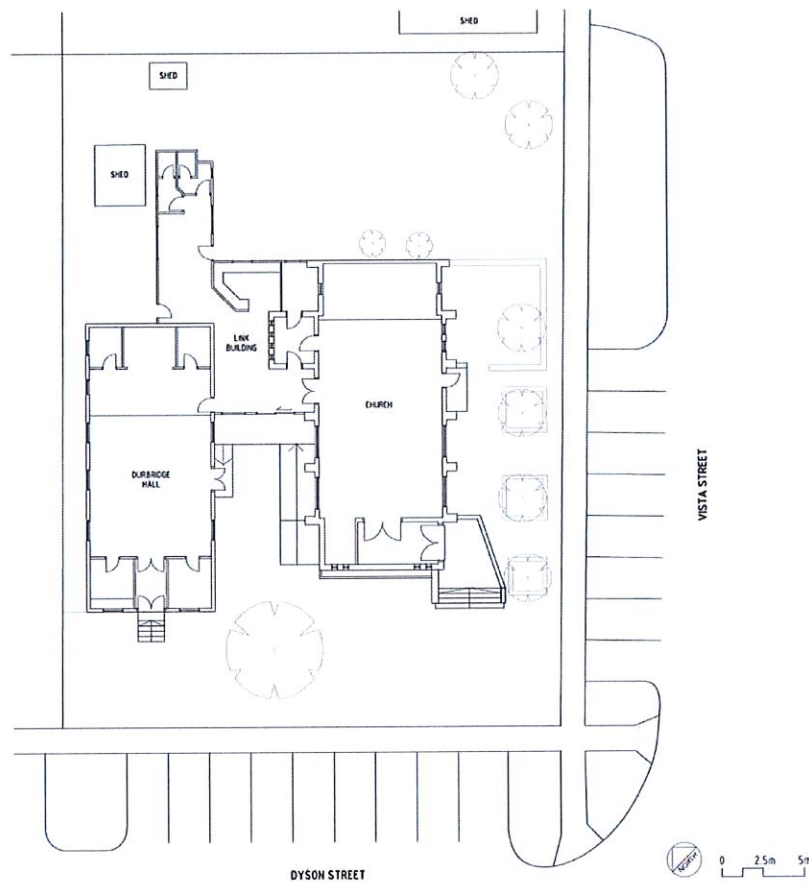
Figure 9 Plan of hall and church not to scale. *Griffiths Architects May 2021*

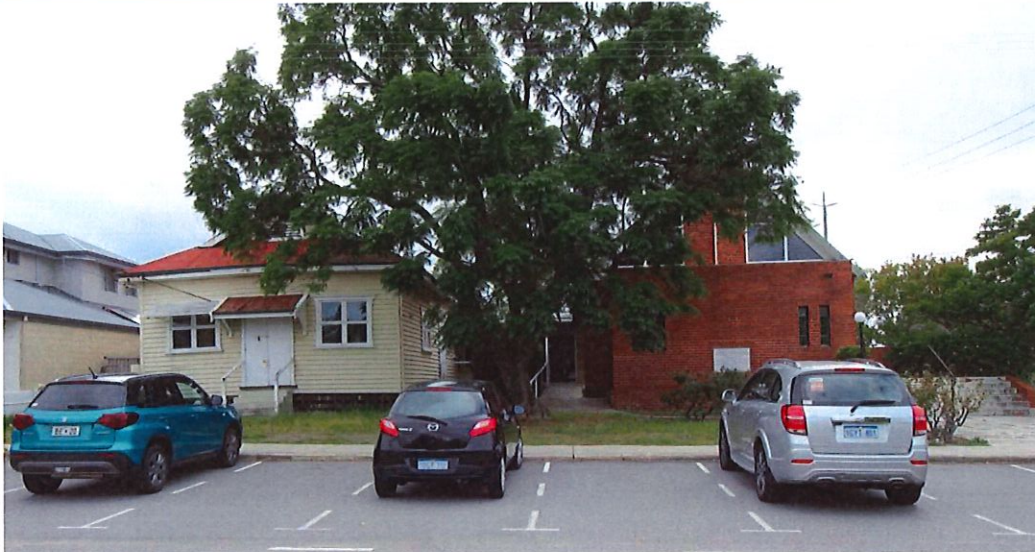
Photograph 1 Durbridge Hall (left) and the Memorial Church of St Martins in the Field (right) viewed from Dyson Street. *Griffiths Architects May 202*

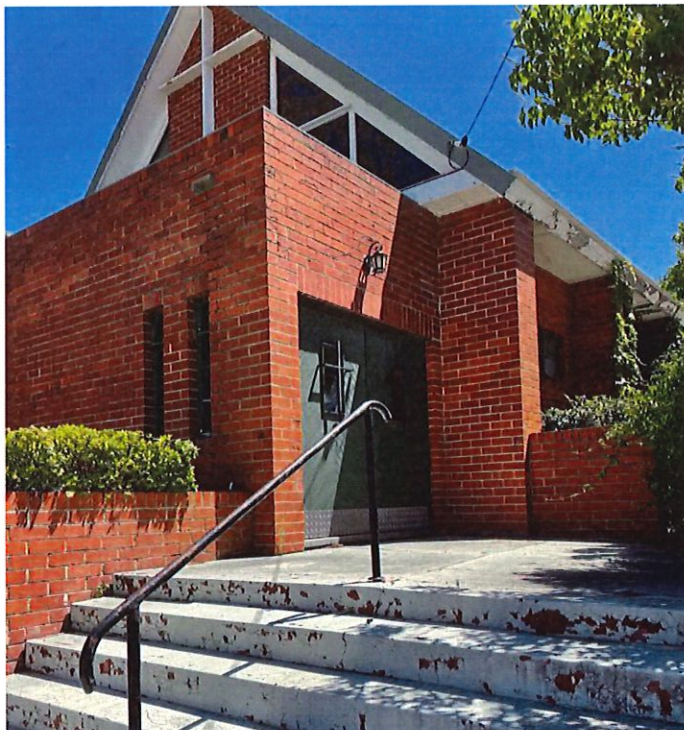
Photograph 2 Painted concrete steps lead up to the double timber with metal cross detail entrance doors at the Church entrance. *Griffiths Architects December 2020*

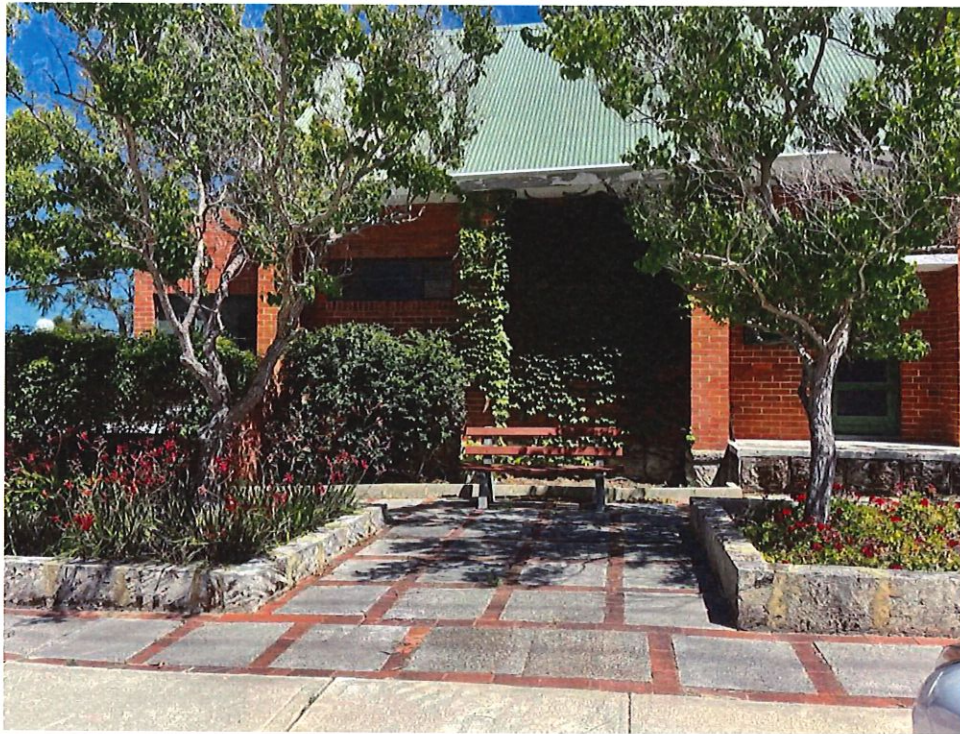
There is a good deal of mortar loss in the brickwork, much of it caused by long term gutter and downpipe failures. The problem appears to be longstanding as there have been several attempts at re-pointing.

Photograph 3 The eastern façade of the church as viewed from Vista Street. Ivy is growing on the building walls and there are 3 limestone planter boxes along the length of the façade. *Griffiths Architects December 2020*

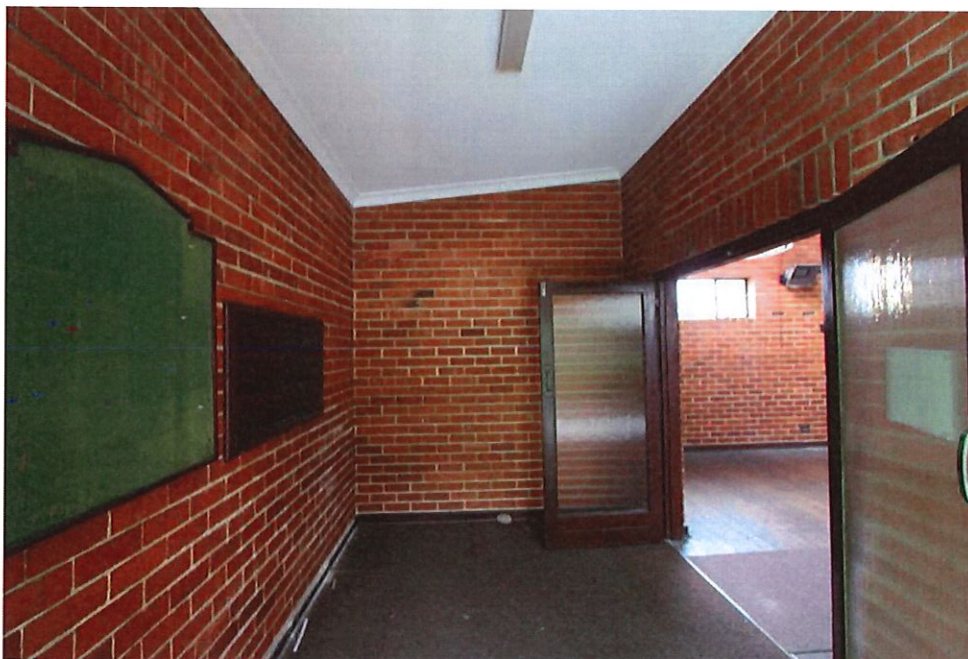
The vestibule has face brick walls, a carpeted timber floor on stumps, recent gyprock ceiling replacing the original 'fibrolite' and a pair of fully glazed timber framed obscure glazed doors into the nave. The baptistry is treated in a similar manner, but the font has been removed.

Photograph 4 Interior view of the vestibule of the Church from the main entrance doors. *Griffiths Architects May 2021*

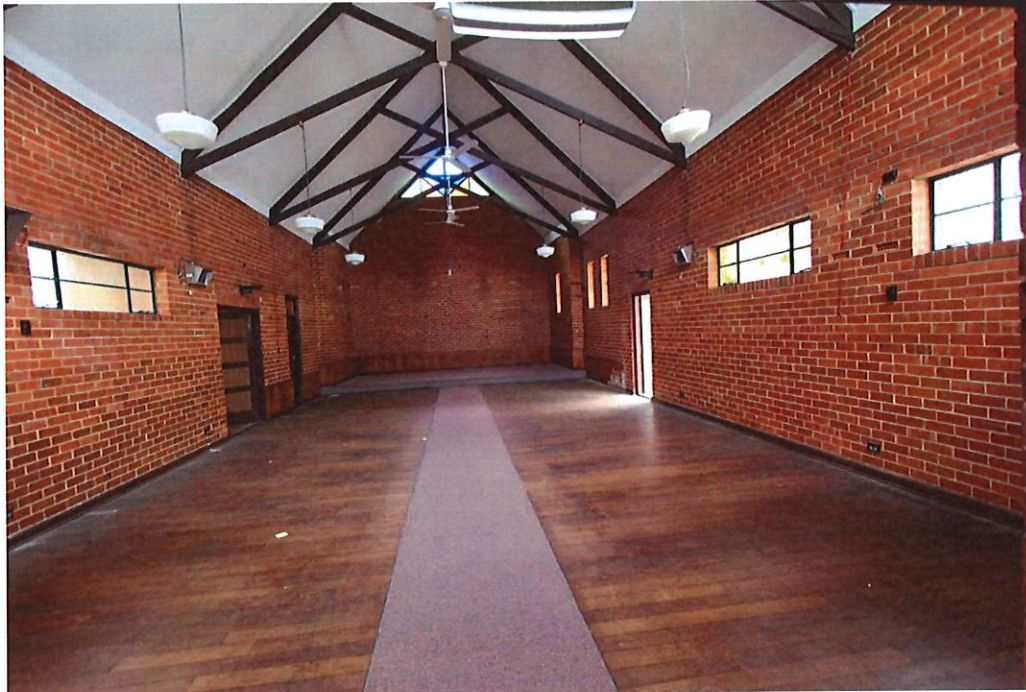
The nave retains its timber floor on stumps, scissor trussed roof, fibrous plaster ceilings and face brick walls, with a bull nosed timber skirting, though the choir and altar have a vertical boarded deep skirting that would appear to have been put in place when the floors in this area were lowered so that now there is a single step up to the altar.

Photograph 5 Interior of the Church looking towards the northern end where the altar used to be. *Griffiths Architects May 2021*

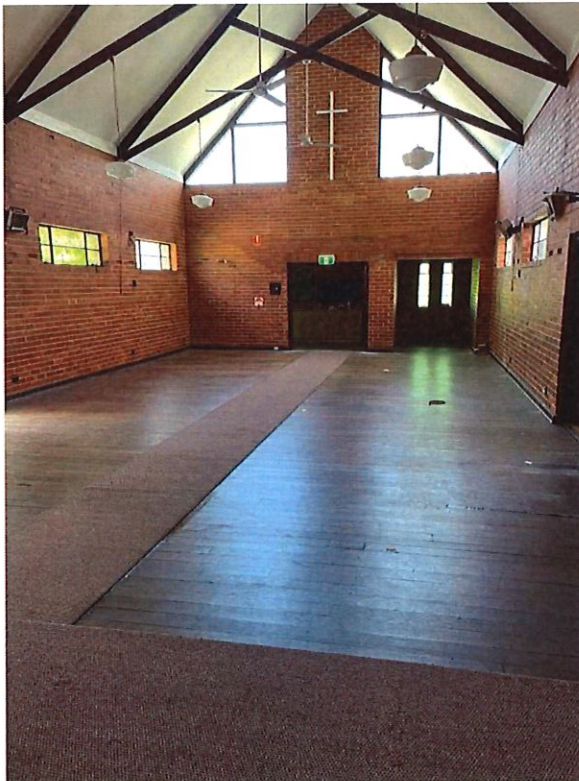
Photograph 6 Interior view of the church looking towards the southern end to the narthex where the vestibule and entrance are. The alcove to the right used to be the baptistry. *Griffiths Architects December 2020*

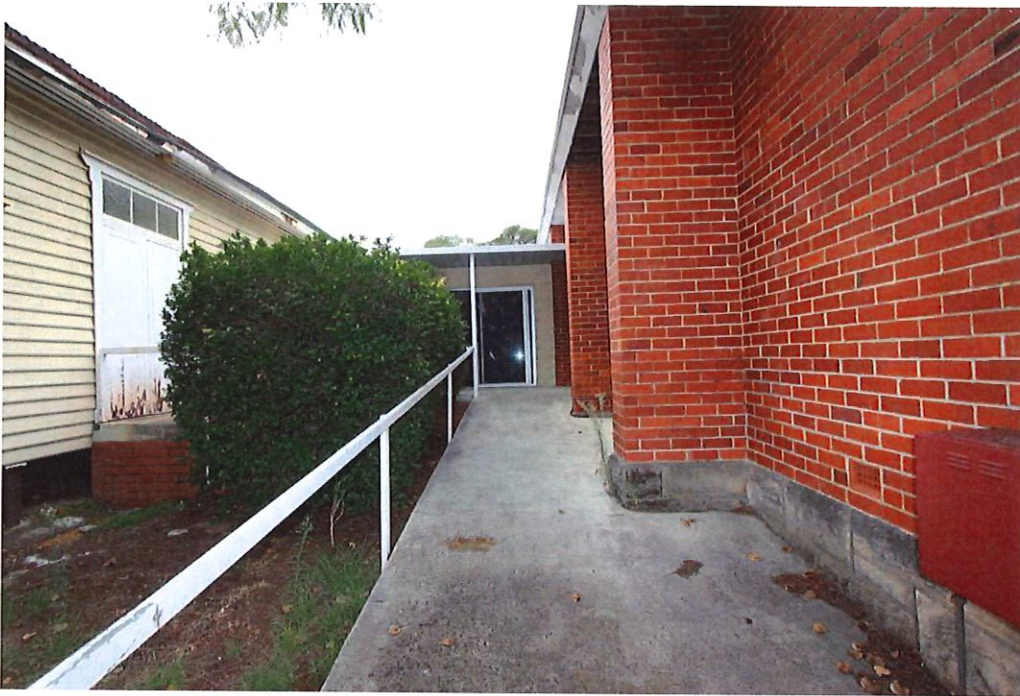
Photograph 7 The ramp between the Church and Hall leading to the entrance of the Link and Hall buildings. *Griffiths Architects May 2021*

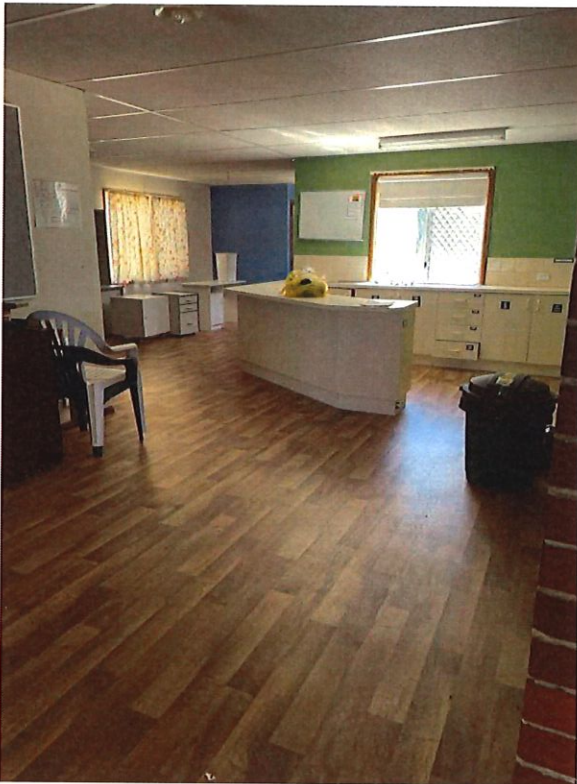
Photograph 8 The kitchen area of the link building looking towards the toilets and the northern end of the building. *Griffiths Architects December 2020*

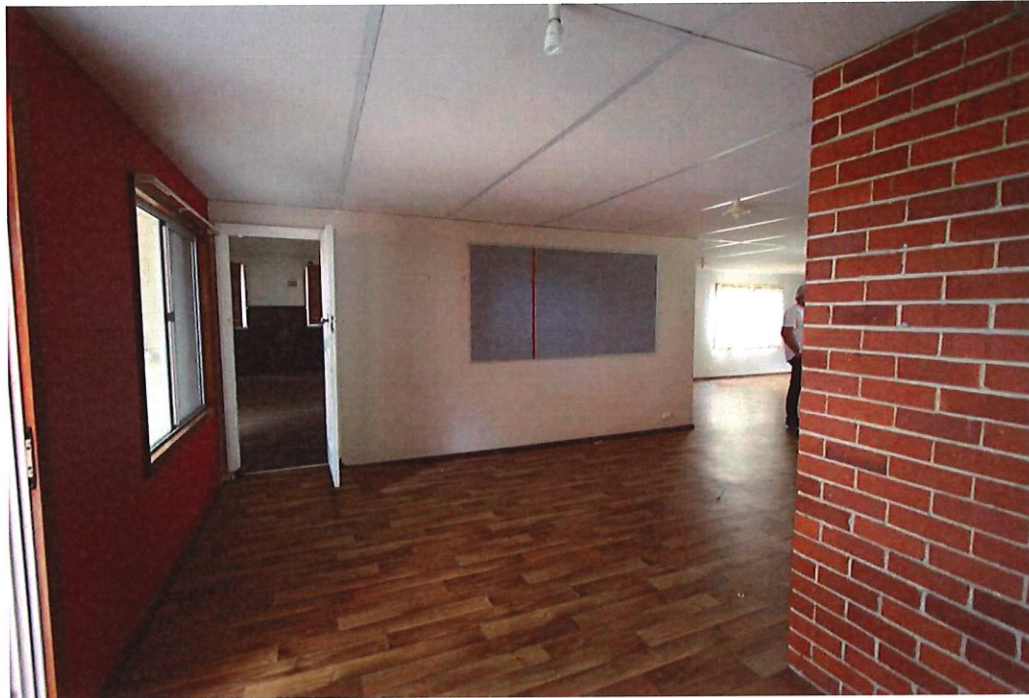
Photograph 9 Interior view of the link building near the sliding entrance doors looking into a door into the Hall. *Griffiths Architects May 2021*

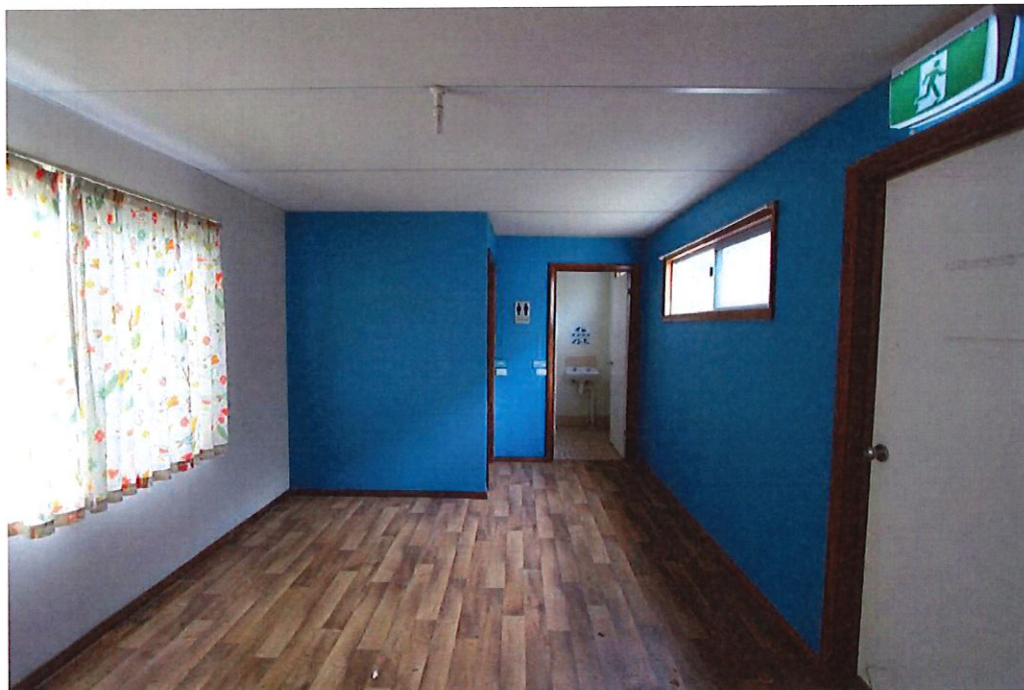
Photograph 10 Toilets at the northern end of the link building. *Griffiths Architects May 2021*

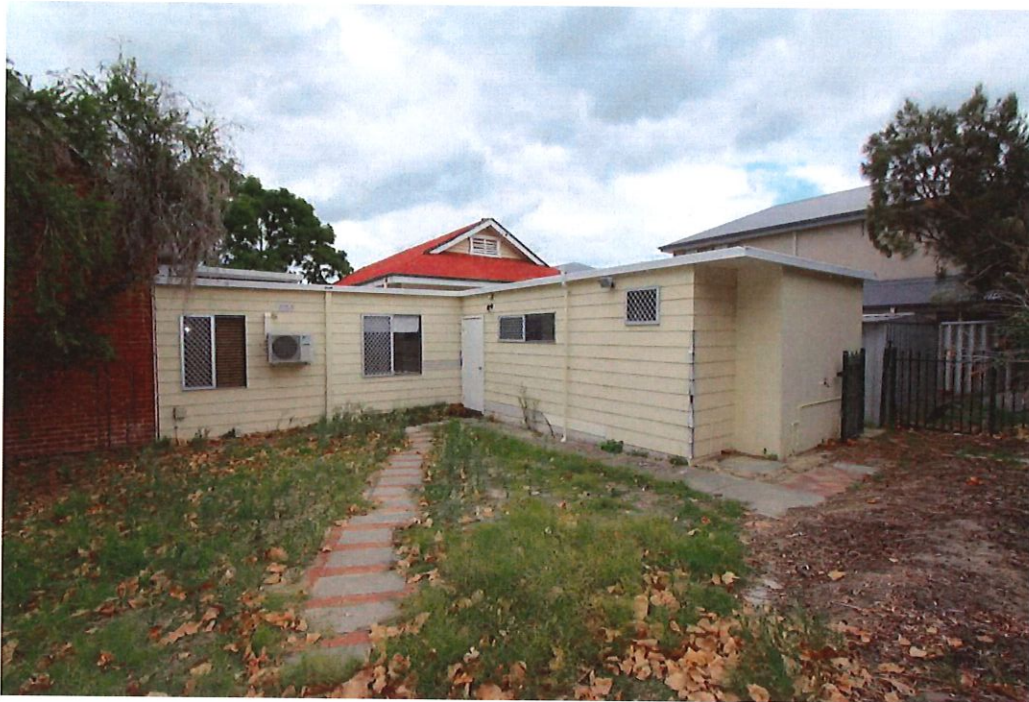
These additions linked church and hall and linked them to an existing toilet to the rear of the hall. This work created a reception area between buildings, a kitchen and social area. The toilets were upgraded at this time. This stage was constructed in light framing with a flat roof and Hardiplank walling, with aluminum framed windows and doors, lined on the interior with gyprock

Photograph 11 Exterior view of the link building from the north east, Church is to the left and the roof of the Hall can be seen above the link building. *Griffiths Architects May 2021*

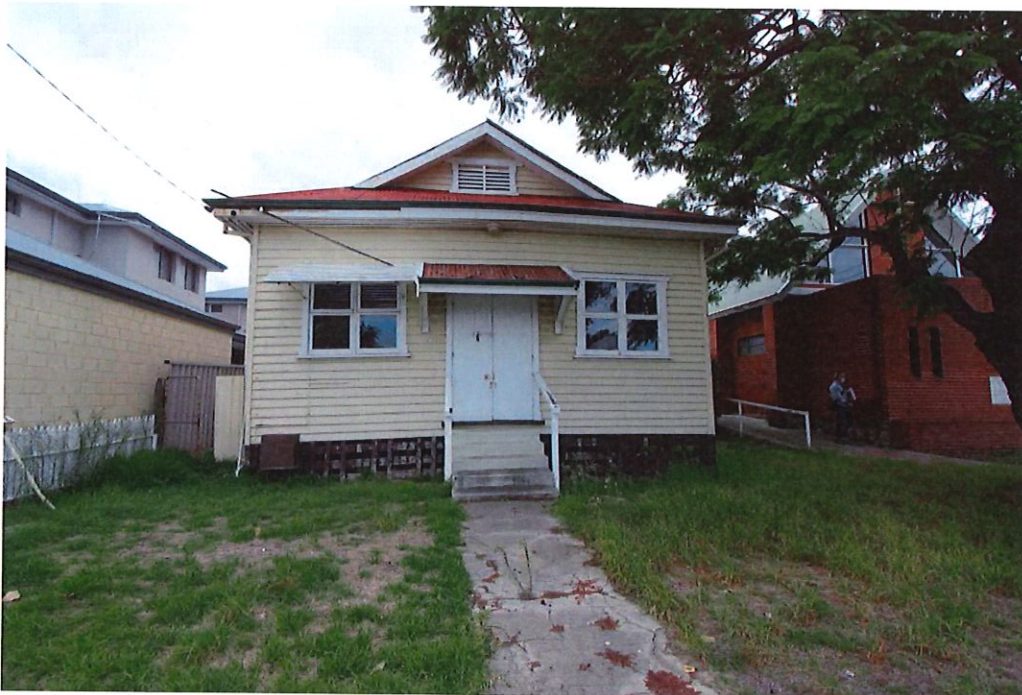
The walls are ship lapped weatherboards. The weatherboards and stop beads are in fair to poor condition, with evidence of numerous ad hoc repairs and lower boards in particularly poor condition. The roof features a louvred vent in the gambrel and its soffits are lined with birdboards.

Photograph 12 Dyson Street elevation of Durbridge Hall. The corners of the building are sagging. *Griffiths Architects May 2021*

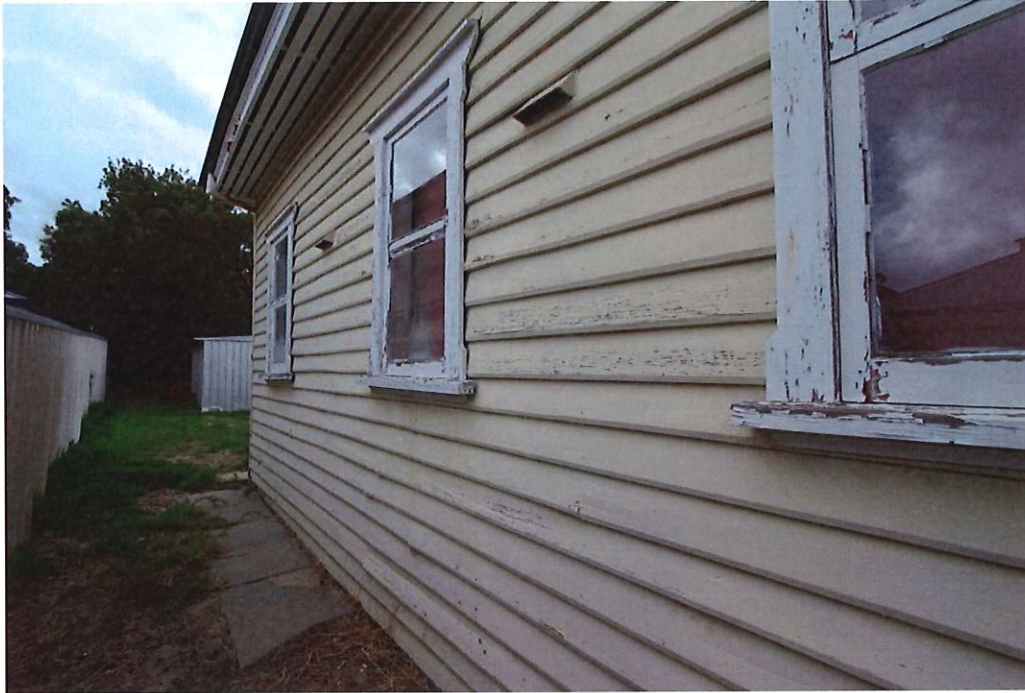
The flanking walls and windows match the front elevation but have hooded wall vents at high level. All casements have been removed and replaced with timber awning lights, most likely in the 1950s. All of this joinery is in poor or very poor condition, with sashes coming apart, putty failing and many members rotting at the ends at joints. The flanks and rear of the church have accreted ground levels so that the weatherboards are partly buried towards the rear of the church.

Photograph 13 The western façade of the Hall shows the general level of deterioration of the entire building. *Griffiths Architects May 2021*

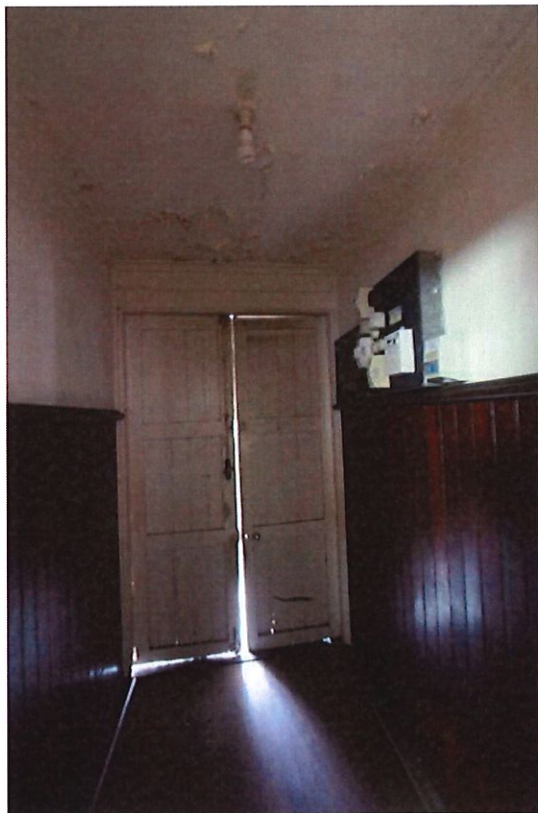
There are no special features on the interior, and it is generally in fair condition, with some areas in poor condition arising from historic leaks and some poor workmanship. The ceiling is quite damaged by roof leaks and painting failures.

Photograph 14 Interior view of the Hall's wind lobby looking toward the entrance doors. The ceiling shows signs of water damage. *Griffiths Architects May 2021*

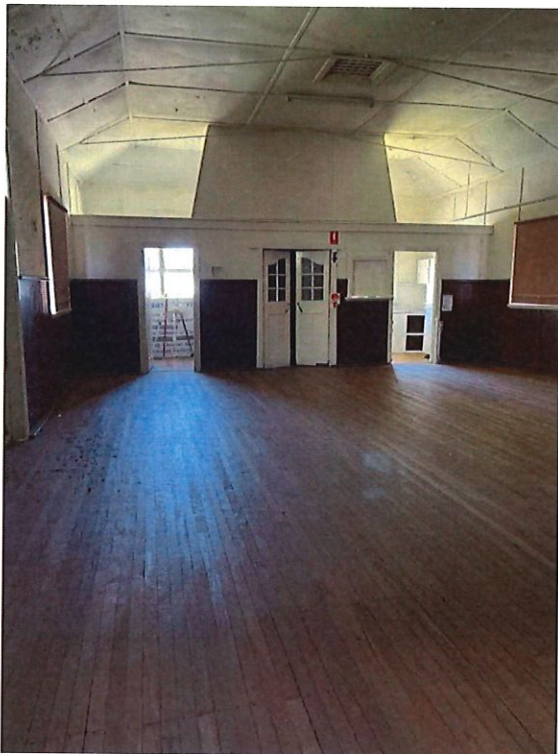
There is a pair of paneled and glazed doors to the interior of the wind lobby. The northern corner room is fitted out as a kitchen.

Photograph 15 Interior view of the Hall looking towards the internal timber and glazed doors of the lobby with kitchen to the right. *Griffiths Architects December 2020*

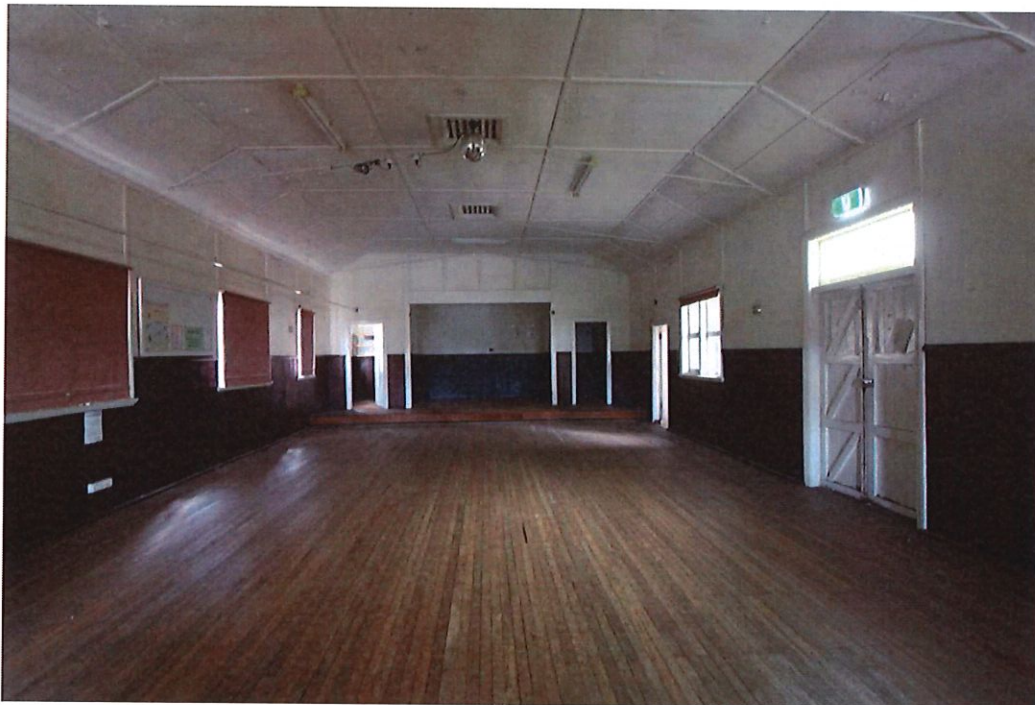
Photograph 16 Interior view of the Hall looking towards the stage at the northern end of the building. *Griffiths Architects May 2021*
