TECHNICAL REPORT

**SALTER POINT
FORESHORE
RESTORATION PLAN
REVIEW**

SEPTEMBER 2015

FOR
CITY OF SOUTH PERTH

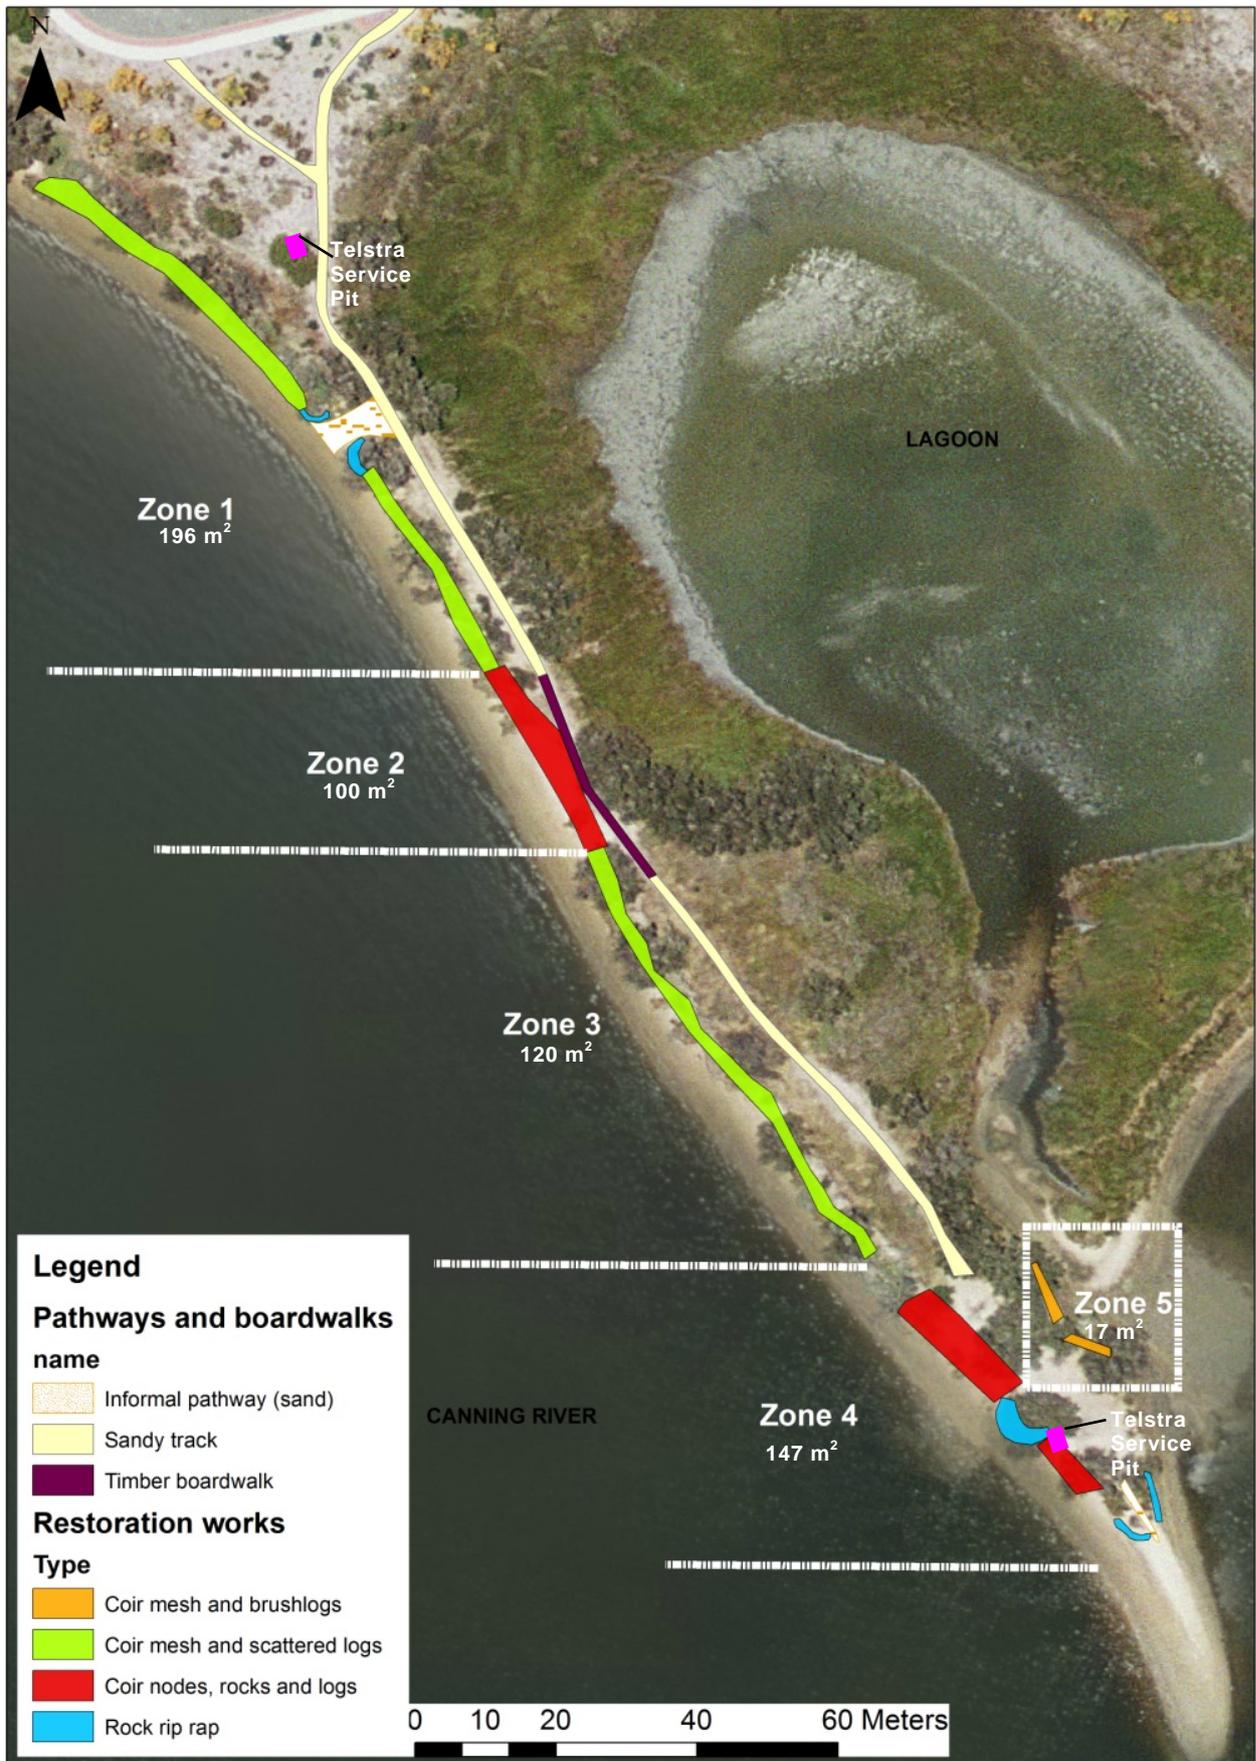
Figure 2 Restoration Zones at Salter Point Spit showing extent of previous (2012) restoration works (Imagery: Landgate, 2006)

In order to best explain the success or otherwise of restoration works implemented in 2012, background information on causes of erosion and vegetation loss on the site are given prior to presenting the results of current investigations. For orientation, the site has been divided into five zones as presented in Figure 2 incorporating the type and extent of restoration works completed in 2012.

Figure 2 also shows the location of access tracks, the boardwalk and two Telstra service access pits. The pathways are constructed of compacted crushed limestone bordered by pine treated logs and metal edging. Due to frequent flooding in winter the northern section of the pathway (north of boardwalk) is overlain by sand. Similarly, the pathway to the spit (Zone 4 in Figure 2) is also sandy. The infrastructure elements such as the southernmost Telstra service access pit and the boardwalk are likely to influence erosion particularly the areas adjacent to these structures.

When viewing this section of the report, Figure 2 should be referred to as it presents an overview plan of the site and labels each erosion zone in a numerical order from north to south of the spit point. The whole site restoration will involve similar techniques as the FRP (Syrinx 2011), most notably brush logs and brush wall.

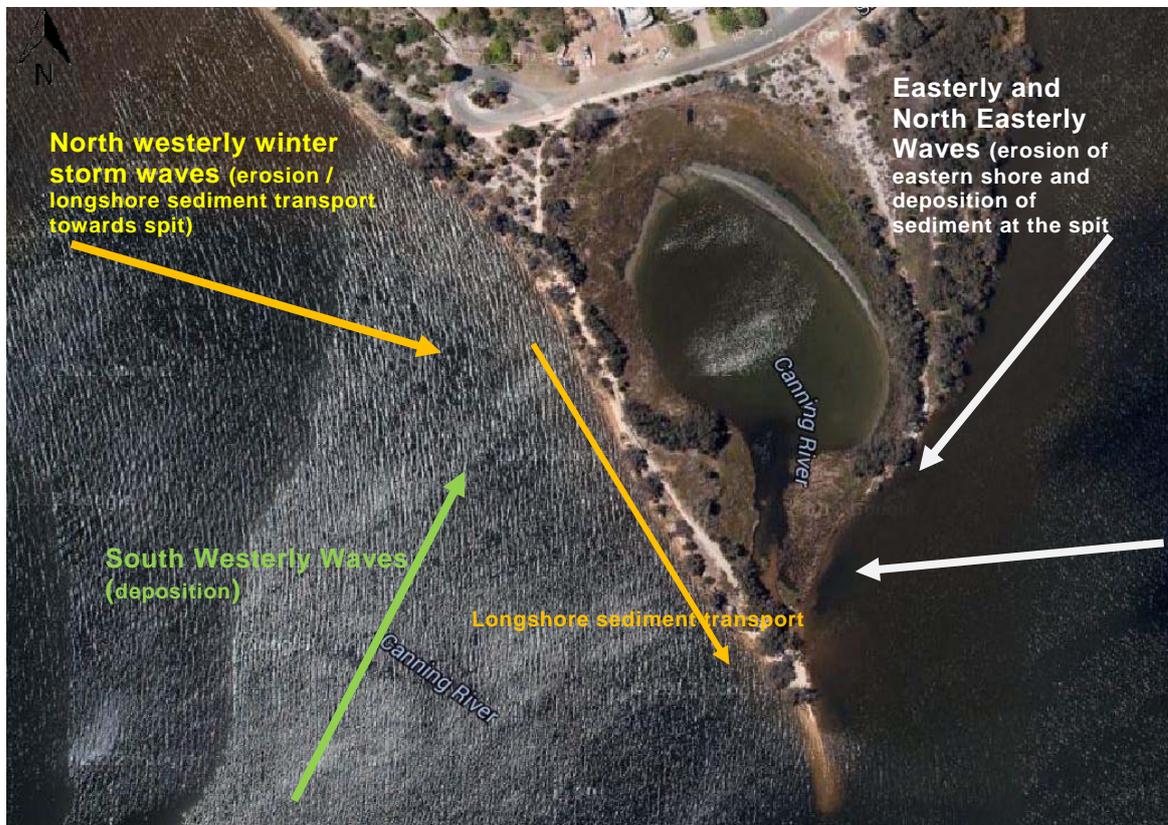
Figure 4 Aerial photograph of the site showing dominant wind / wave direction (Imagery: Google, 2012)

The analysis of wind roses for the Perth area suggests that the dominant wind directions are light to moderate north easterlies in the mornings and moderate to strong south westerlies in the afternoon for the majority of the year. The prevailing south westerly winds deposit sediment, whereas the north westerly winds that blow in winter, particularly during storms, erode it (Figure 4).

When the wind speed is high and water levels rise (due to tides and the storm surge events) the height and the period of waves increases causing them to reach areas of upper foreshore that are usually not subject to wave action. Unaccustomed to this change, the vegetation found in these areas is susceptible to damage by waves. Once the vegetation is damaged and the cover reduced, the soils erode further allowing waves to penetrate deeper into the foreshore profile. This is most evident in Zones 2 and 3 where waves reach higher elevations (~ 0.6 mAHD).

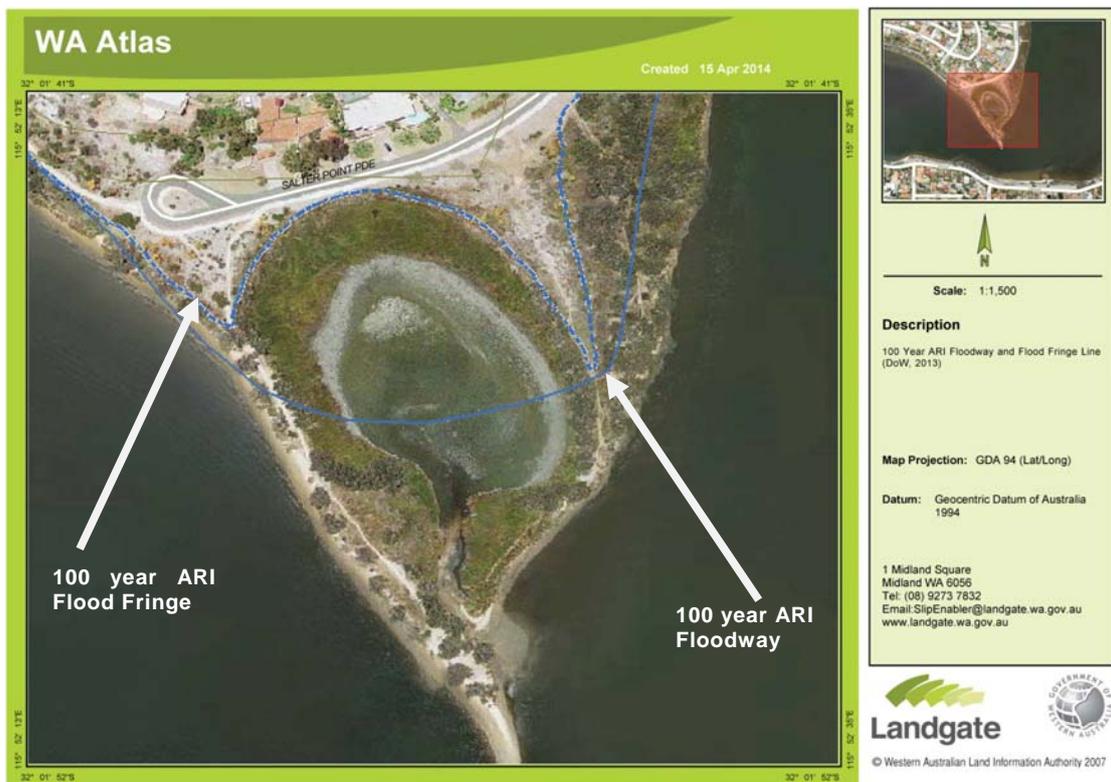
Figure 5 100 year ARI Floodway and Flood Fringe Line (Source: Landgate, 2014 with dataset by DoW (2013))

The DoW has mapped the 100 year floodway and the flood fringe boundaries for the Swan Canning River System for the present day conditions. The section relevant to Salter Point spit is shown in Figure 5 and indicates that almost entire site is subject to flooding under current 100 year ARI (DoW, 2013).

Sea level changes up to 0.5m will submerge the current extent of the lower shoreline vegetation up to the access path. Any storm surges would inundate the entire spit as previously shown in Figure 5 Section 6.1.2.1. Sea level rise of 0.9 m would inundate the spit area and the lagoon entirely leaving only small parts of the dryland adjacent to the end of Salter Parade (north end of the promontory).

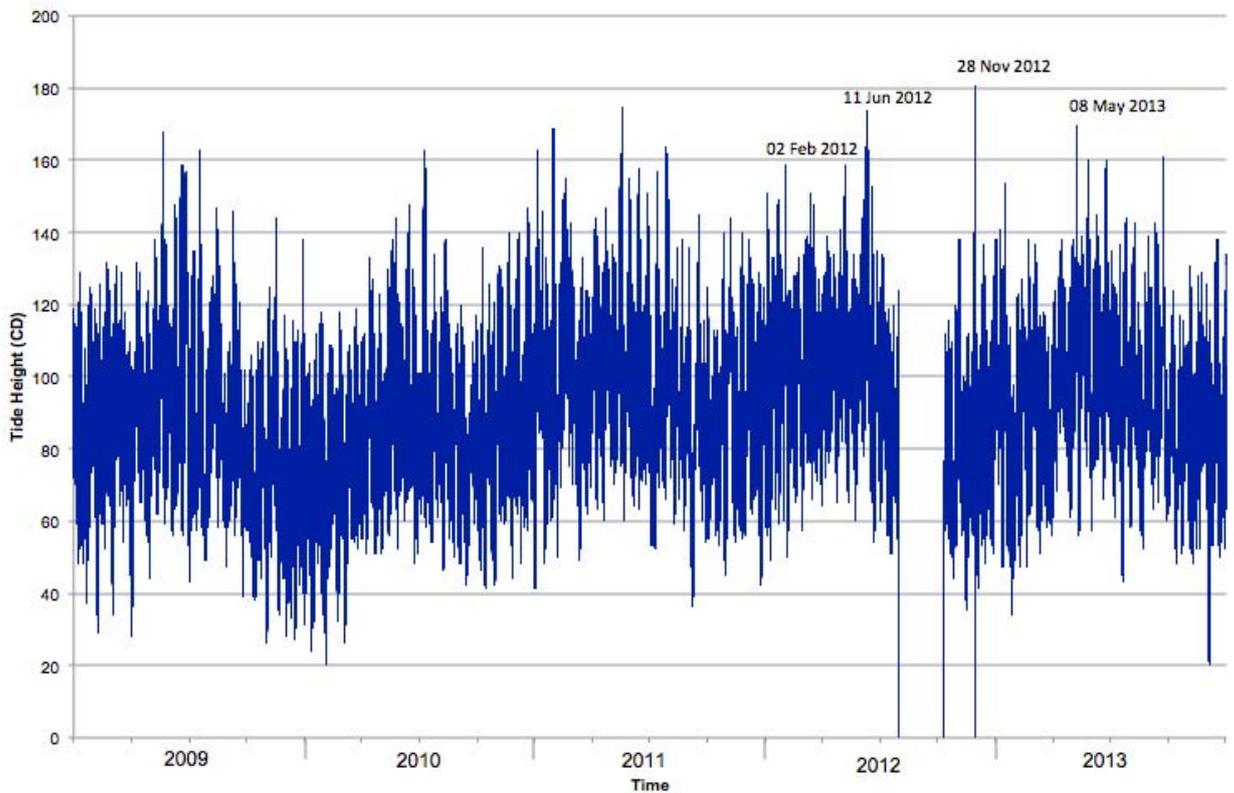
Figure 7 Tide records for Barrack Street Jetty 2009 – 2013 (Data from DoT, 2014)

The review of the tide data for the 2009 – 2013 period collated by the Department of Transport (DoT) (Figure 7) for Barrack Street Jetty, shows that since June 2012 event another surge occurred on 28 – 29th November 2012 which reached 1.03 mAHD (1.78 m CD). During 2013 most significant tide was recorded on May 8 with a recording of 0.92 mAHD (1.67 mCD). Although short in duration, it is likely that these events also contributed to the poor establishment of vegetation, however February 2012 and June 2012 events are most significant as they occurred during and immediately after planting thus causing most damage.

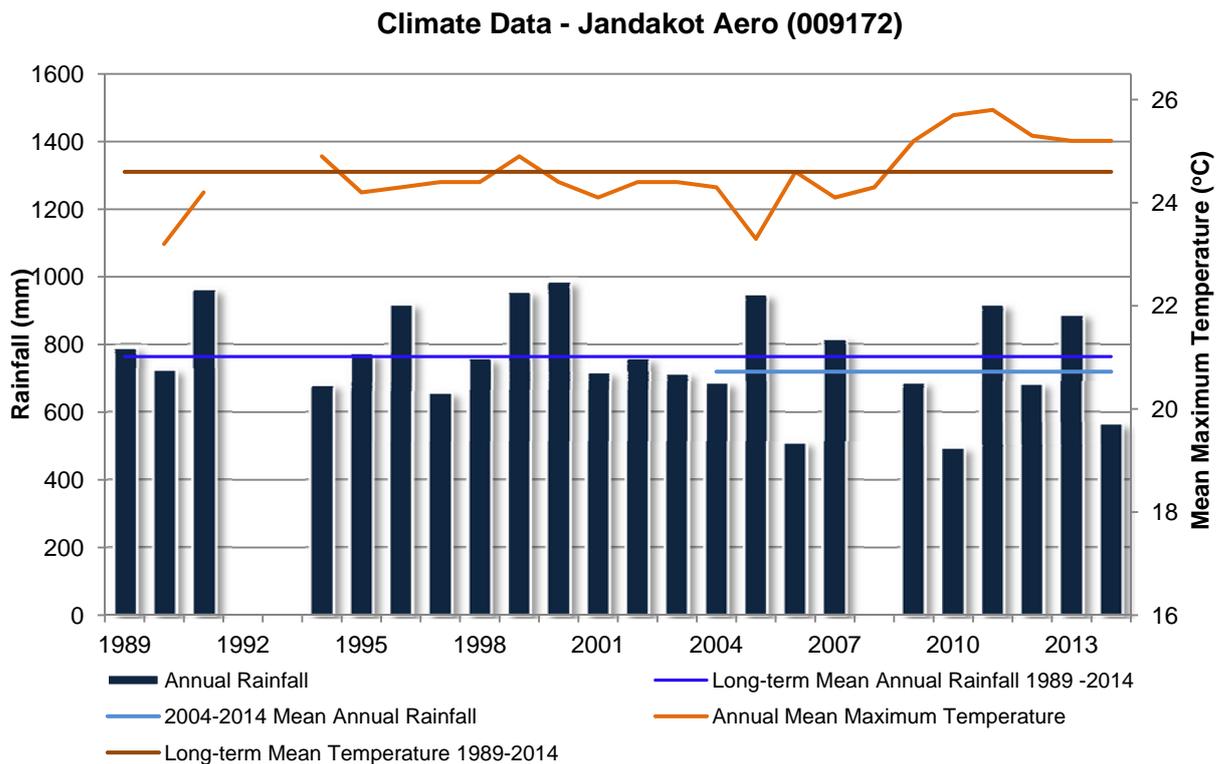
Figure 13 Annual rainfall and mean temperature maxima for Jandakot Aero (009172) weather station for years 1989 to 2014 including the long-term (42-year) mean annual rainfall (BoM 2015)

Historical climate data for Jandakot Aero (009172) weather station, showing annual rainfall and mean temperature maxima for the years 1989 to 2013 is summarised in Figure 13.

Mean annual rainfall for the years 2004 to 2014, represented by the pale blue line, is 720 mm, 99.3 mm below the 42-year (1972-2015) long-term average of 819.3 mm. Annual rainfalls well below the 10-year average (2004 – 2014) of 720 mm were recorded for 2010 (496 mm), 2006 (509 mm), and 2014 (566 mm).

Since 2008 the mean annual temperature maxima have consistently exceeded the long-term average of 24.5°C with temperatures in 2010 and 2011 having temperatures of 1.2 and 1.3°C

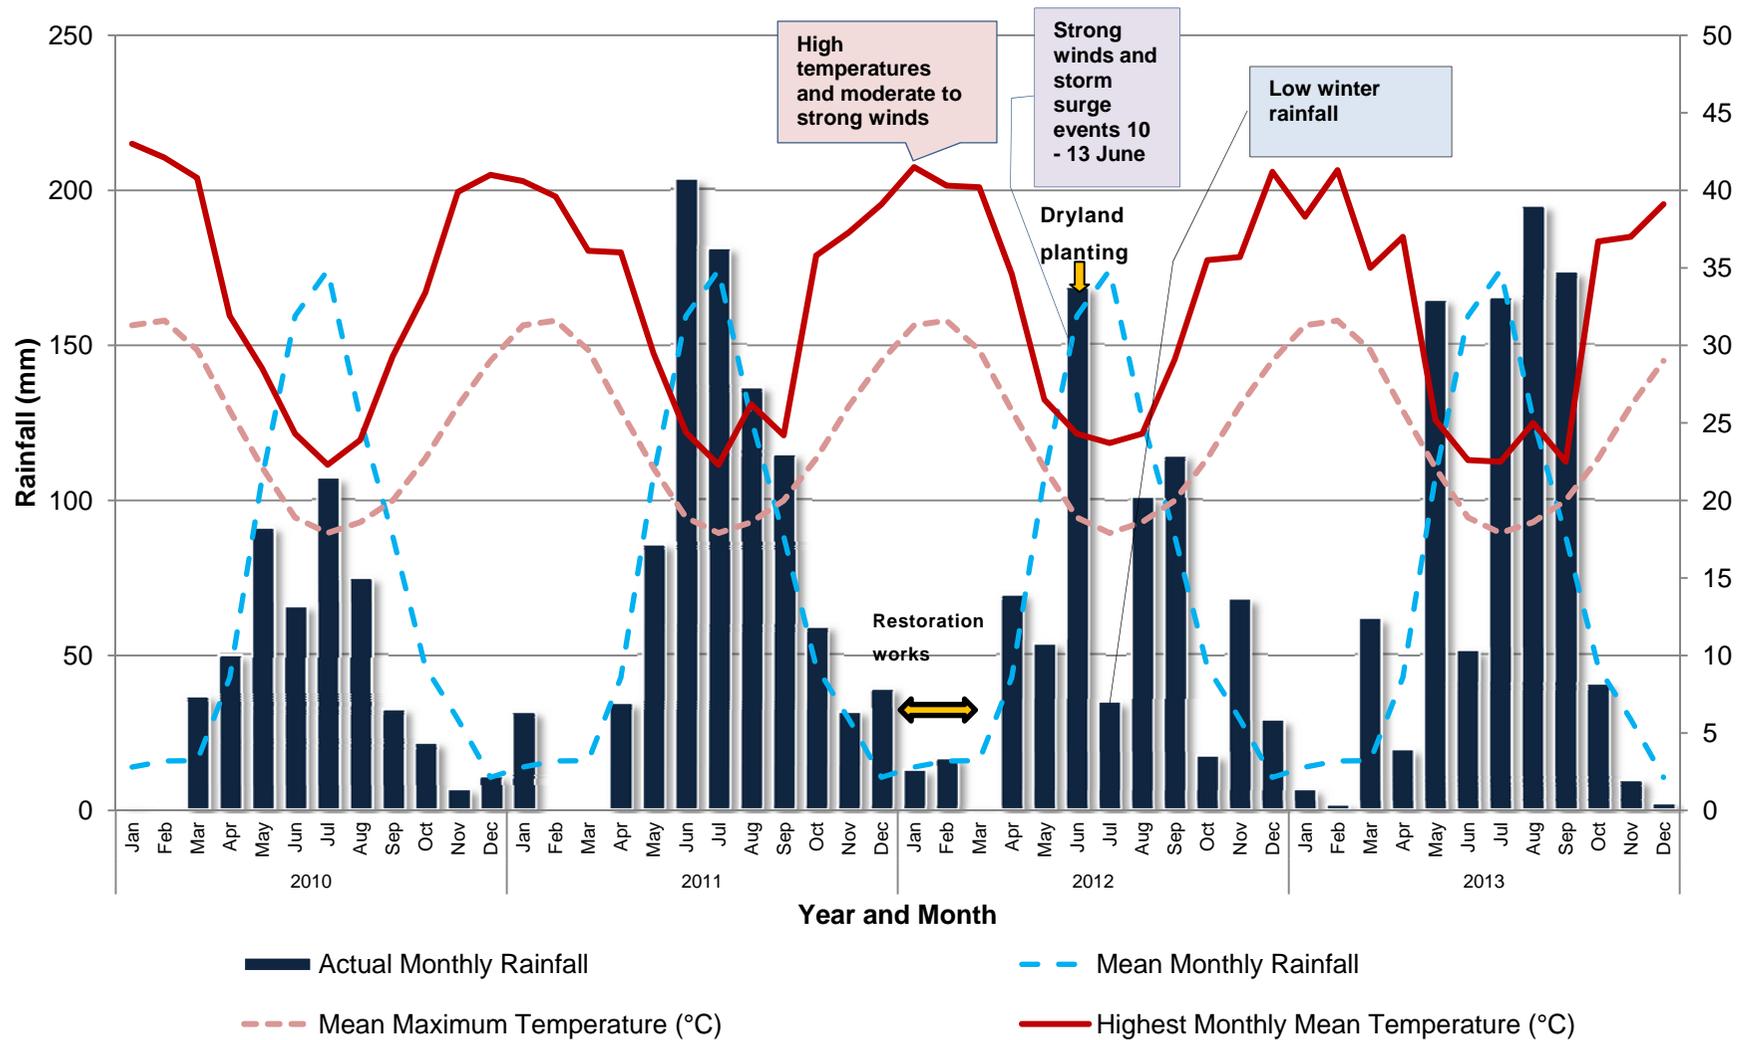
Figure 14 Monthly rainfall and the long-term average monthly rainfall for Jandakot Aero (009172) weather station for years 2010 to 2013 (BoM 2014) showing significant weather events during restoration works

Most Salter Point foreshore planting works have occurred late January – March 2012 (Figure 14). Although no rainfall occurred in March 2012, the average summer rainfall and possibly the groundwater conditions on site would have been suitable for initial establishment of the foreshore species. However, the temperatures recorded during the planting period were much higher than average and combined with winds on site have contributed to high transpiration or water loss from the plants. Whilst the plants were watered during the establishment period, the watering frequency was low (limited by budget constraints) and amount was not adequate to counteract water losses.

Low winter rainfall also had an effect on the growth of dryland species which were planted in June 2012. The below average July rainfall, lack of manual irrigation and water repellent nature of existing soils has likely contributed to the poor establishment and death of the dryland species. Whilst the temperatures were slightly higher than the mean average maximum temperatures, this is unlikely to have been the cause of the poor dryland / upper foreshore vegetation establishment (Figure 14).
